**Appendix 1A - Christine Thomson, Decorative Arts Conservation, Salem, MA**  
**Notes and stratigraphic charts by room from investigations at the Parsons**  
**House, 2024-2026.**

**Nathaniel Parsons House, Northampton MA**  
**Room 101 Notes**  
**December 6, 2024**  
**Revised January 16, 2026**

Nathaniel Parsons House Historic Structures Report  
Myron O. Stachiw et al.  
April 2026

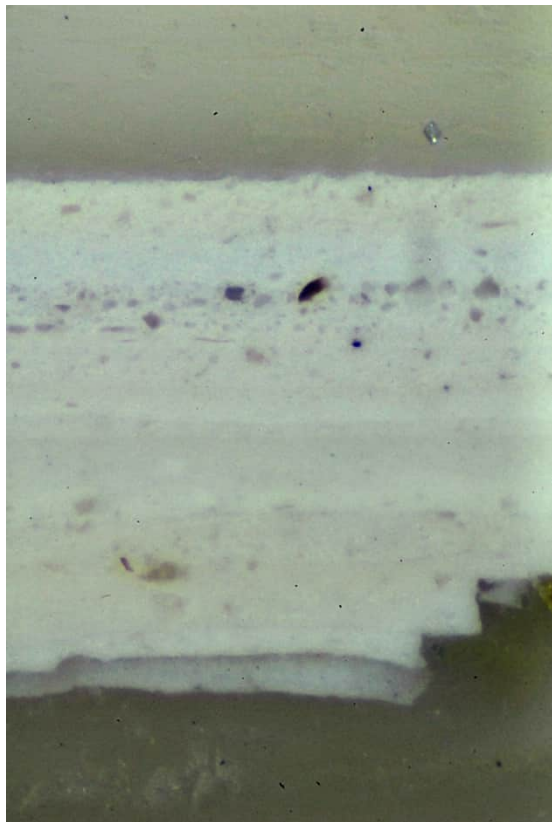
Most of the paint in this room had been removed as part of a previous renovation; however, we identified some areas that did not get completely stripped. A build-up of several paint layers was found on the south side architrave around the door leading to Rm 102. In this location (sample 039) there appear to be at least 12 coats of paint, mostly off-whites and light grays. It is difficult to see the separate paint treatments in visible light, but in UV light the demarcations between layers are more pronounced.

039 East wall architrave, south side vis. 125X

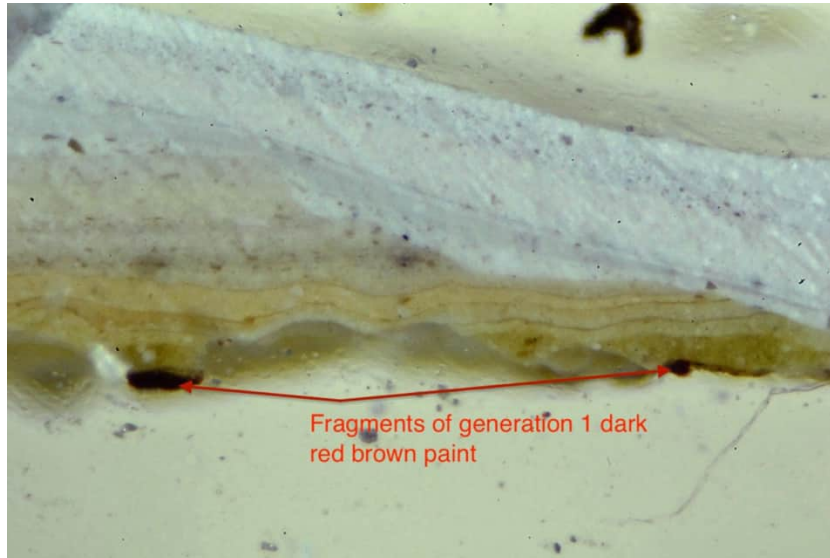
There is a boxed post east of the exterior door and a sample was removed from the side facing north. The generation 1 paint color is a dark red brown.

036 South wall boxed post, side facing north

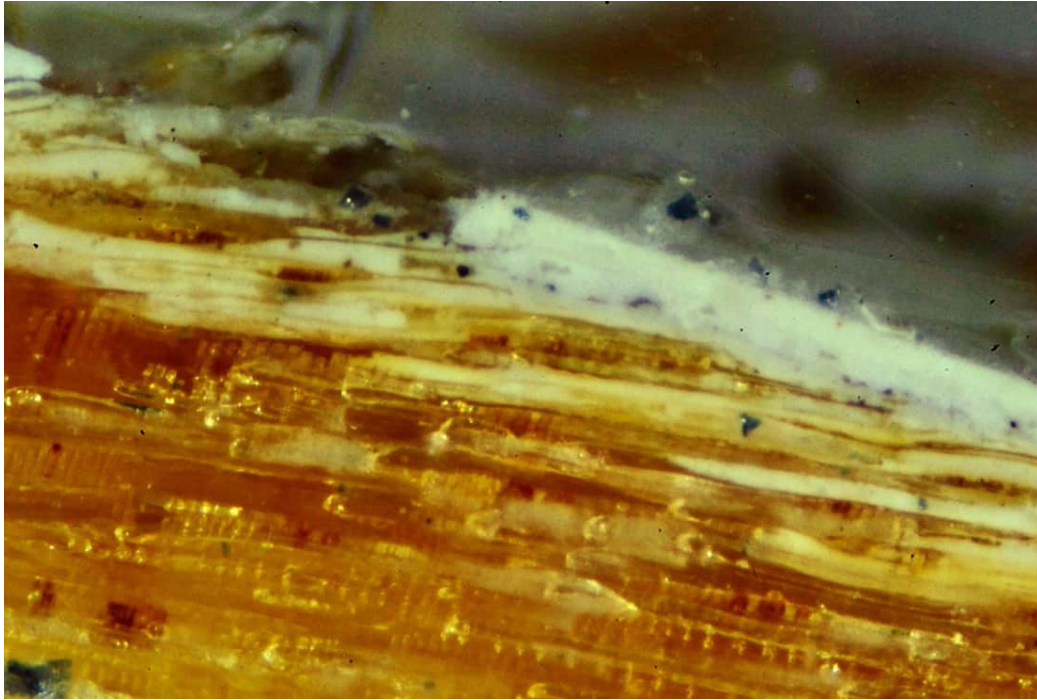
NPH 012 vis. 12

Much of the current woodwork has been stripped of most of its paint, during the renovations that took place in the 1950's and 1980's. Most Federal period woodwork surfaces were found to have only two layers of off-white paint which was applied after stripping. In areas where stripping did not remove every bit of paint, fragments of earlier paint were identified, indicating that the first-generation color on the Federal period woodwork in this room was yellow brown. The yellow brown color as generation 1 was also identified on the wainscot at the right side of the door to the hallway, and on the east wall wainscot. The photomicrograph of sample 012 below shows the stripped baseboard surface with the generation 1 yellow brown paint trapped in the pores of the wood, covered by a light tan, possibly a primer, and two coats of off-white paint, the lower one slightly yellow in color.

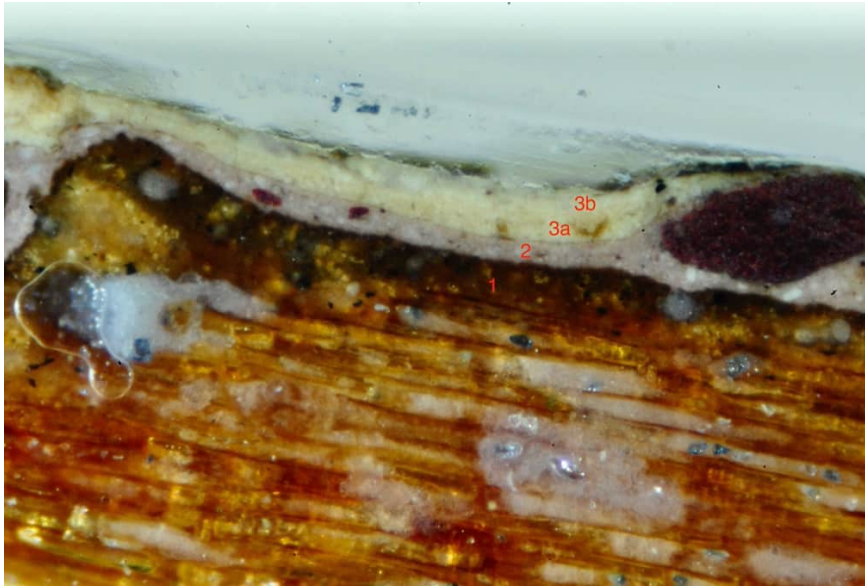
**Sample 001 West wall, earlier exposed paneling, right side of fireplace.**

NPH 001 vis, 50X

Sample 001 is from the earlier (Phase 2) chimney breast wall paneling that has been exposed. It has three generations of paint finishes, applied prior to its being covered by the present built-out wall. The first generation appears to be a pigmented stain and/or a large amount of dirt and grease forming a dark brown/black coating. Black pigment is visible under the microscope in this first layer but it is unclear if it is soot or another black pigment. Generations 2 and 3 are more like paint layers. Layer 2 is a light lavender brown color *in situ*, and the uppermost layers (3a and 3b) are a yellowish buff color. Their similarity in color and appearance along with the lack of a dirt layer suggests that generation 3 was a two-coat paint treatment. These layers – 3a and 3b – are the earliest Phase 2 paint layers on the woodwork in this room.

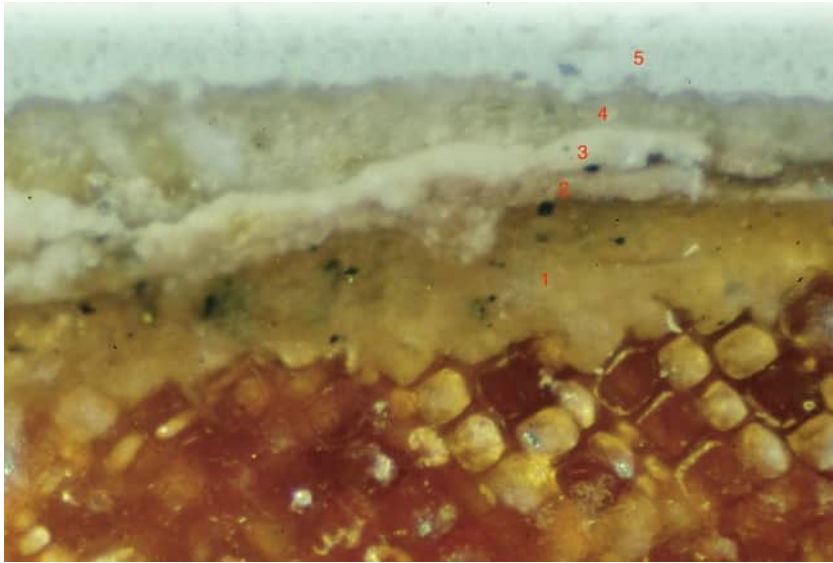
**Sample 002 Southeast corner post, side facing west, at girt**

NPH 002 vis, 125X

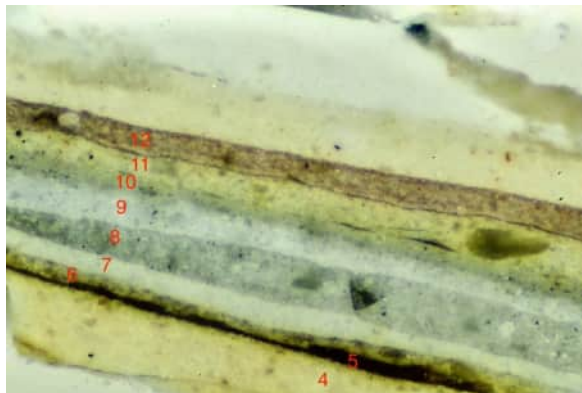
Sample 147

The woodwork in this room has not been stripped, and selected elements (fireplace, window and door architraves and baseboards) appear to have full paint histories. The door to room 104 was found to have approximately 12 layers of paint.

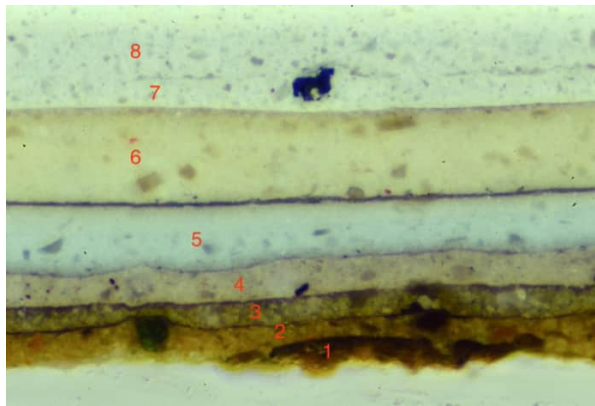
Some elements in room 109 were not stripped, thereby retaining their paint histories. The north wall cased post (108) side facing east, does not appear to have been stripped or altered in any other way. It has a paint sequence of approximately 11 treatments. A bit of gray paint was noted at the bottom of the bottom layer. It is possibly a floating fragment and unlikely that it is part of the stratigraphy.

The most unusual component of this stratigraphy is the bright green treatment. (#7) Green pigments were expensive and not particularly stable so it was more typical to create an optical green from blue and yellow pigments. In this case it is clearly a green pigment mixed with white.

Sample 109 North wall, cased post, side facing south vis. 125X

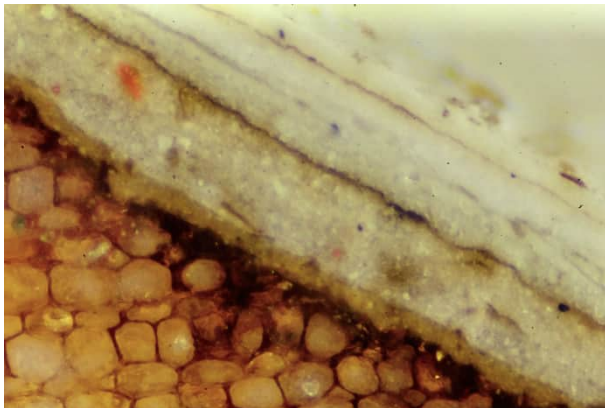
A comparison of samples 046 and 047 indicate that the molded tops were not painted the generation 1 brown but rather the generation 1 color of the rest of the woodwork. Below the sample 047 from the baseboard molding has no brown layer on the wood but there is a sealer or stain, followed by the generation 1 paint colors – yellow tan on a gray/tan/green primer.

047 East wall baseboard, molded top vis. 50X

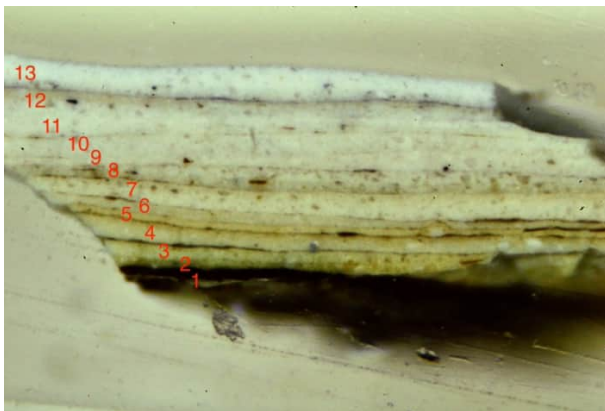
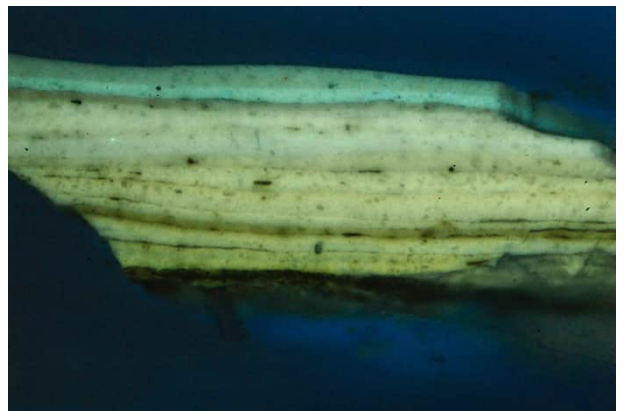
053 North wall baseboard at NE corner vis 50X

An image of sample 053 above shows a sample in cross-section from the north wall baseboard at the northeast corner of room 112. Originally dark brown, the baseboard was then painted to match the east wall paneling ca. 1810-20.

It has a total of 16 paint layers, the maximum number identified on woodwork in this room. The two uppermost white layers are missing, having detached during the sampling process. Some paint treatments are made up of two or more layers so we can estimate that there are approximately 12-14 paint treatments. In the early 19<sup>th</sup> century, grays and tans were most common, then for the rest of the paint history the colors are lighter tans, yellows, creams and off-whites, culminating in modern white paints. The color choices have become lighter and whiter as time has passed.

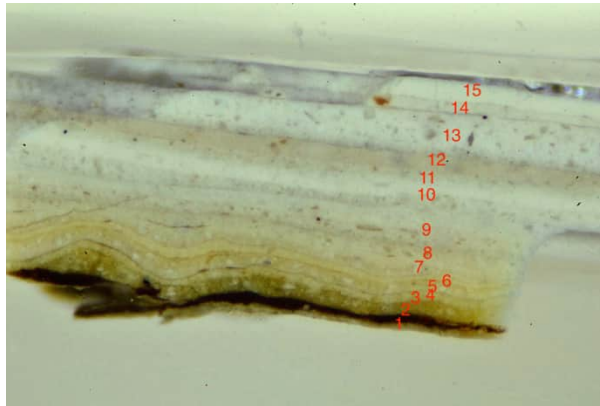
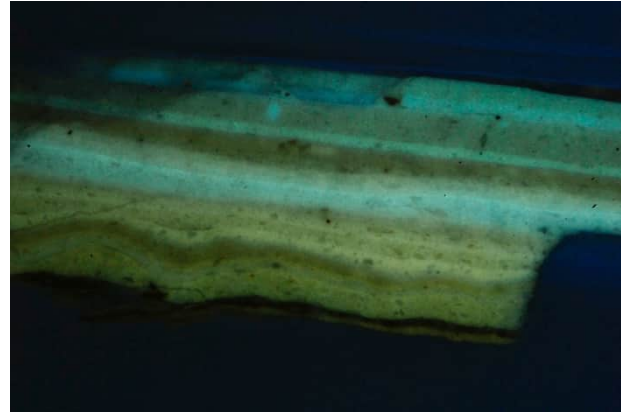
072 South wall baseboard, below window vis. 50X 072 UV 50X

Sample 072, from the south wall baseboard, shows the same generation 1 dark brown on a tan primer, the same as sample 053, also missing two of the uppermost layers. The yellowish-brown tone of the lower layers is partly the result of oil paint that has darkened over time.

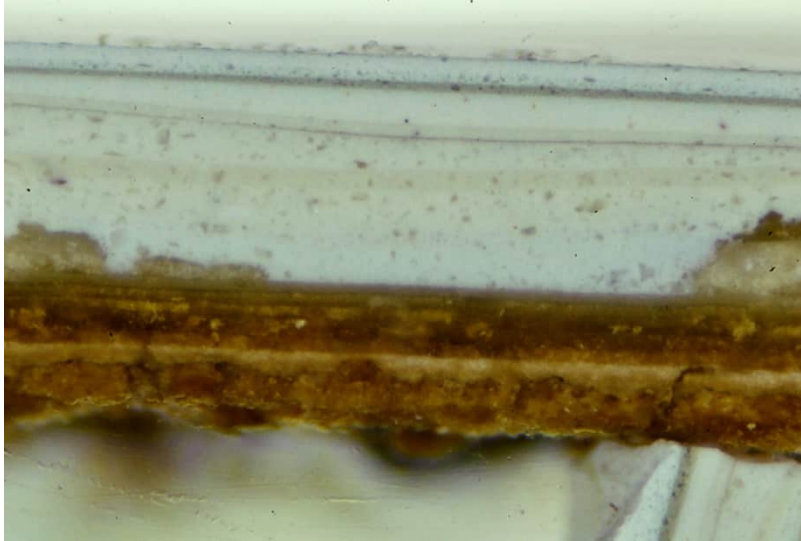
071 East wall cornice behind removed cupboard, NE corner vis 50 X

Sample 071 has the early "graining" treatments but is missing some intermediate layers, as would be expected if it were covered for a period of time by a cabinet. There are approximately 8-9 layers of paint applied after the cabinet was removed.

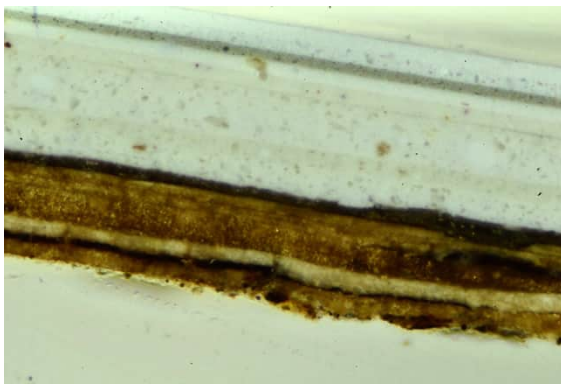
079 East wall cornice ogee near ceiling vis. 50X

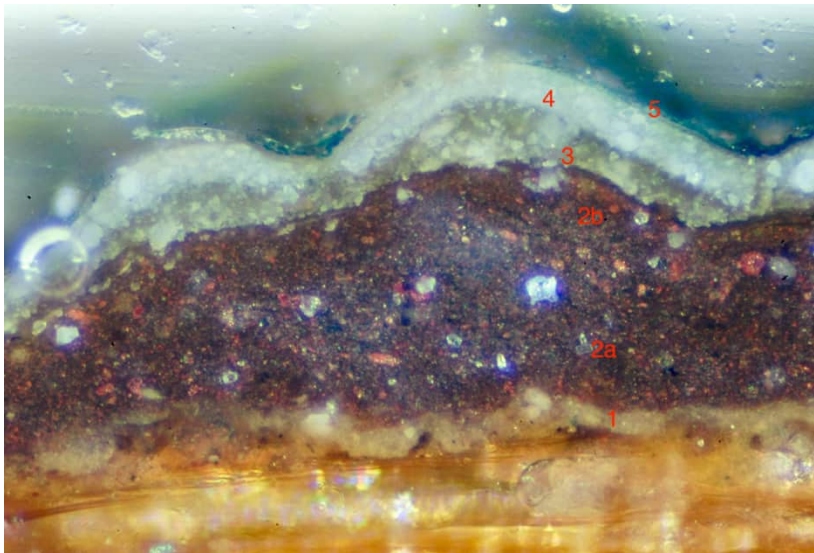
The interior of this cabinet has been painted with strong colors, not found anywhere else in this room. The shelves were originally painted dark red with a red pigmented varnish on top, while the walls were bright blue green. The uppermost layer on the shelf was painted bright green but only fragmentary bits survive. The colorful interior is more suggestive of an 18<sup>th</sup> century color scheme. This cabinet was constructed as part of the c.1810-1820 Federal Period paneled chimney breast wall.

055 East wall, inside engaged cabinet vis. 125X
