# Placing the Parsons House: The Cultural and Ecological Context for Constructing a Connecticut River Valley House

## **Appendix 7 - Historic Northampton Nathaniel Parsons House Maintenance/Repairs Record, 1911 – 2019**

Reference: Parsons House - Structural Conditions Assessment

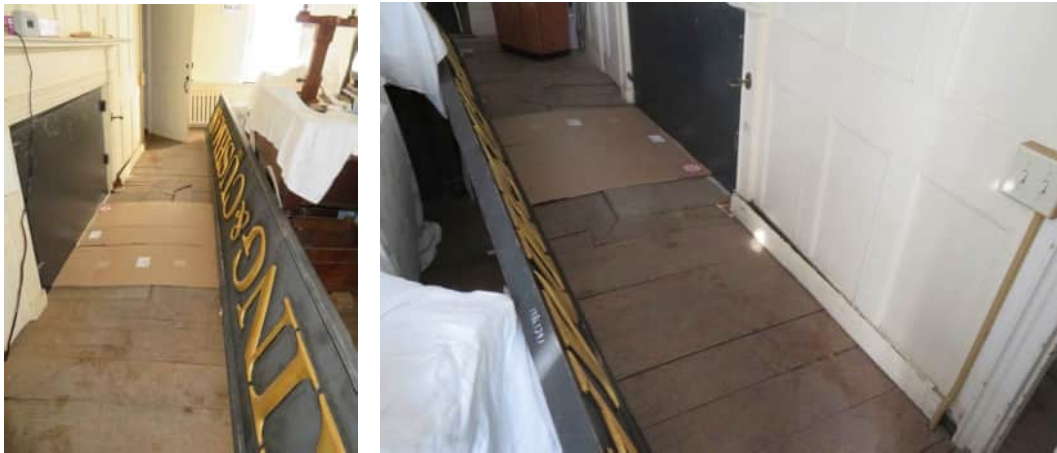
1. Settlement in West Room of Main House (Room 112) at Hearth. A significant downward pitch or compression below the floor is evident along the chimney (east) side of the west room. Myron Stachiw, in his concurrent HSR update field work, found evidence that suggests that movement in this area has been longstanding, and that some settlement had already occurred prior to the 1816 renovation that "Federalized" the building.

*Deflection at hearth in west room, from north and south respectively*

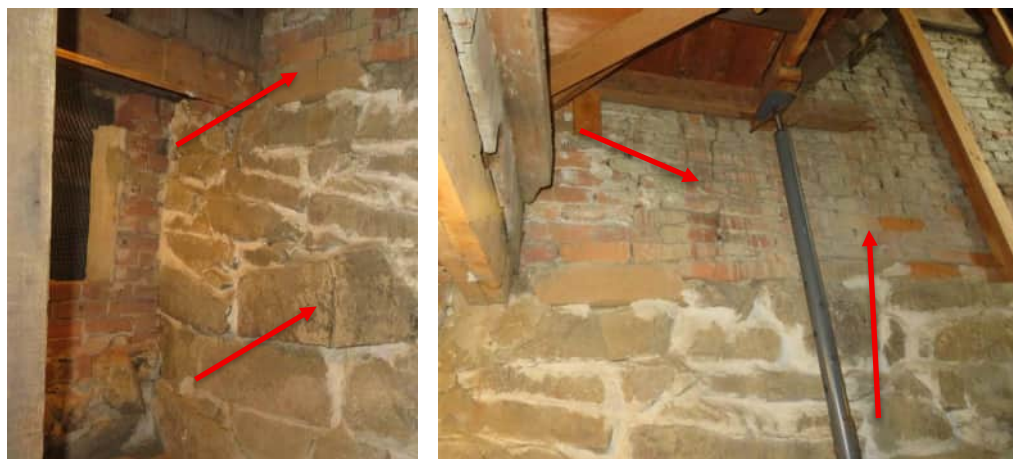
In the basement on the south side of the chimney mass, two different defects were observed. Vertical cracks in the masonry at the west end are present and suggest a downward or outward movement of the west side of the chimney mass base. Additionally, mud-colored drips are visible adjacent to the stair suggesting a water ingress issue that is leaching clay mortar out of the chimney mass masonry.

*South wall of chimney base, red arrows indicate cracks and water staining*

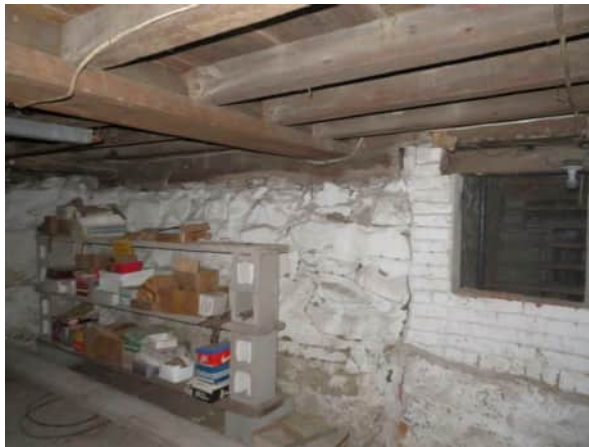
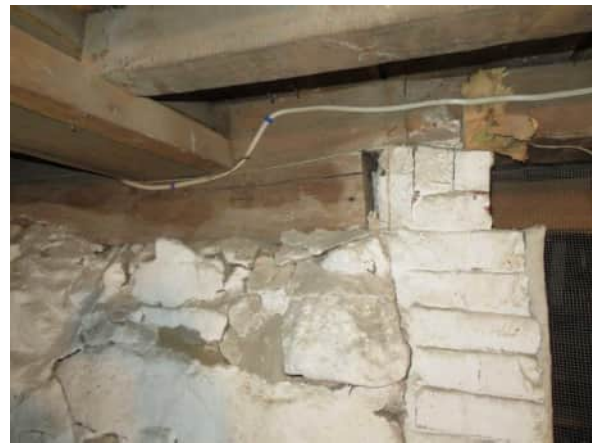
On the west side of the chimney base (in the west basement) a bulge and cracking in the wall are evident, as is a prominent dip in the chimney girt just above it that attaches to the floor framing and is the direct connection to the deflected deck above. The dip is adjacent to a deep notch in the girt (thought to be cut out for head room prior to the wall below being infilled with brick) which may have weakened the beam's overall stiffness.

*West wall of chimney base showing bulge and compressed chimney girt*

- Review documents from 1981/82 work to determine if CMU block along the chimney mass is underpinning the existing chimney mass or constructed alongside it to serve as a buttress. If documentation not available, consider performing exploratory openings.
- Expose and review: a) the space below the basement landing to view the geometry and condition of the underpinning on that location (below the cracks in the brick; and b) the drywall concealing the connection between the brick separator wall and CMU exterior south basement wall.

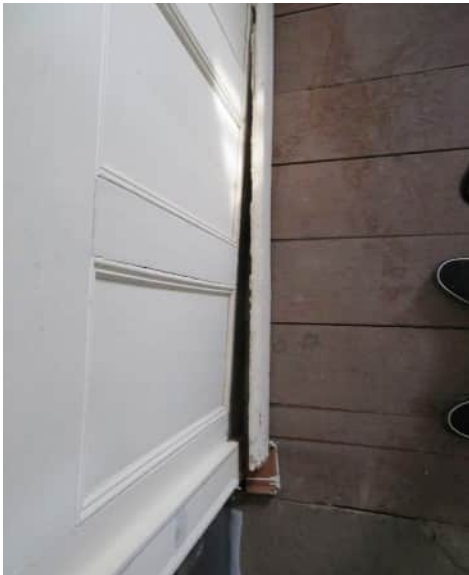
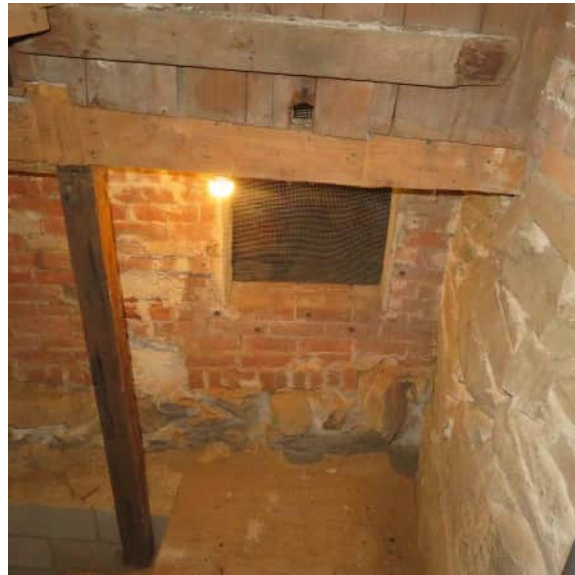
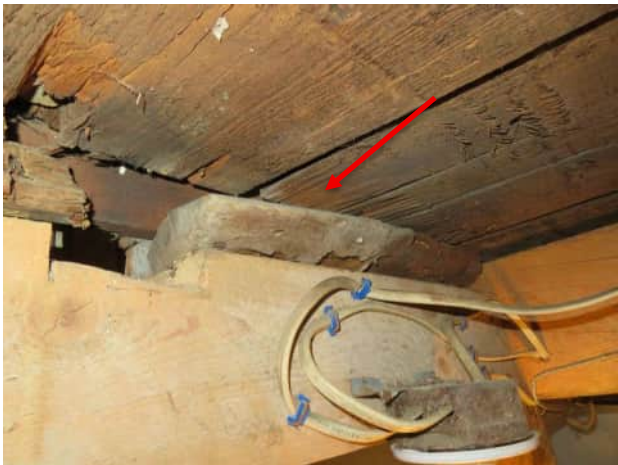
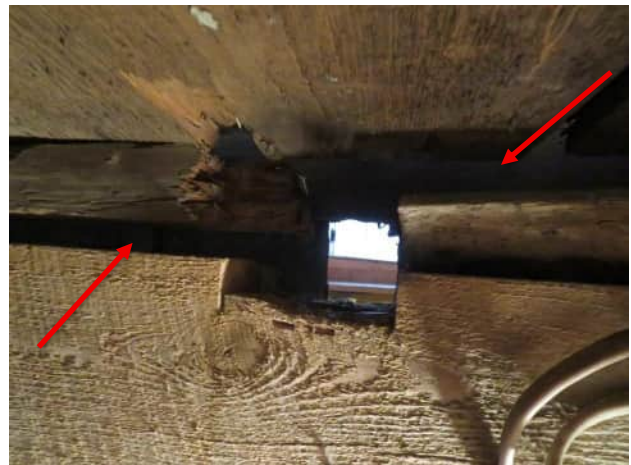
We also observed a framing connection defect where a short length of sub-floor connects to the basement stair header just to the south of the chimney mass. The existing blocking that is intended to provide a bearing surface for the decking has shifted leaving a gap under the end of the now unsupported sub-floor. The shifted blocking is directly below the loose baseboard in this area. *This issue is easily remediated by installing blocking or shims that provide full contact bearing between the header and subfloor and ensuring that the paneling is well fastened.*

*East wall panel from above west and below east respectively*

*Directly below east wall panel from east showing gaps in 2 different views*

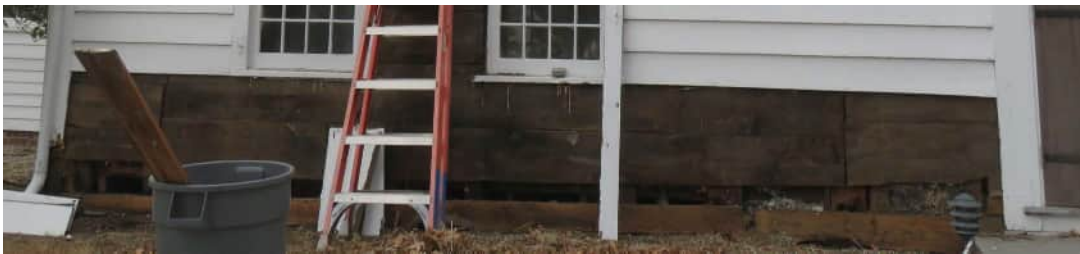
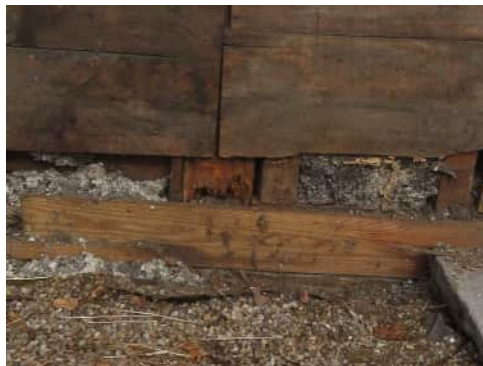
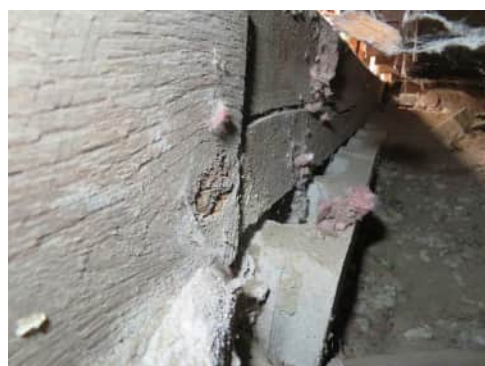
Maintenance logs note that part of the front sill was replaced in 1975. Removal of the siding confirmed a newer replacement sill at the west end along with unfilled CMU block below it, and replacement short joists between the basement wall and outer foundation. Photos from the crawlspace reveal that the CMU "foundation" and sill above have settled and rotated inward, perhaps from unequal pressure from the higher exterior grade. The movement is significant enough that the short joists are no longer supported by the sill. A later nailer on the outside of the sill may be helping to support wall studs. The 'sill' above the south basement wall appears decayed, the extent of which is unclear, as does the post base to the west of the entry vestibule. *The west end of the south wall needs a holistic repair campaign including outer foundation wall repairs (likely replacement), inner sill repairs or replacement, support / connection augmentation between the outer sill and joists and wall studs, and a potential timber dutchman repair at the base of the post.*

*Condition of south wall of west block. Top: After trim removal; Bottom Left: Replacement sill condition above grade; Bottom Right: View of shifting CMU foundation and sill.*

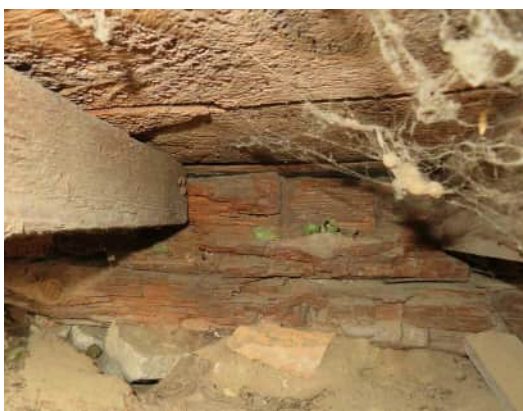
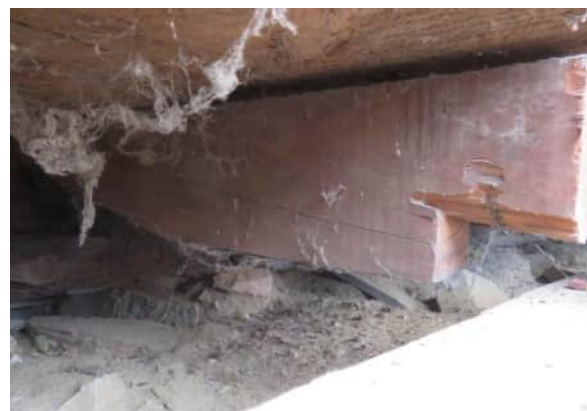
*View of decayed inner sill and suspended short joist end (not bearing on outer sill), respectively.*

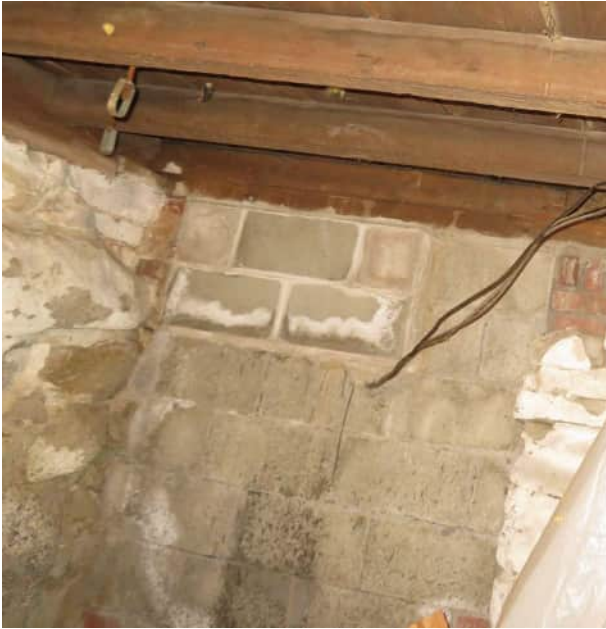
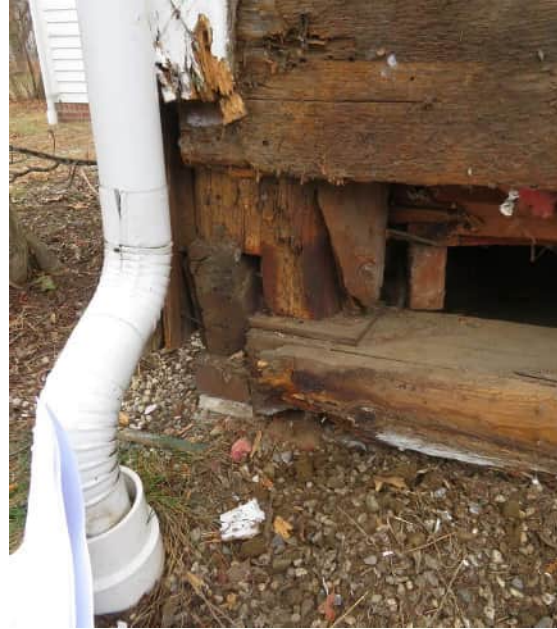
3. Southwest Corner Post. Saturation of the structure at the southwest corner of the main house due to an ineffectively draining downspout has caused water ingress into the basement and decay in the corner sill and post. *It is recommended that the malfunctioning downspout is remediated, and that timber repairs be performed on the decayed timbers in the form of traditional timber frame repair such as dutchman.*

*Left: Southwest corner inside basement showing salts from water ingress and dark staining suggestive of mold (note CMU bulkhead infill); Right: Southwest corner on exterior showing deteriorated sill and post base.*

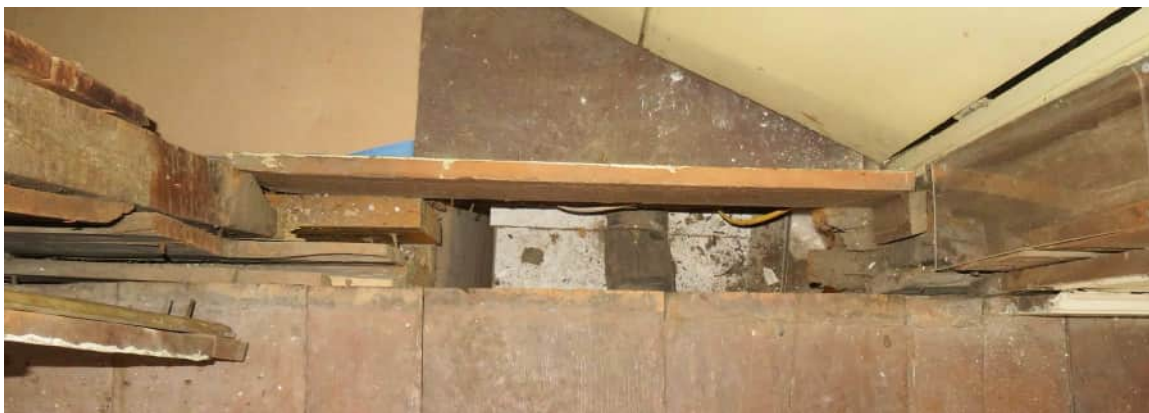
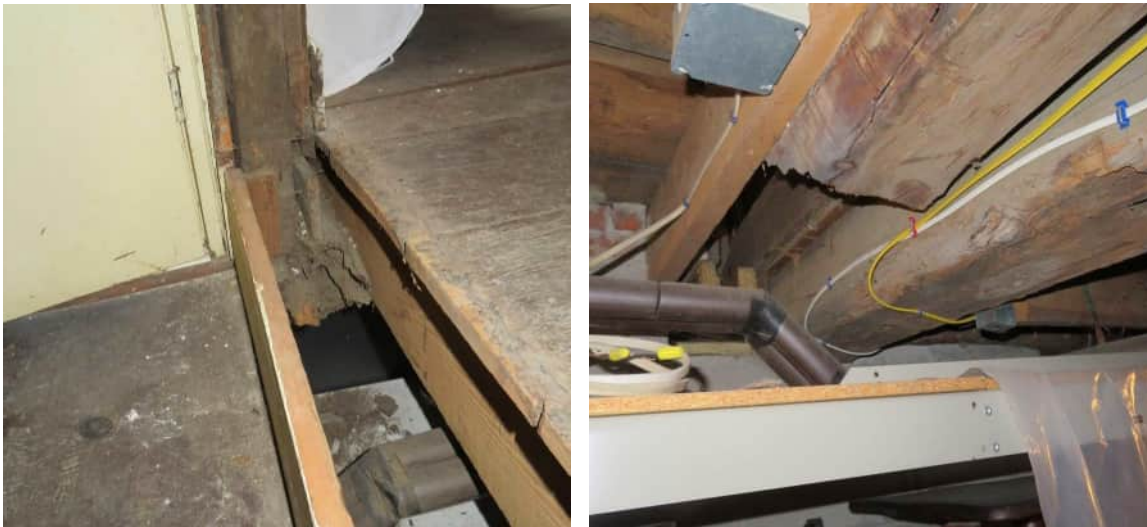
4. Former Repair in East Block of Main House (Room 102), First Floor. During prior repair work, presumably during the 1981-82 east block framing augmentation, the heavily deteriorated portion of the original north sill of the house, adjacent to the later lean-to, was lightly sistered but not replaced. This area is below the threshold of the door at the step-up between the lean-to and east room. Without the full sill, there is little support for the wall studs or for nailing of floor and trim. Maintenance logs reference floor leveling work in the 1981-82 project; settlement patterns prior to leveling can be seen when comparing new and existing framing in this location. *We recommend that an infill timber in the size of the former joist be slipped into the void of the former sill and secured via the sister to allow for a structural member to properly support this area. Alternatively, a full timber replacement sill can be installed in this location if desired.*

*Top: Looking down at door threshold without trim; Bottom Left: Looking east to end of abandoned timber; Bottom Right: Looking west at augmented framing from below.*

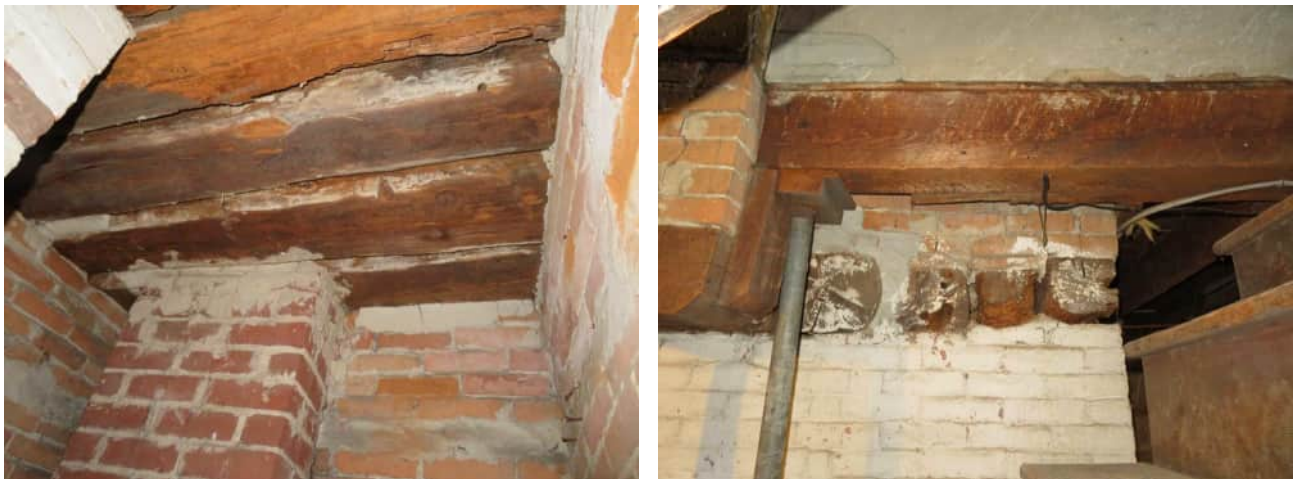
5. First Floor Chimney Mass / Hearth Support in Kitchen Ell (Room 004). The heavy timber “deck” upon which the chimney mass and hearth above the basement is built, has some areas of wood deterioration, particularly in one of the timbers. Water ingress from the chimney landing on the hearth, either past or current, is a possible root cause of the deterioration and should be investigated. A more recent brick chimney was installed below the deck, likely to create an exhaust route for newer mechanical equipment in the basement. The smaller chimney is built up to the bottom of the deck and it is unclear how the timbers were treated at the flue opening. *The chimney cap could be checked by using a drone. The deteriorated timber should be checked with a drill and thin drill bit to determine how deep the deterioration goes, and to better identify if repairing in place with a wood consolidate approach would work, or if a timber replacement is necessary.*

*Deteriorated timber platform supporting Kitchen Ell chimney mass above*

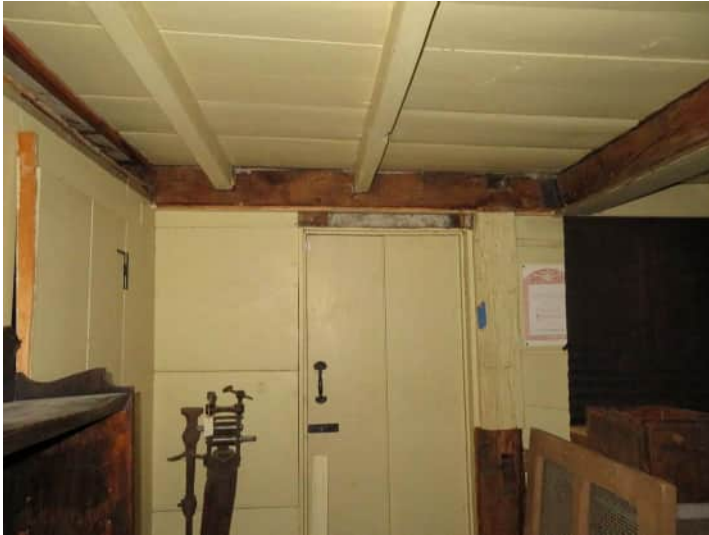
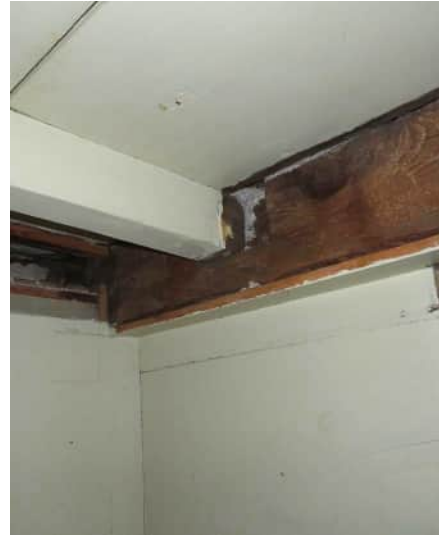
*Second floor joists framing into the north wall plate with diminished bearing visible after removal of trim board.*

*been removed at the time of our visits). During the design for the hangers, existing and proposed connections at both ends of the joists should be checked to confirm that the second floor north wall plate is adequately tied into the frame. Additional concealed joist hangers can be added if needed.*

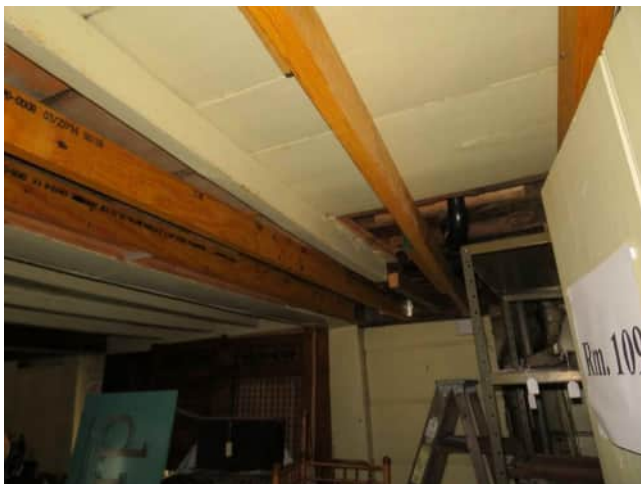
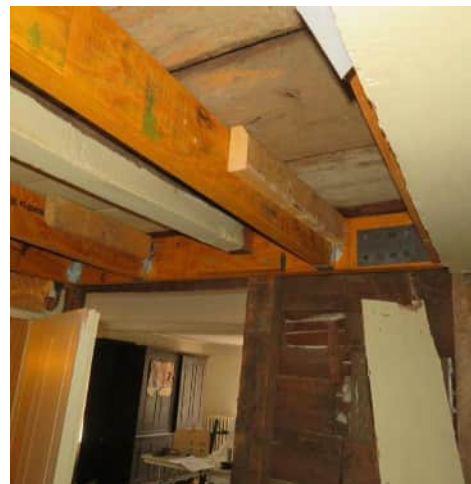
7. Second Floor Framing at Lean-To Stair Infill (above Room 109). The former stair opening was infilled, presumably in 2015, at the east end of Room 109, an area that also experienced movement of the outer wall and deflection of the floor framing above due to the shifting wall plate from the sill below deteriorating as noted in Item 6 above. The infill floor joists use modern engineered lumber and contemporary fasteners, presumably to meet building code strength requirements, in a way that does not meet the Secretary of the Interior's Standards for the Treatment of Historic Properties (SOIS). An engineered lumber ledger, which seems to have replaced an historic timber version, appears to be inadequately fastened to the historic material behind it. We also identified an adjacent joist with a substantial notch removed from it thus reducing its capacity. *Framing in this area should be evaluated in conjunction with the determination of uses and proposed finishes on both floors. Framing deficiencies as identified above will likely need to be remediated to accommodate proposed live loads. If the floor framing in this area will be exposed from Room 105 (as it currently is), the infill should be reframed to be in better alignment with the SOIS.*

*Infill framing at former stair opening looking north and south respectively*

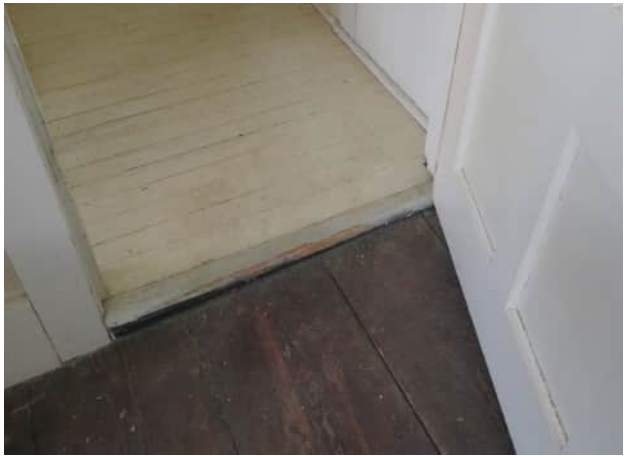
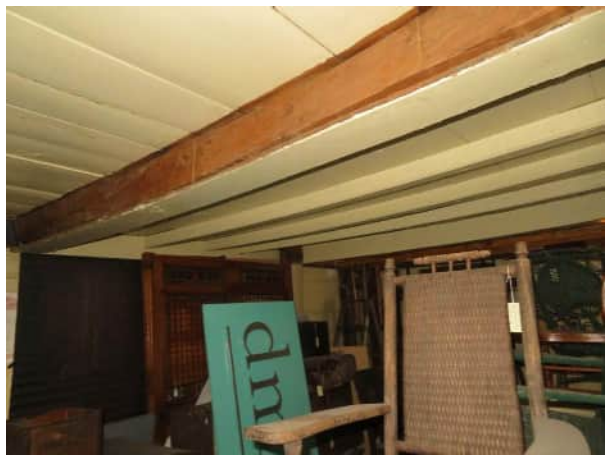
*Left: Second floor door threshold above stair infill showing floor deflection; Right: Overall view of lean-to framing showing sag*

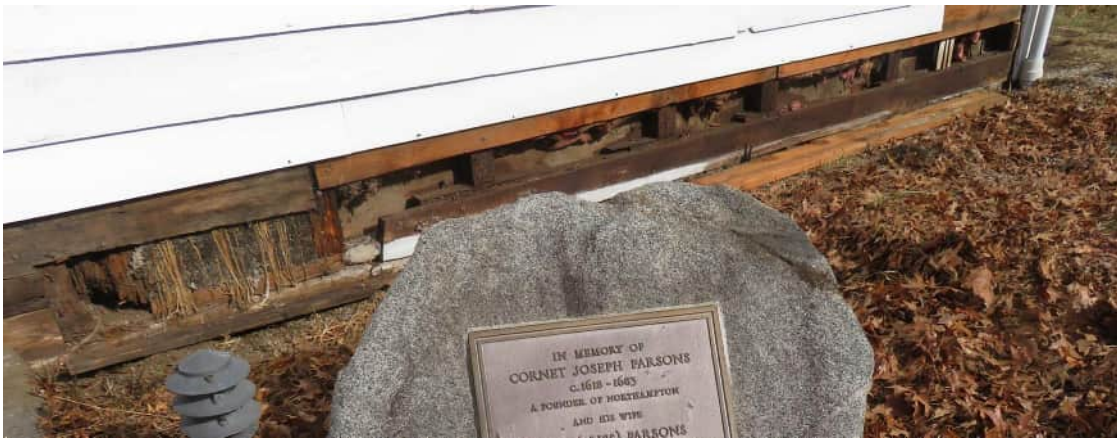
8. South Sill Deterioration, East Side. Upon exposure, the west end of the east block of the south sill, adjacent to the entry vestibule is showing deterioration and biological growth as is the base of the post to the east of the vestibule. *Damaged sill lengths and post base should be replaced in like kind with a naturally rot resistant species of timber, such as white oak. New timber components should be positively fastened with traditional timber repair techniques such as half lap at the sill and a dutchman at the post. The entry stairs may need to be removed to access the west end of the deterioration. The stair should be reset with a slight pitch to the south to help direct rainwater away from the structure.*

*Exposed south sill, east block overall*

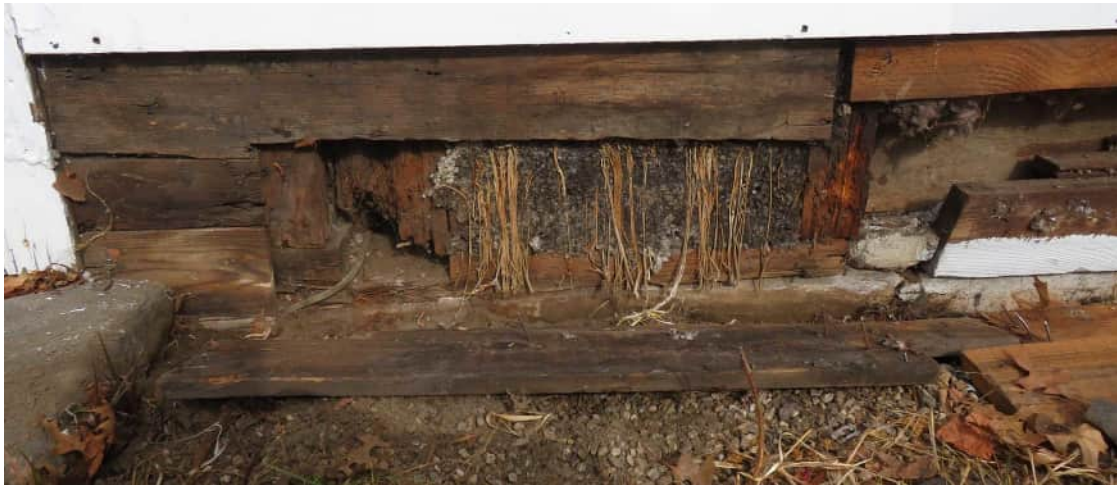
*Deteriorated portion of the south sill and post*

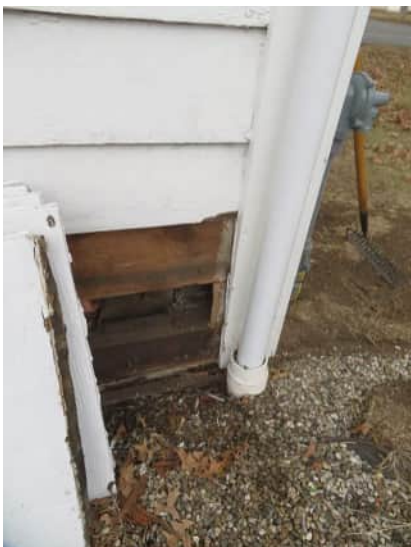
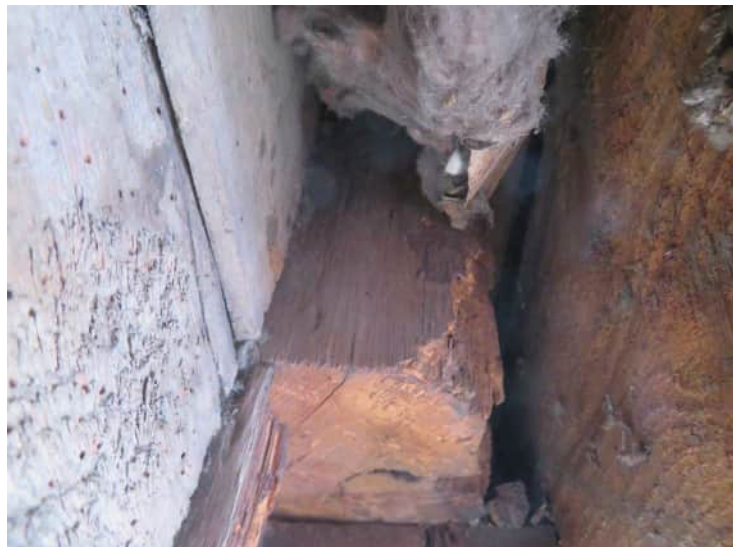
9. Southeast Corner Post Deterioration. Upon exposure of the sill, photographs inside the wall cavity in the southwest corner identified the post base being cut, presumably due to deterioration, but not augmented with a replacement post base. *We recommend that the southeast post base be supplemented using a post base dutchman to give the post full bearing on the sill as intended.*

*Southeast corner post base from exterior and from wall cavity respectively*

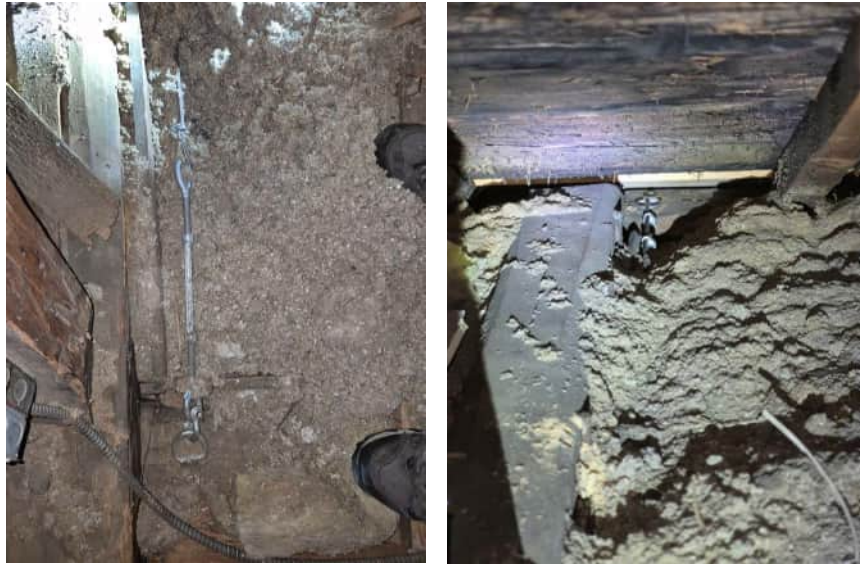
10. Cable Ties at Attic. Two cables were observed in the attic space over the north lean-to end of the Original House. It is likely that the cables were installed to provide tension and positive tie-in to resist the wall moving out due to the former sill deterioration or even foundation settlement, both addressed in 2015 repairs. It is likely that the condition is no longer active; *therefore, no action beyond occasional observation is currently required.*

*Cable ties over lean-to in attic*

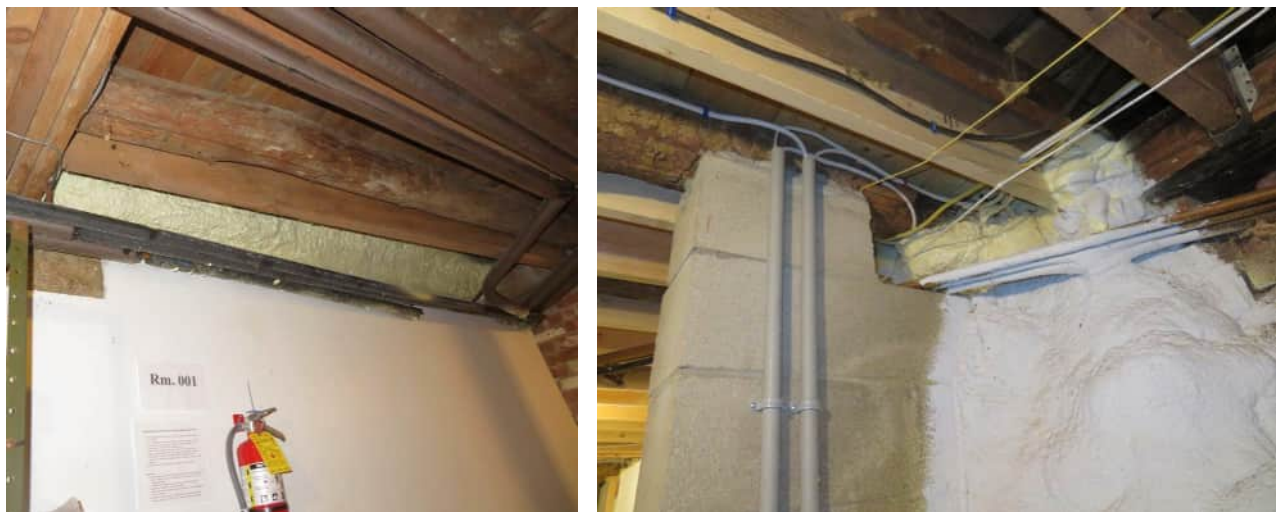
11. Spray Foam. Spray foam insulation has been extensively applied within the basement, particularly along the building perimeter, where it fully encases the interior faces of the sill framing. While likely intended to improve thermal performance or mitigate perceived moisture issues, this application prevents the wood from drying to the interior and can trap moisture against framing members that are already vulnerable to exterior moisture exposure. Over time, this condition can accelerate concealed deterioration of sills and adjacent framing. *We recommend that removal of the spray foam be considered in conjunction with other planned work in the basement (such as sill repair or replacement), and that efforts be made to better understand and address the underlying sources of moisture that the insulation was attempting to manage, rather than relying on impermeable materials to mask those conditions.*

*Multiple generations of spray foam insulation apparent in the basement, particularly along the perimeters of the building*

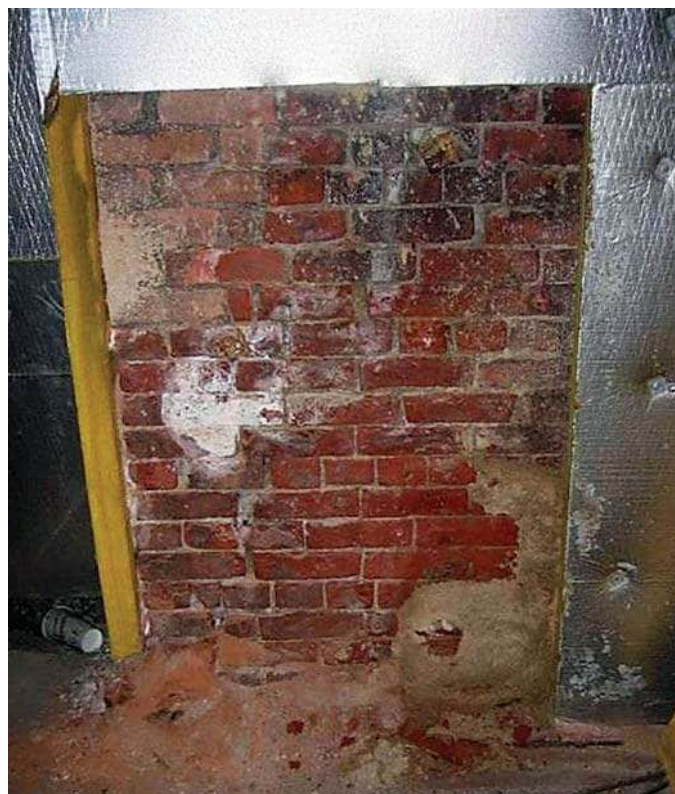
Fig. 21. The interior face of a brick masonry wall shows damage that resulted from the installation of a vapor retardant (foil facing) and thermal insulation. Photo: Simpson Gumpertz & Heger.
