# SHEPHERD HOUSE HISTORIC STRUCTURE REPORT

NORTHAMPTON, MASSACHUSETTS

HISTORIC NORTHAMPTON

*FEBRUARY 5, 2026*

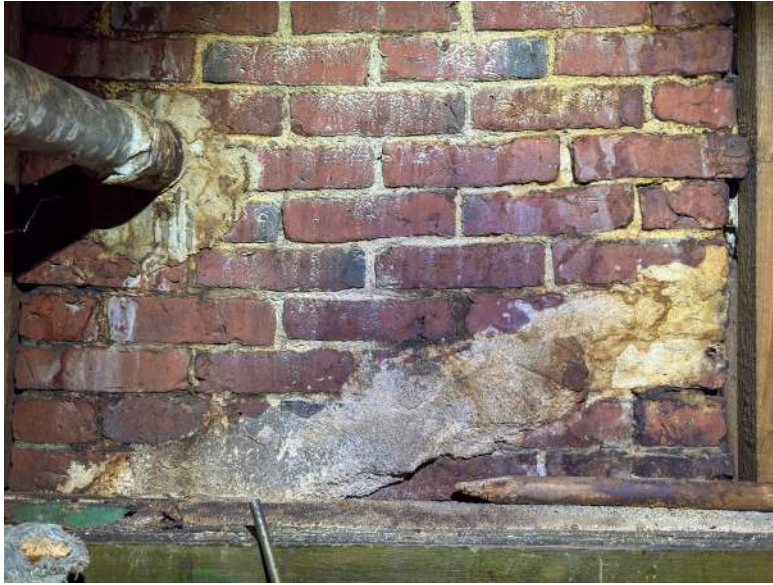
*Figure 8. Shepherd House attic, view of rear of east chimney showing evidence for earlier roof in mortar flashing and projecting flashing course.*

The house's exterior was weatherboarded and its windows on the principal elevations cased with Roman double architraves on the first and second floors. On the ground floor front and sides, these were further embellished with a molded cap. Windows were originally fitted with 12-over-12-light sash, though only one of these remains. The house was covered by a shallow hip roof, which was replaced, along with its cornice, soon after 1844. Its pitch and height are both visible in the room designated 303 on the plan in the attic, along the north face of the east chimney (see restored south elevation drawing on page 86). The shallow pitch and low rise of the original roof is revealed in the diagonal mortar wash near the bottom of the chimney in the attic (Figure 8). Confirming that this was the original roof pitch is the projecting brick, forming a flashing course, just above the top of the mortar wash.

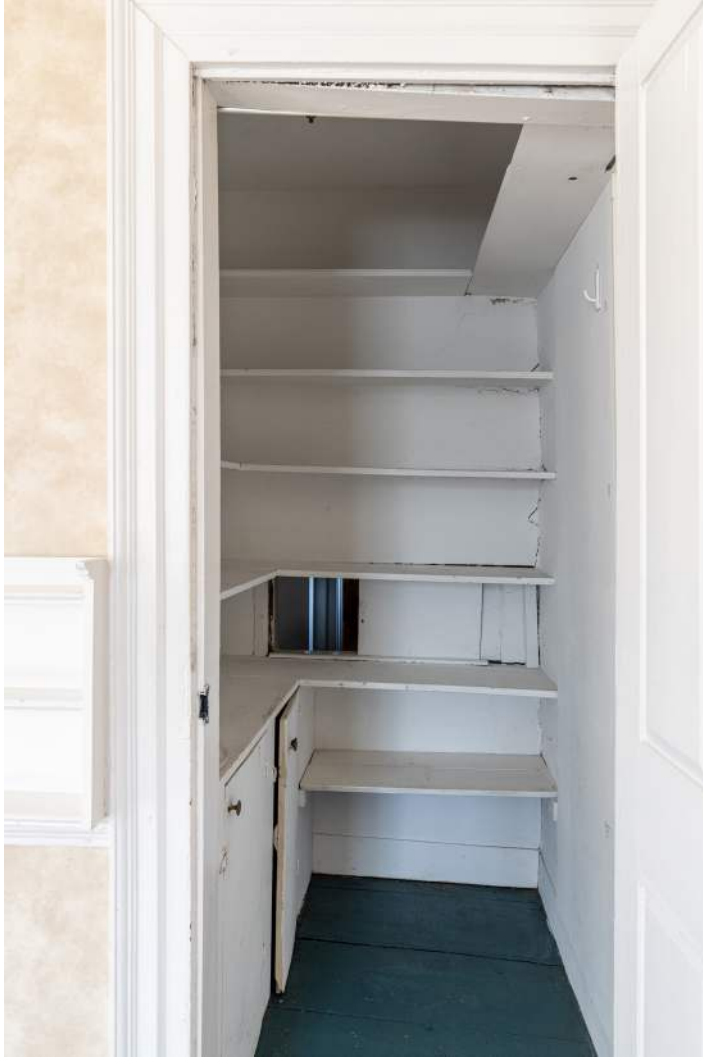
*Figure 9. Shepherd House, dining room (100) closet showing early shelving and pass-through to kitchen with sliding shutter open.*

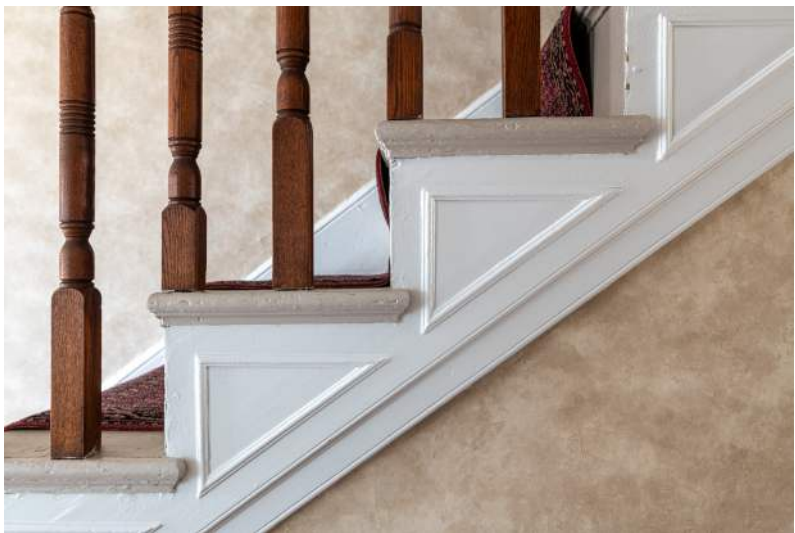
*Figure 10. Shepherd House, front stair as altered c. 1900, detail of period IV baluster and period I applied bracket.*

Neither of the two staircases in the house is in its original form. The principal public stair has always risen from the front passage. Its structure, beaded stringer, and triangular stair brackets all survive from the 1790s. These decorative elements use moldings observed on demonstrably early woodwork elsewhere in the house (Figure 10). The newel, balusters, and handrail were all replaced around the turn of the 20<sup>th</sup> century. The secondary stair opens directly from the kitchen, from which it rises to the back passage. It cannot be any later than the installation of the door casings in this room. The stair carriage is assembled using cut nails, so it cannot be any earlier than the early 19<sup>th</sup> century. Though it is not from the 1790s, it seems to have been planned from the outset. An inspection of the framing between the first and second floors could confirm this reading, should the opportunity arise. The door separating the kitchen from this stair was still in place until at least 1976 (Figure 11).

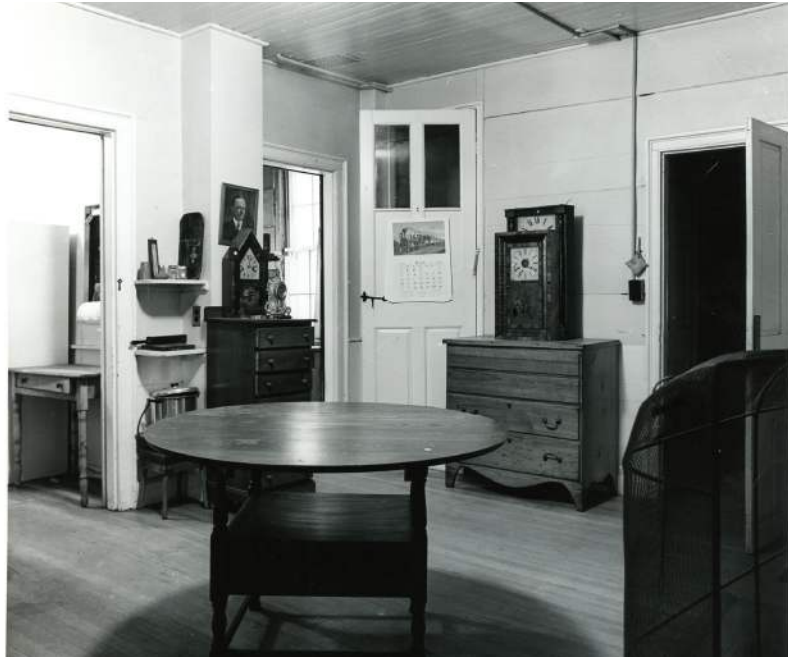
Figure 11. *Shepherd House, 1976 photograph of kitchen, looking towards shed. Note tall glazed door, since removed, at base of kitchen stair. Collections of Historic Northampton.*

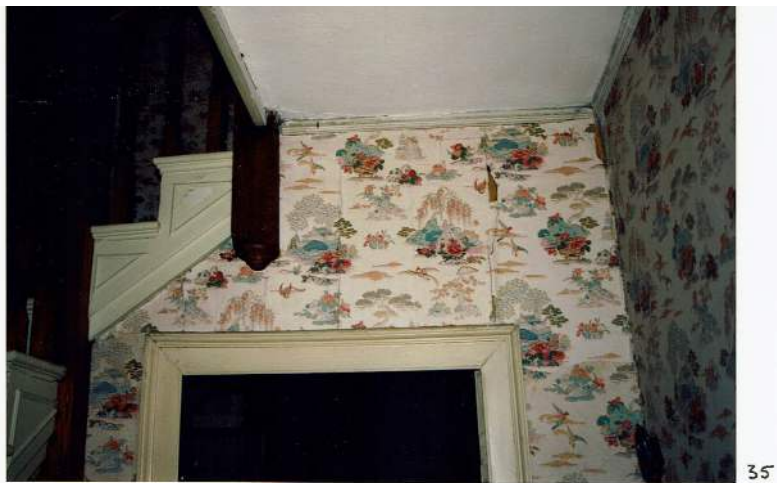
Figure 12. *Shepherd House, c. 1992 view of passage partition taken for SPNEA report by John Leeke and Gregory Clancey.*

This social division between front and rear is still clear on the second floor, where a partition between the front and back passage remains in place. It is less evident on the ground floor following the removal of the corresponding wall in the early 21<sup>st</sup> century. George Clancey and John Leeke observed this partition in 1992 and thought that it was not original because of the way that it abutted the side walls of the passage and cut around the baseboard. We have not been able to observe it directly, but we note that the door opening, visible in some photographs, appears to be relatively

early. Photo 35 in the Clancey and Leeke report seems to show a backband with a quirked ovolo terminating in an astragal that is very similar to casing type E that was installed in the kitchen and rear bedchambers around 1810 (Figure 12; compare to figure 7).<sup>92</sup>

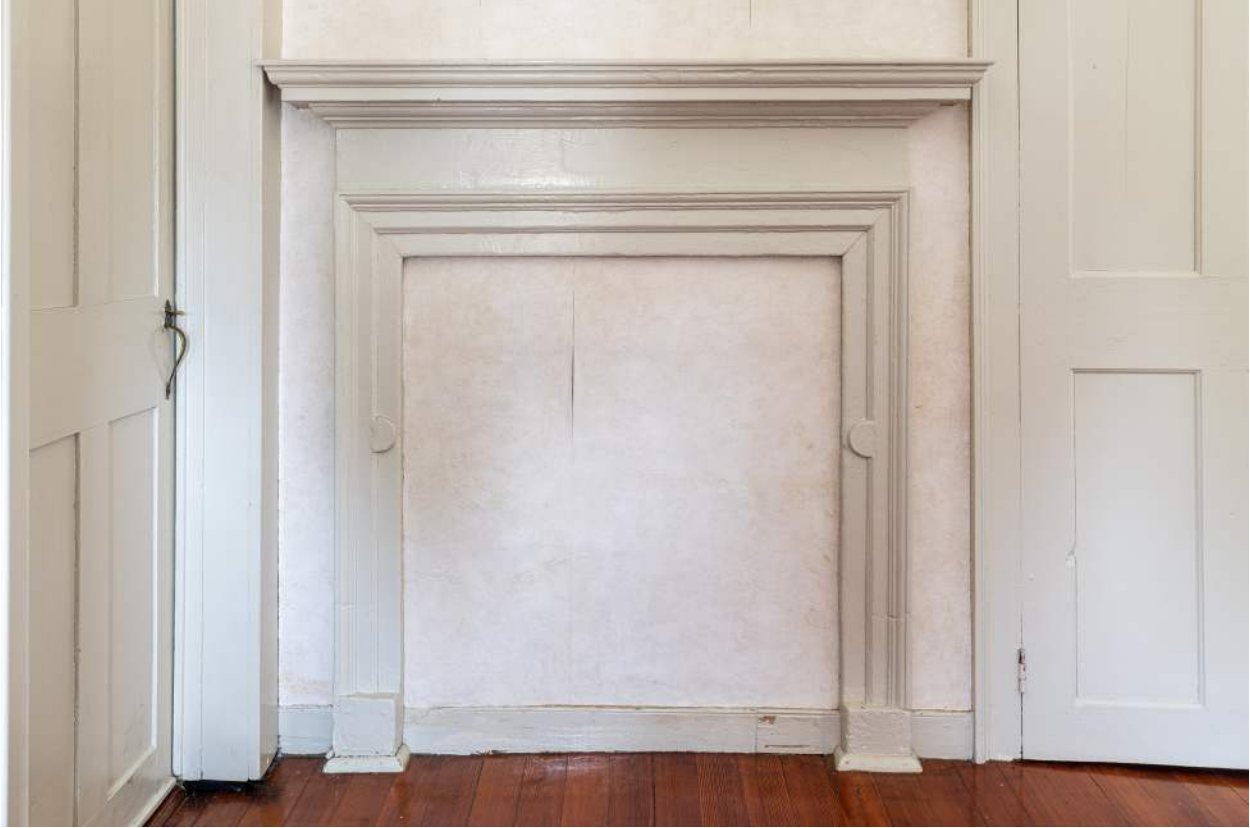
Figure 13. *Shepherd House, mantel in northeast bedchamber (204).*

The earliest mantels in the house are likewise nicely elaborated and of a similar character to the best door casings. These remain in place in back rooms on the ground floor (103) and the second floor (204), though that in room 204 has certainly been relocated here. This room is not fitted with a fireplace and was likely unheated before the installation of steam radiators. This surround matches the profile of the extant casings in the dining room, so it may have been relocated from there following that mantel's replacement in the 19<sup>th</sup> century; alternatively, it may have originated in

the dining room chamber, whose smaller firebox fits the mantel's smaller size more plausibly (Figure 13).

The mantel in this room is refined, despite its relatively low status and lack of a heat source. It is one of just two remaining in the house that likely date from the late 18<sup>th</sup> century (Figure 13). It is composed of a broad double architrave surround with a robust mantel shelf above, supported on a bed molding. The backband is an ovolo with an astragal. Its opening has been closed for a long time with plaster and wallpaper and there is not room behind it for a fireplace—the masonry edge of the east chimney rises up 1'-7 1/2" east of the west edge of the fireplace opening. Adjoining this is

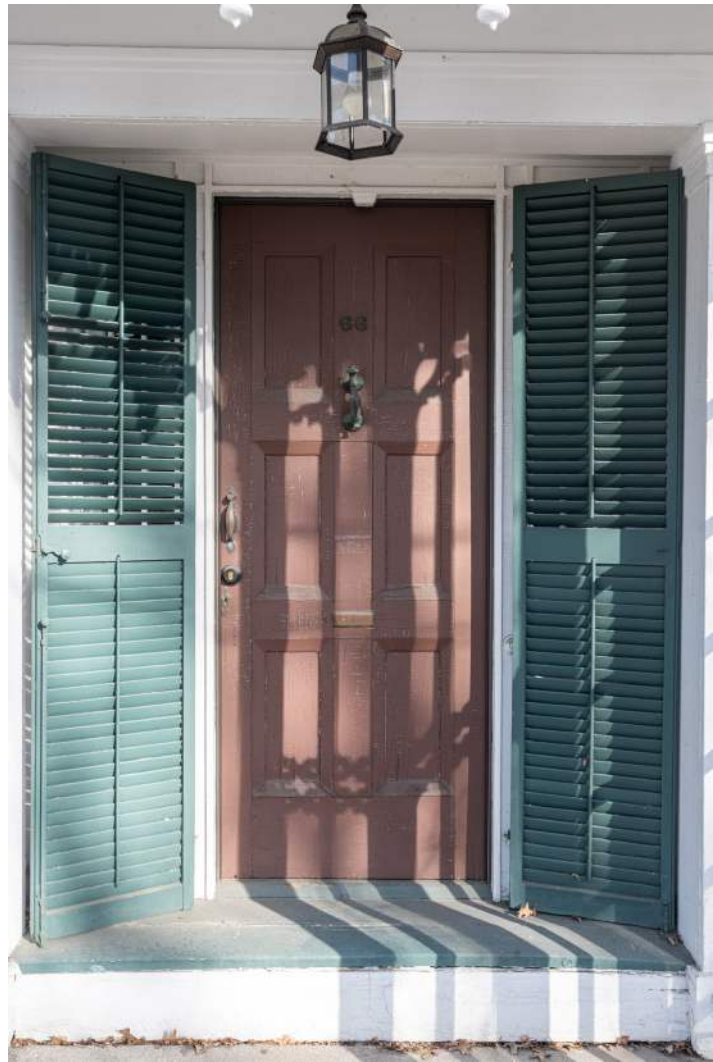
Figure 15. *Shepherd House, detail of front door, as altered in period III.*

It was likely during this phase of alterations that the Hawleys replaced the front door and ornamented it with a broad new Greek Revival frontispiece. The door panels and the frontispiece are both finished with mature Greek ornament, characterized by relatively flat ovolos and minimal embellishments (Figure 15).

The entry was improved around the time that the roof was raised in the 1840s. It is a broad Greek Revival assembly with a 2'-10" wide door framed by 13" sidelights (Figure 15). This is ornamented by square Greek Revival pilasters supporting a tall entablature. The door is protected by a pair of louvered shutters that retain their early hardware, including slender head and foot bolts and a latch with porcelain knobs. The door is a six-panel leaf, decorated with very flat, 1 ¾" broad, Greek ovolos. It has a heavy brass knocker and an early 20<sup>th</sup> century thumb latch, but its original hardware seems to have been replaced. There is also a nameplate on the lock rail with "Shepherd" incised in

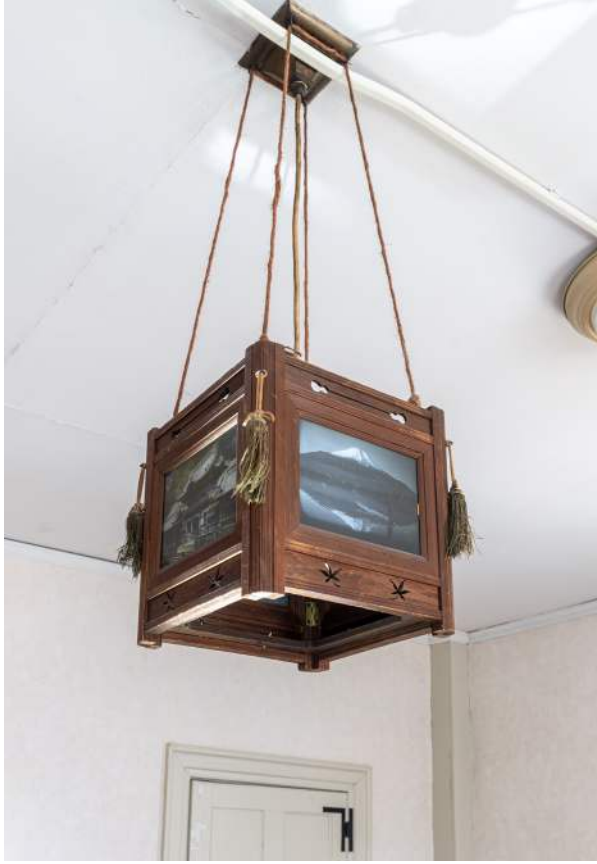
Figure 17. *Shepherd House, parlor chamber (202), light fixture with glass photograph of Mt. Fuji.*

One of the central ornaments of this room is an artifact of the era of Thomas and Edith Shepherd, a souvenir of their travels in Asia (Figure 17). It is hung from the ceiling by four cords and electrified by a cloth-covered wire. It is a hinged wooden lamp frame with incised decoration and four sides filled with glass-printed photographs of scenes from Japan. These include a scenic view of Mount Fuji and a historic temple. The photographs are beautifully printed and the fixture seems to be a romantic souvenir of the couple's honeymoon.

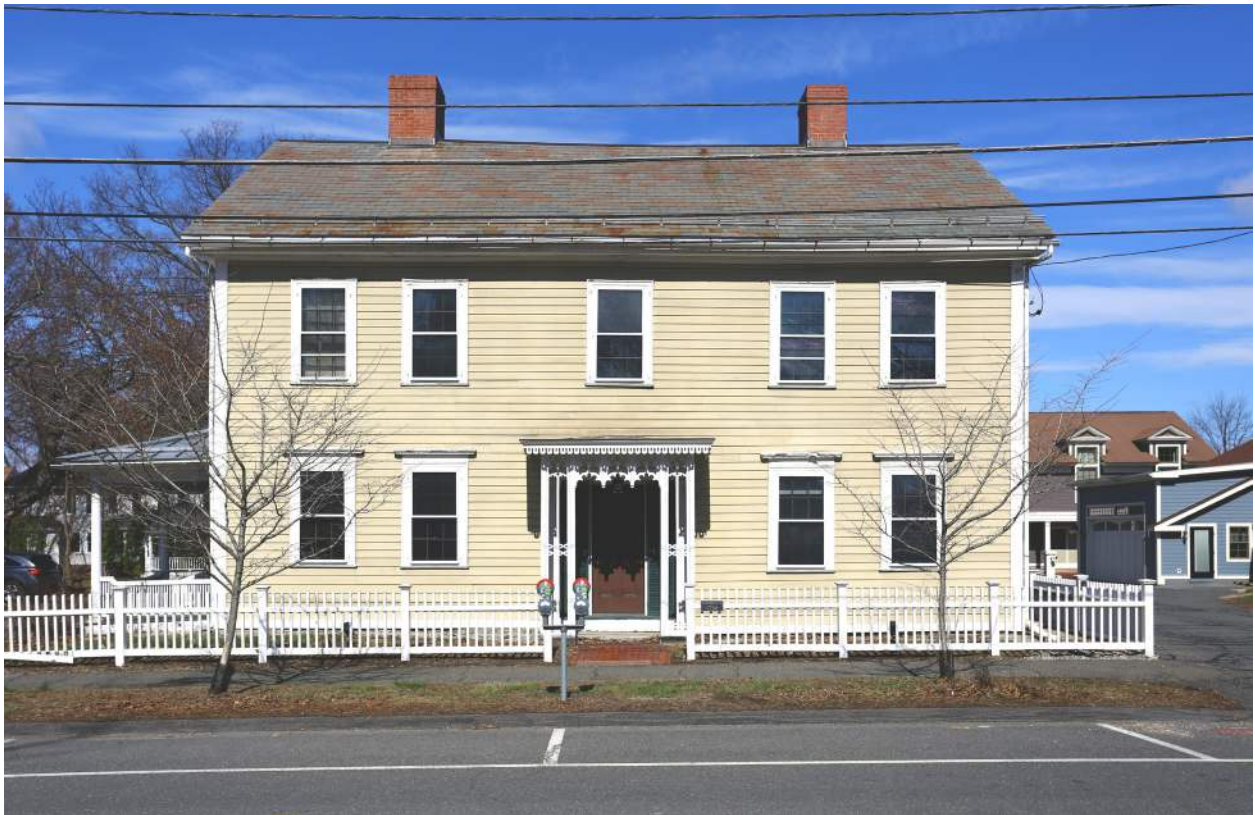
Figure 18. Shepherd House, view of south front.

The south front, the house's principal façade, is five bays wide and two stories tall. It is clad with sawn, un-beaded weatherboards with 5" of exposure (Figure 18). On this side, all of these appear to be late 20<sup>th</sup> century replacements that are secured with wire nails. The wall is framed with a 5 ½" tall skirting board at the base and 7 ¾" corner boards with 5/8" beads on either side. These are patched at their bottom but mostly historic material. The corner boards are likely an artifact of the mid-19<sup>th</sup>-century renovation of the house, but this hypothesis should be

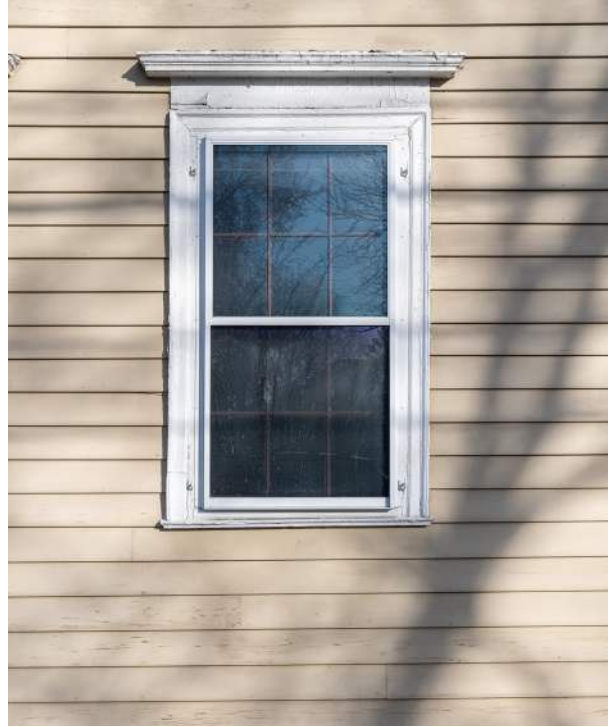
Figure 19. *Shepherd House, detail of ground floor front window, east wall.*

The deep eaves are decorated with a bed mold and a crown molding, all installed when the roof was rebuilt in 1845. There is a half-round gutter and down spouts that all appear to date to the early 21<sup>st</sup> century. The windows have six-over-six sash that we regard as an early improvement pre-dating 1844. All windows are framed with 5" double architraves with Roman ovo-lo backbands and have many layers of paint on them

(Figure 19). Unlike the sash, the surrounds appear to be original. They sit on molded sills that are 1 ¼" tall. The first-floor windows have a molded cap with a cyma crown above a plain unmolded frieze board.

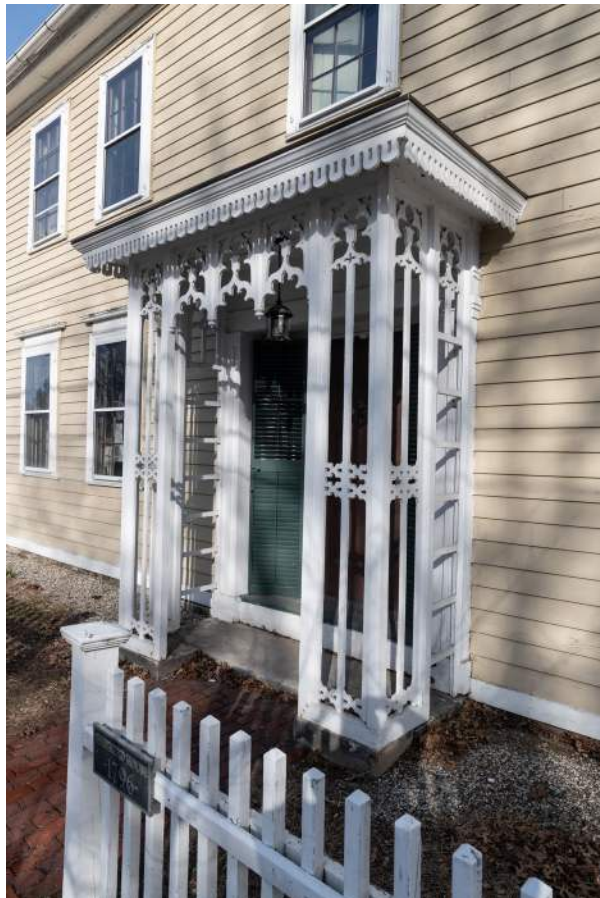
Figure 20. *Shepherd House, view of entry porch.*

The Greek frontispiece sits on top of a broad granite step. It is partially obscured by a porch that has the character of a later improvement, seemingly of the 1860s or 70s (Figure 20). The porch is decorated with scroll-sawn ornament beguilingly terminated with tulips at the top of each of five panels across the front. There are sawn rails on its two flanks, evidently for training climbing flowers. This porch, too, sits on granite blocks. The porch has a flat roof, all of whose decorative elements appear to have been replaced in the early 21<sup>st</sup> century. There is a brick-paved walk leading from the public sidewalk to the entry. At the transition from the public walk to the paved walk is a plausibly ancient sandstone step that is 3'-4 ½" across by 12" broad. Its depth is unknown.

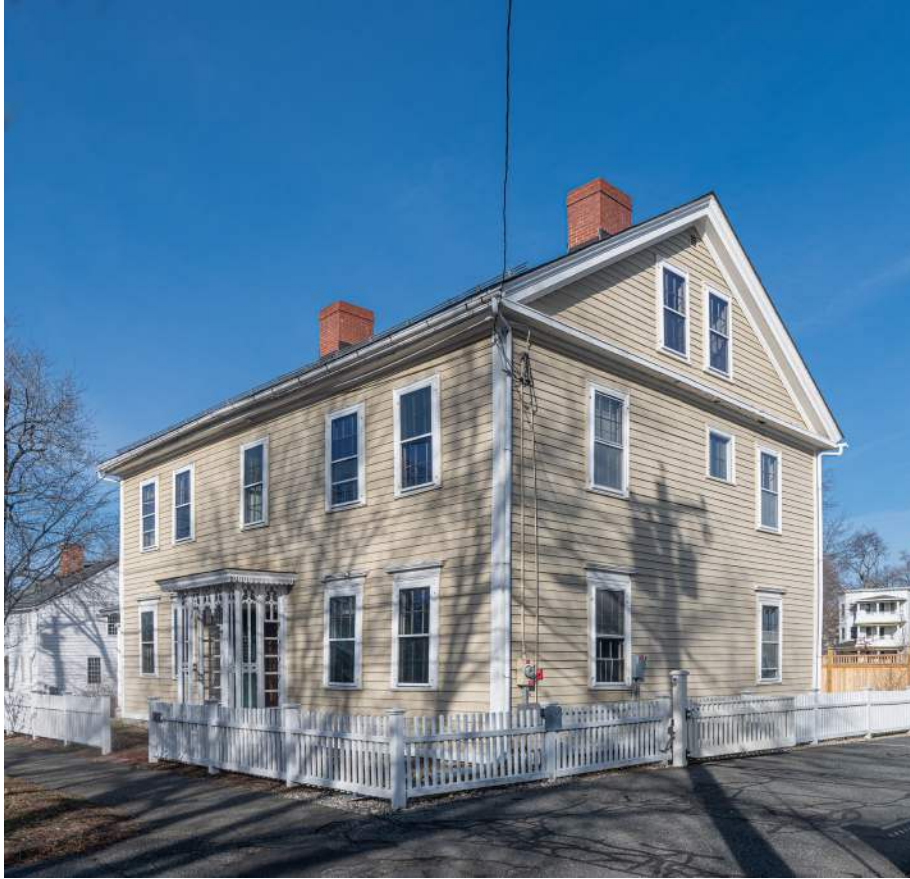
*Figure 21. Shepherd House, view of south and east fronts.*

Two windows in the gable light the attic rooms. These are six-over-six sash like those on the first two floors, but they are set in single-architrave surrounds with quirked-ovolo backbands that resemble those used in the parlor, without the terminating astragal. The attic sash have distinctive knife-edged muntins. The sills are unmolded.

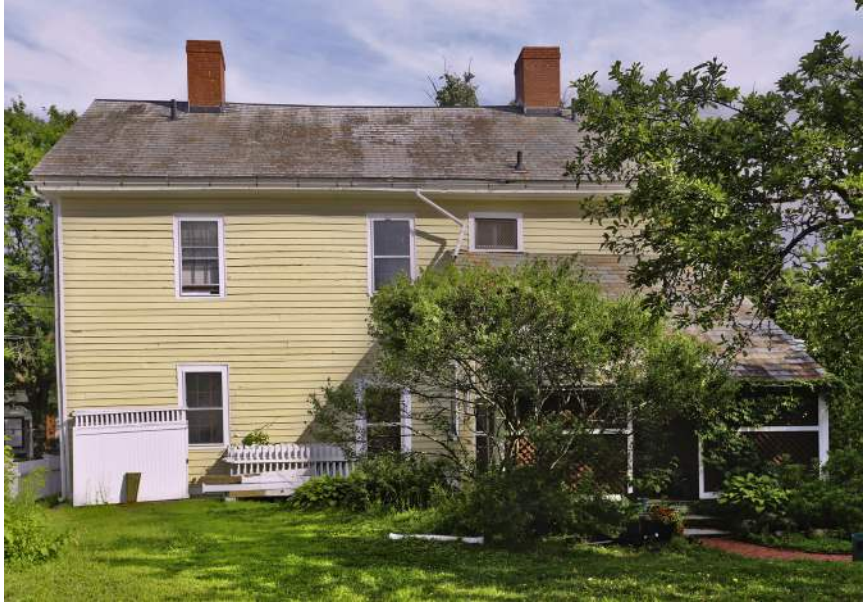
Figure 22. *Shepherd House, north front.*

The north wall is treated similarly to the south and east but is clearly of secondary importance, with less elaborated finishes throughout (Figure 22). It

There are only three window bays across this elevation. The windows have the same six-over-six sash observed on the south and east fronts, but are more modestly cased, with a single-architrave surround with a 1  $\frac{1}{4}$ " quirked ovolo backband terminating at a delicate astragal. This is similar to the casing that decorates the interior of the windows in the rear rooms on both floors.

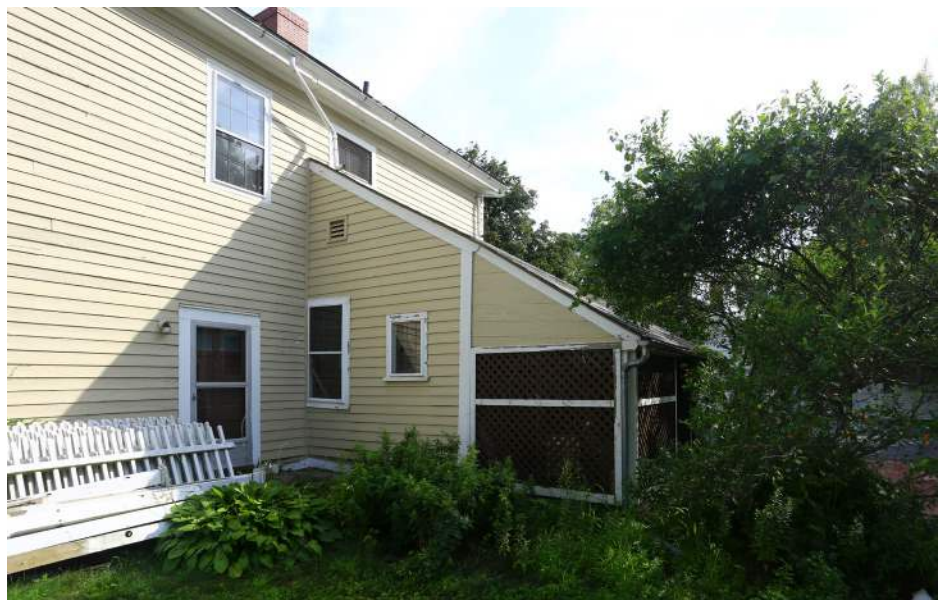
Figure 23. *Shepherd house, view of rear shed and enclosed porch.*

Extending out from the north wall and covering its western third is a broad shed, 17' wide and 16'-6" deep (Figure 23). The first 10' in depth of this shed is enclosed, including two service rooms that are an appendage of the kitchen and clearly original. The remainder of the shed is unenclosed and has always been open to the weather. An important question is whether this is an extension of an earlier shed or an original feature. Flush sheathing boards above the wall plate on the east side are relatively late in date; inside the shed, we can see that these are circular-sawn. Arguing, conversely, for an early date is the evident age of flush sheathing boards that enclose the upper part

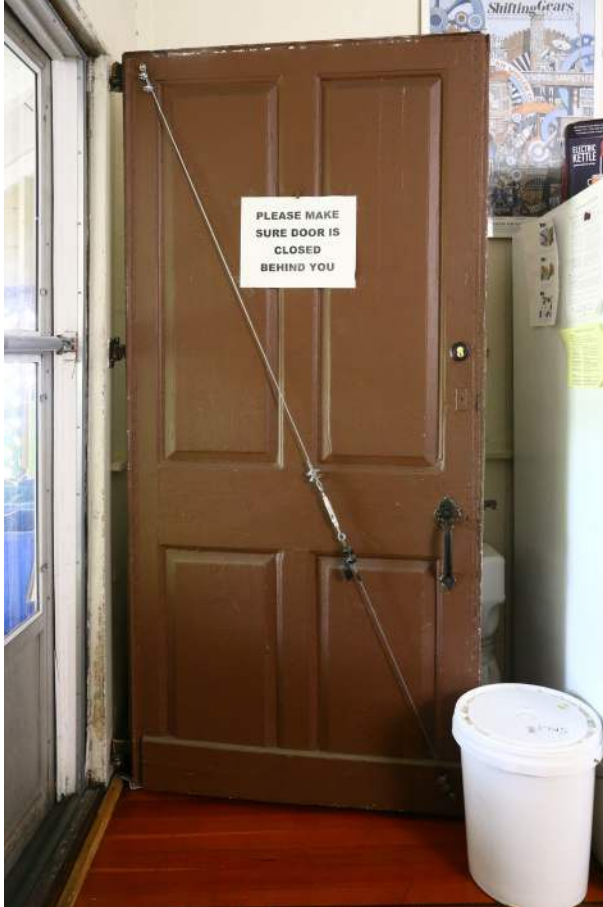
Figure 24. Shepherd House, detail of door to rear shed.

The north wall of the open part of the shed is enclosed with modern diagonal lattice attached to dimensional lumber. The north wall of the enclosed part of the shed is clad with the plain un-beaded weather boards, as elsewhere, with 5 to 5 ¼" exposure. Because these have been protected by the open shed for so long, they survive very well. There is an early door centered in this wall that gives access to the large room behind the kitchen. This is composed of four raised panels framed by Georgian ovolos, and is the oldest extant exterior door in the house (Figure 24). It is 2'-10" wide and 6'-1" tall. It is currently operated by a cast iron Blake latch and is hung on broad strap hinges. It is set in an unmolded 5" casing.

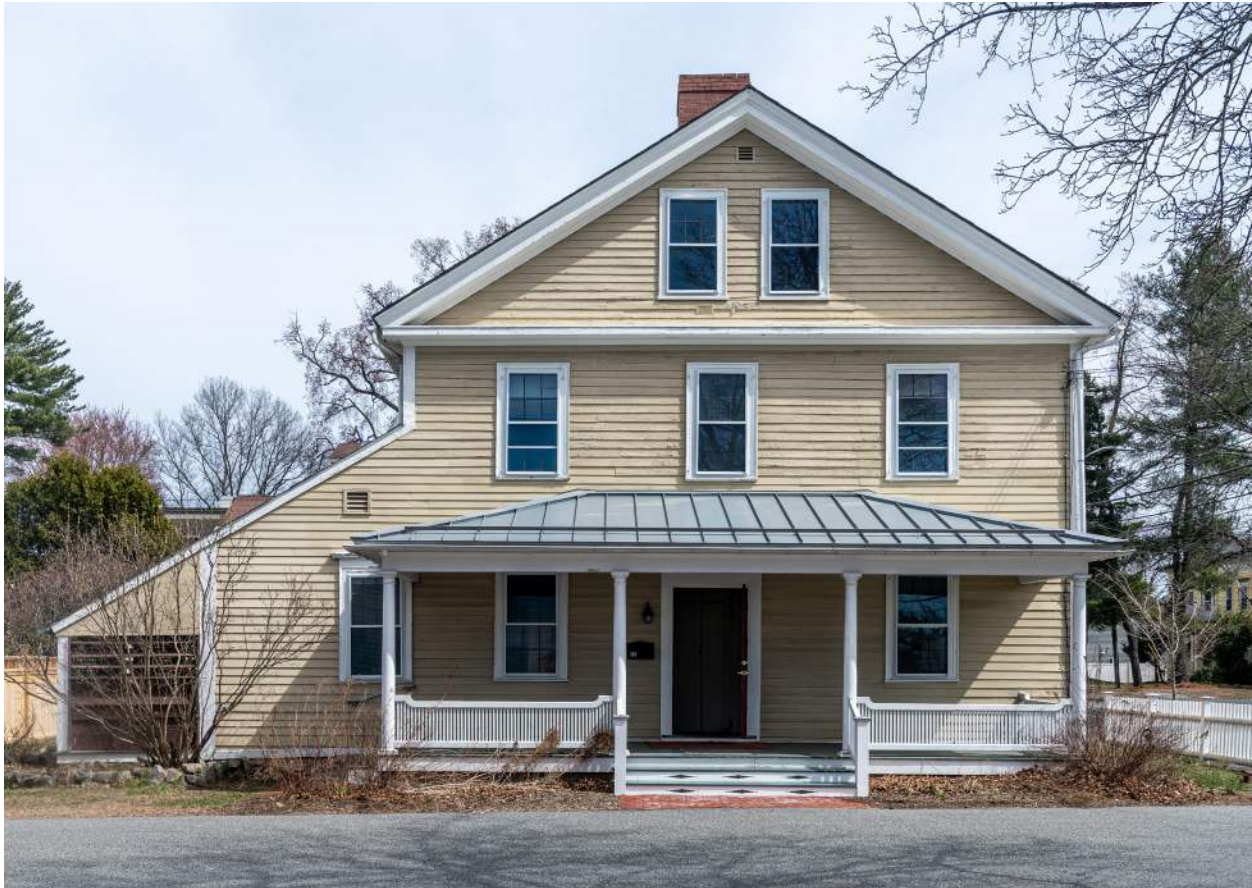
Figure 25. *Shepherd House, west gable end, showing roof as raised in 1845.*

The west wall is a mirror image of the east (Figure 25). It preserves important evidence for the development of the house from the 1790s to the 20<sup>th</sup> century. It is framed, like the other principal fronts, by a 4 ¾" high

skirting board and 7 ½" broad corner board. This survives at the southwest corner, but the corner board at the northwest corner (at the rear of the shed) has been replaced. The eaves are decorated with a deep Greek Revival pediment, with the bed mold and tall crown molding seen on the opposite side of the gable end.

As on the other walls, this face is sided with sawn, unmolded weatherboards with 5" exposure. They survive well on this wall, except in the west wall of the rear shed, where they have been replaced recently.

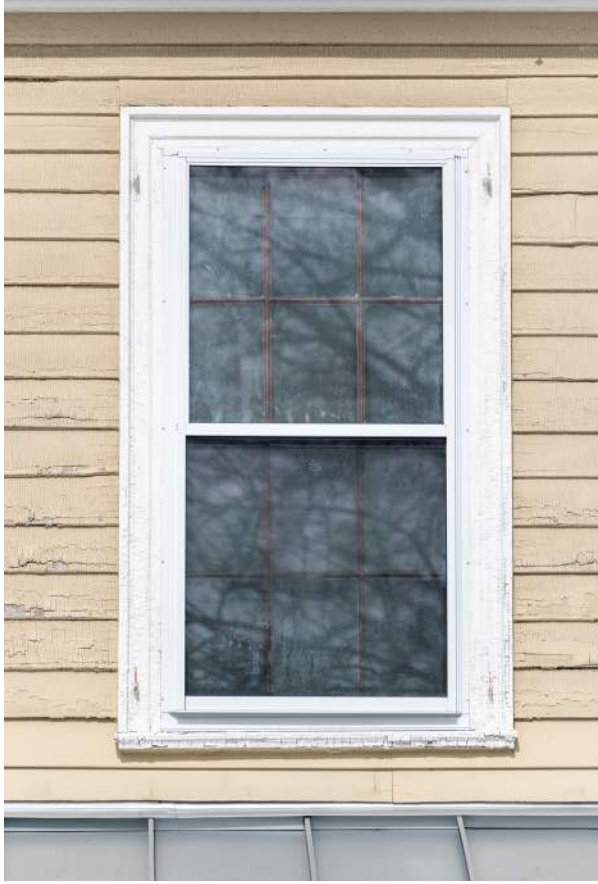
Figure 26. *Shepherd House, period II second floor window, set in period I casing, in west wall.*

As on the south and east fronts, the first- and second-floor windows are six-over-six sash framed with 5" double architraves, decorated with 1 ¼" cyma backbands (Figure 26). They sit on molded sills. Like the south and east fronts, the first-floor windows are further elaborated with molded caps formed by a cyma

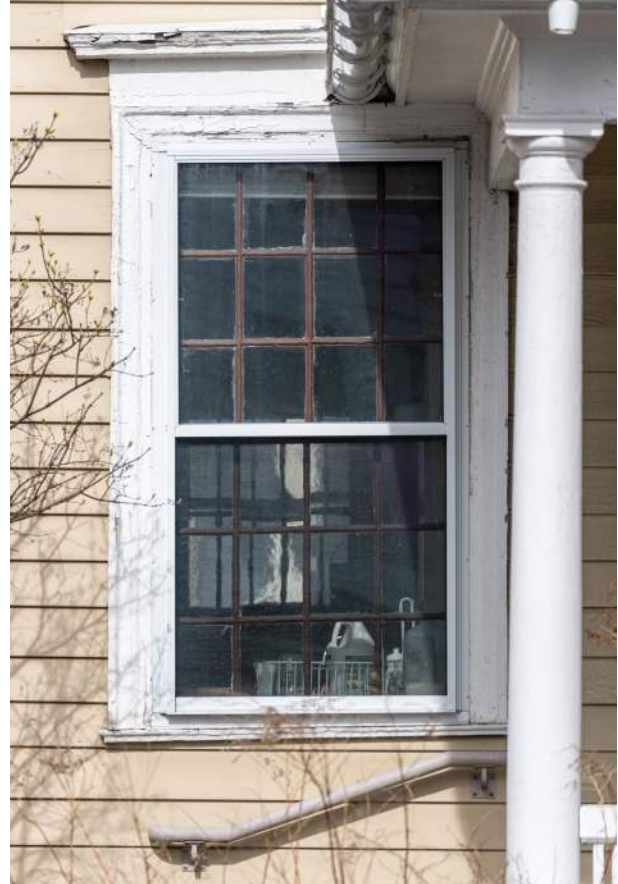
Figure 27. *Shepherd House, period I ground floor window in service room behind kitchen. Note 12-over-12 sash.*

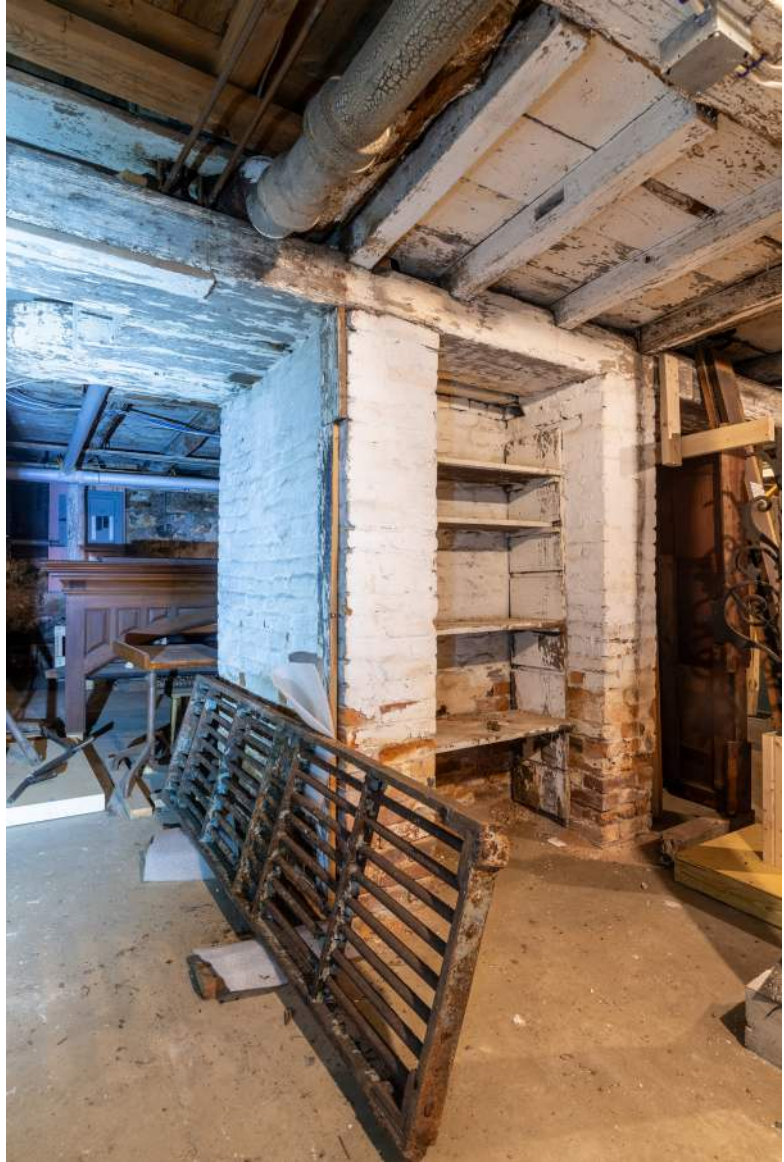
*Figure 28. Shepherd House cellar, showing base for east chimney.*

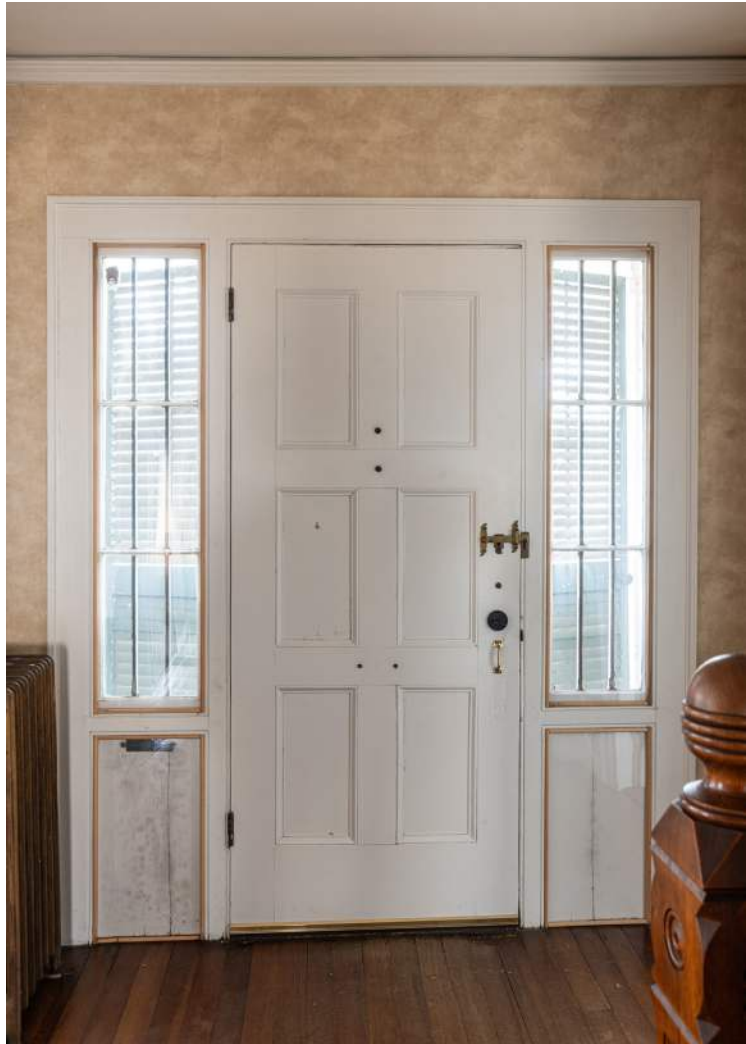
*Figure 30. Shepherd House, front door, interior.*

with flat Greek cymas. Its surround, like that of the sidelights flanking it, is finished on its interior with relatively broad 5/8" beads. The entire frame is cased in a thin 1 1/4" backband finished with a quirked cyma (Figure 30).

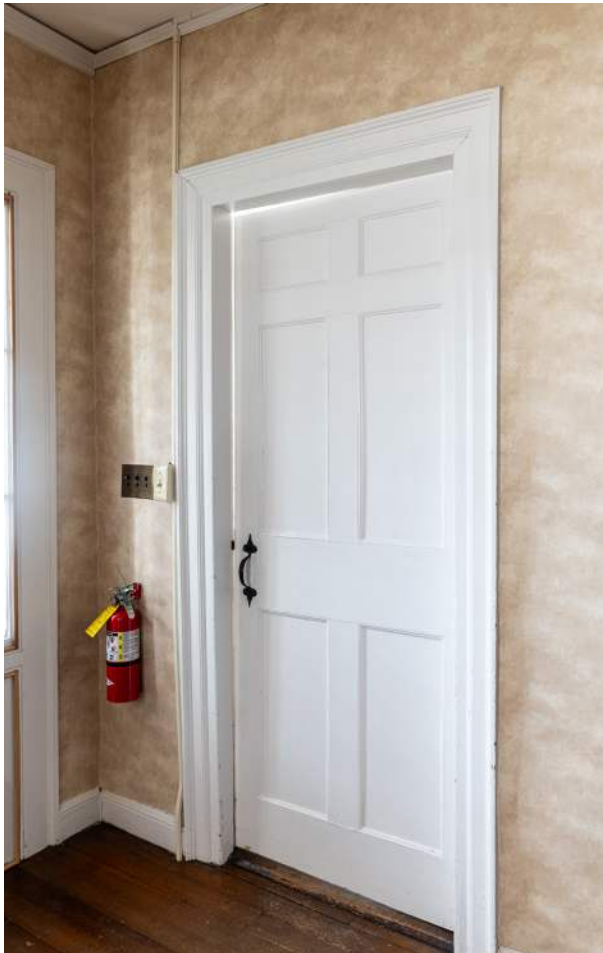
Figure 31. *Shepherd House, door from passage to dining room.*

The door surrounds in the passage reflect the three major periods of alteration in the house. The casing leading to the dining room is finished with a refined double architrave from the 1790s (Figure 31 and type A in the casing diagram). The front door was reconfigured in the 1840s. And the broad cased opening leading to the parlor was installed by Thomas Shepherd, sometime between 1885 and the death of his mother in 1896.

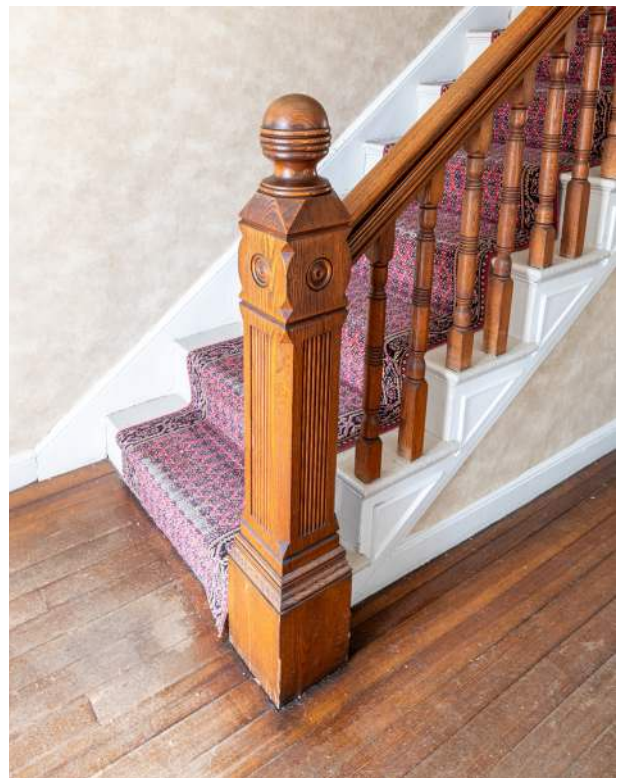
Figure 32. *Shepherd House, front stair as altered c. 1900, newel detail.*

The stair brackets and the stair nosings also date to the 1790s but the newel, handrail and turned balusters clearly part of the turn-of-the-20<sup>th</sup>-century improvements made by Thomas Shepherd. This material would not be out of place in a stylish bungalow of the early 1900s. Its robust oak baluster is ornamented with deeply cut grooves on its faces, chamfers at its corners, and a substantial grooved finial for its top (Figure 32). The handrail, too, is oak and richly molded. This sits on symmetrically turned oak balusters. The stair was one of the most stylish and modern elements of the house at the turn of the 20<sup>th</sup> century, dispensing with the Colonial Revival aesthetic that governed the changes to the adjoining parlor around the same time.

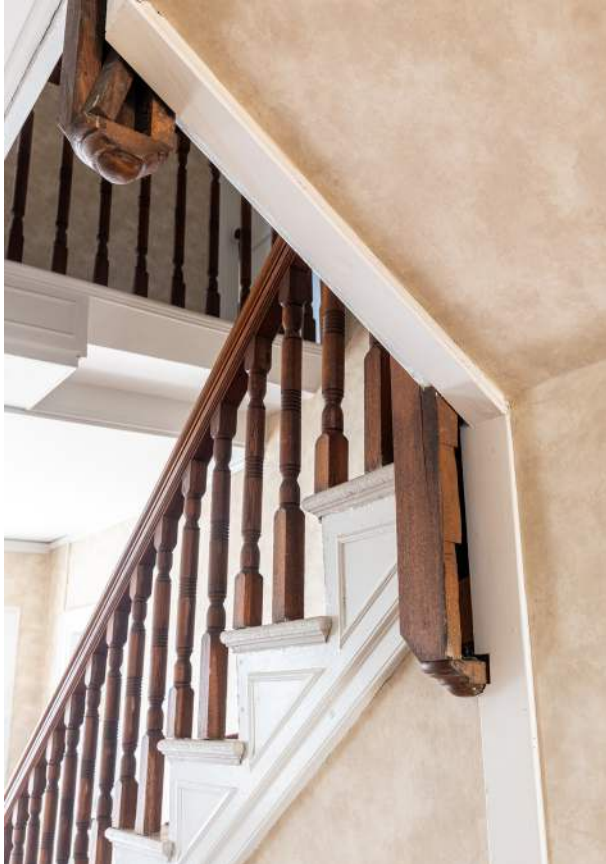
The stair passage currently runs through the entire depth of the house. Until the early 21<sup>st</sup> century, however, there was a partition at the front of the stair landing that subdivided the front passage from the rear. The picture rail on the east wall is mitered; when this was installed, it returned across the partition. When the oak newels were installed at the upper part of the stair at the turn of the 20<sup>th</sup> century, they, too, were set against the partition (Figure 33). The partition was still in place as recently as the 1992 Clancey and Leeke report on the house, in which it was depicted in figure 35. It was installed at the same time that the kitchen and rear bedchambers were finished, around 1810, and was still in place at the end of the 20<sup>th</sup> century.

*Figure 33. Shepherd House, front stair as altered c. 1900, detail of drops as cut to fit against removed partition.*

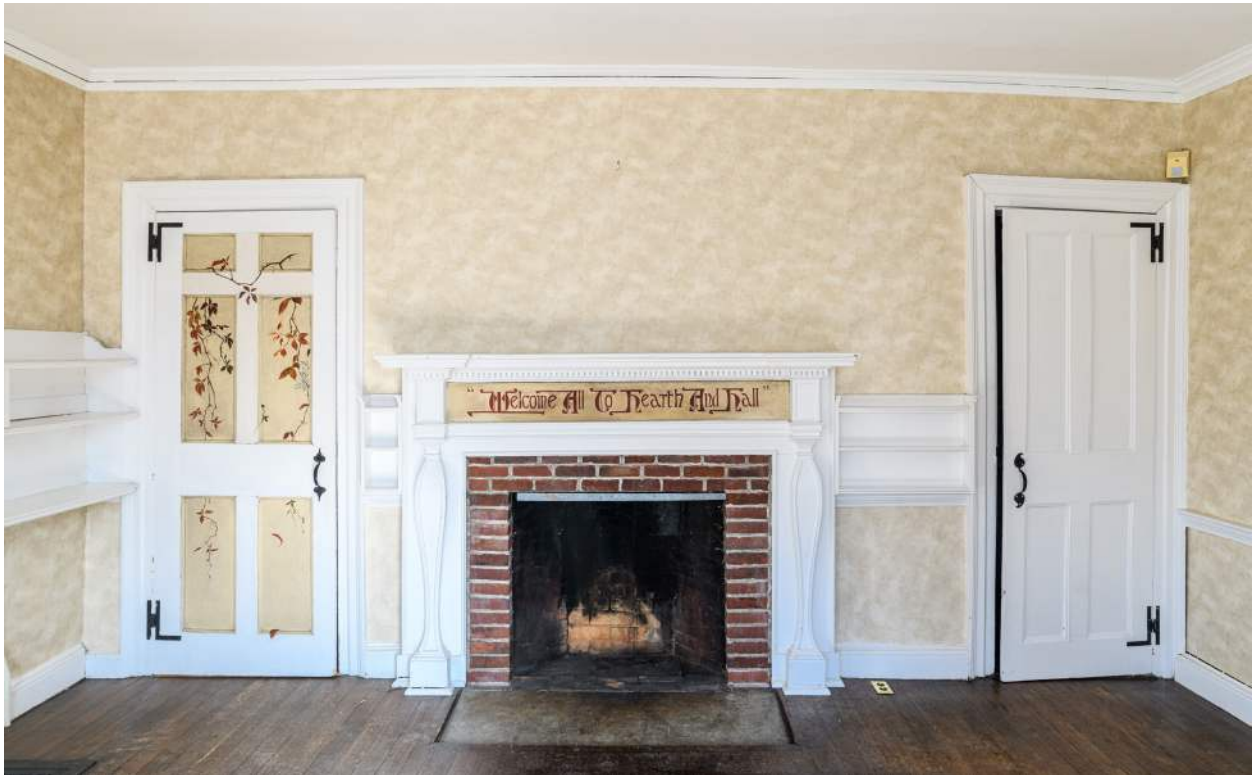
*Figure 34. Shepherd House dining room fireplace wall (southwest room, 100).*

We interpret the front left room as a dining room because of its proximity to the original kitchen (Figure 34). Whatever its customary function, it was certainly a public reception room: it has some of the most refined finishes in the house, and it occupies a prominent position, adjacent to the entry. It is also one of the largest rooms in the house, at 16'-6" wide and 14'-9 1/4" deep. From the modern strip oak floor to the modern drywall ceiling, this room is 8'-10" tall. It is accessible from the front passage and the side entry, and connects via a sliding shutter in its large closet to the kitchen behind.

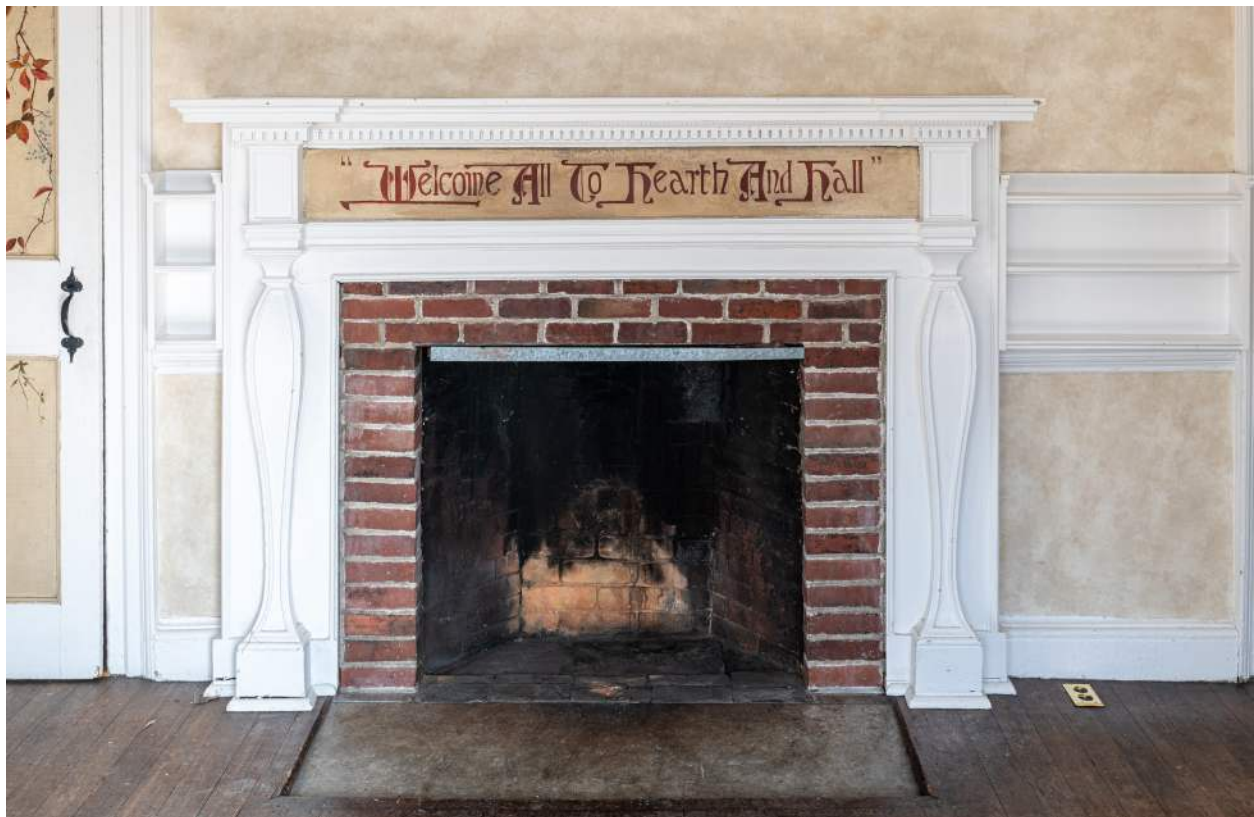
Figure 35. Shepherd House, dining room (100) mantel.

Though the mantel was moved here in the early 1900s, it is in fact an antique element, evidently from the early 19<sup>th</sup> century (Figure 35). It is framed by a pair of bulbous, tapered pilasters. These support a conventional frieze capped by a punch-and-gouge-work band of dentils, which is itself framed by a pair of rope moldings. This supports a deep shelf that is capped by a third rope molding below a quirked cyma backband. The mantel is, in short, typical of the freewheeling use of the neoclassical decorative language of the 1810s.

tury, the front of the firebox was re-faced with modern brick set in a hard Portland cement mortar. The original firebox itself remains in place, however. It is 3'-2" wide and 10" deep. The inner part of the hearth also appears to be ancient, with handmade brick set in sand. The forehearth is a broad stone slab, 4'-6" wide and 1'-6 ½" deep and set about an inch below the level of the present flooring.

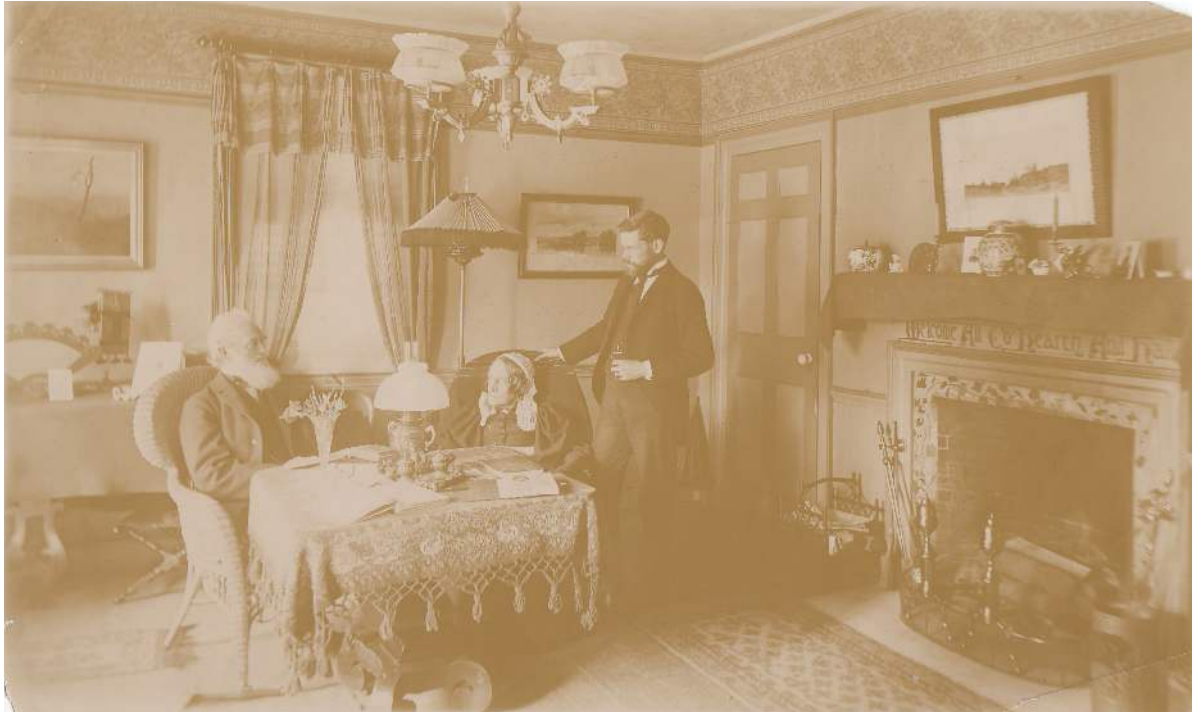
a polite room of the 1790s, with a frieze and mantel shelf over an architrave surround whose profile is similar to that of the door- and window-casings in this room (Figure 36). The present mantel was moved to this location from elsewhere in the early 20<sup>th</sup> century as part of the renovations for Thomas and Edith Shepherd. Its romantic motto, “Welcome All to Hearth and Hall,” painted on the frieze, has been carefully preserved as a poetic evocation of the spirit of this phase of work.

*Figure 36. Shepherd House, photograph of Shepherd family in room 100 taken c. 1896. Note original mantel still in place; molded surbase with no shelving or built-in seating, wallpaper border, and ceiling light fixture. Photograph courtesy of Historic Northampton.*
