# SHEPHERD HOUSE HISTORIC STRUCTURE REPORT

NORTHAMPTON, MASSACHUSETTS

HISTORIC NORTHAMPTON

*FEBRUARY 5, 2026*

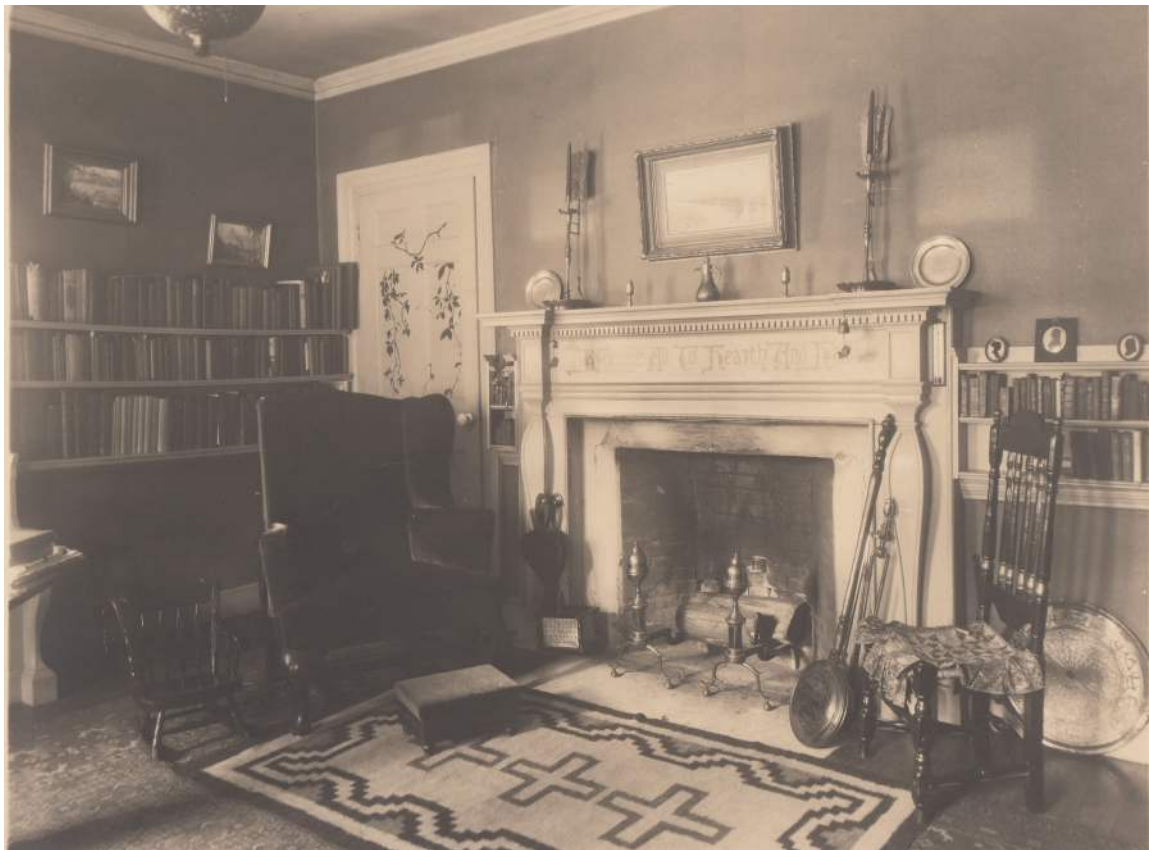
*Figure 37. Shepherd House, c. 1924 photograph of dining room (room 100), following installation of shelving in 1902. Note replacement mantel, removal of patterned wallpaper, and installation of electrified ceiling light.*

Like the parlor across the passage, this room was improved in the early 20<sup>th</sup> century with new fittings. These include the antique mantelpiece and its flanking shallow shelving on the north wall, the built-in seating in the southwest corner, and the additional cabinetry in the southeast and northwest corners (Figure 37). The settle in the corner is a low bench with bookshelves above it, both terminated by molded stanchions. A second, slightly higher upholstered bench sits below the west window. Between the window and the door to the back passage is another set of shelves, also terminated with a molded stanchion. All of this is treated in the manner associated with the early colonial revival, informed by an Arts-and-Crafts aesthetic that is characteristic of the contemporary shingle style used throughout coastal New England.<sup>108</sup>

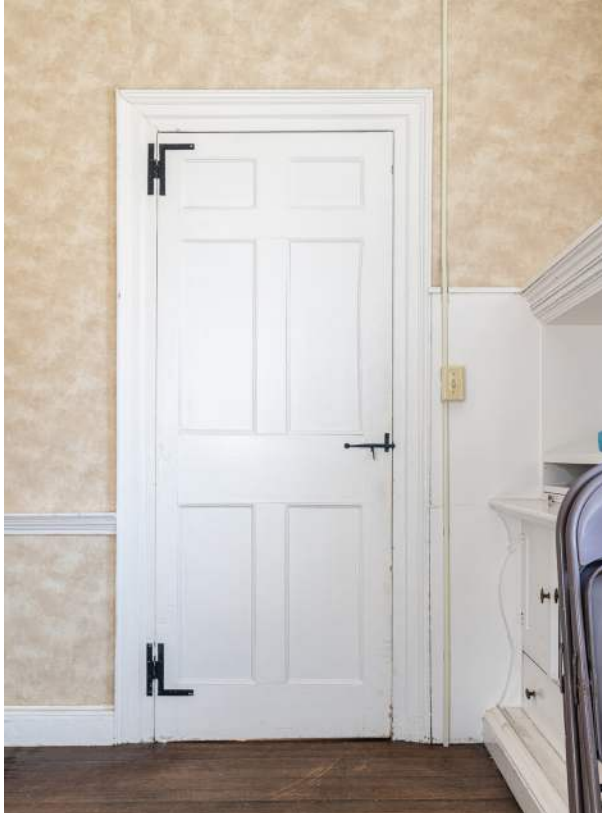
Figure 38. Shepherd House, dining room (room 100) door to passage. Thumb latch and H-L hinges installed mid-20th century.

There are two varieties of door leaf in this room, both early. Doors to the front and side passage have six panels, each of them flat and set in place with delicate applied cymas (Figure 38). The closet door is treated similarly, with flat panels set in place with tacked-in slender cymas, but with only four panels.

times, on both butt hinges and reproduction H-Ls. It is not clear which of these was first, but its present orientation, swinging from the north jamb, is plausible, and this is the side from which it was hung in a photograph from the 1890s. All doors and windows in this room are cased with Roman double architraves with a robust ovolo backband, terminated by an astragal (type B in the casing diagram).

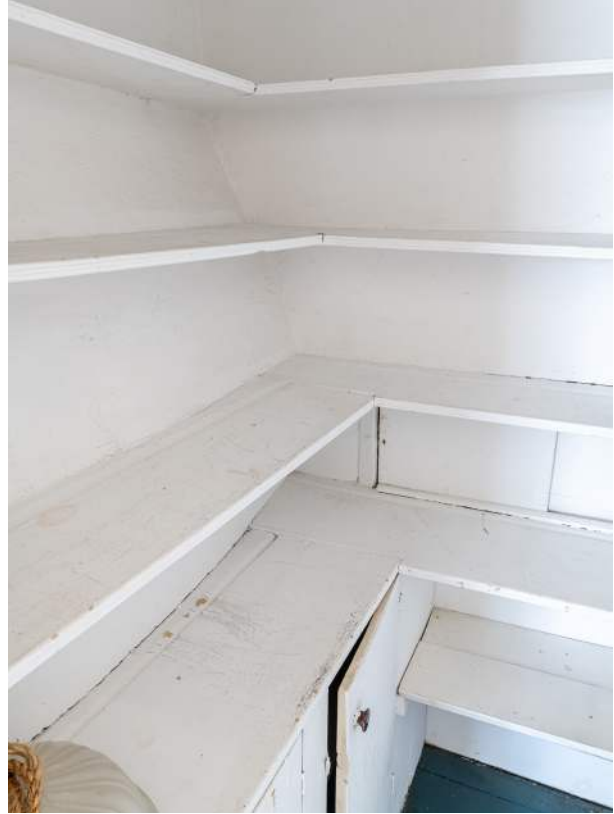
Figure 39. Shepherd House, dining room closet with early shelving and pass-through to kitchen, at lower right. Note plate rails.

The closet adjoining the fireplace is a remarkable survivor and an important artifact of domestic service in the early history of the house. There are six rows of shelving, each finished with a groove on its inside face and a plate rail (Figure 39). Additionally, there are a

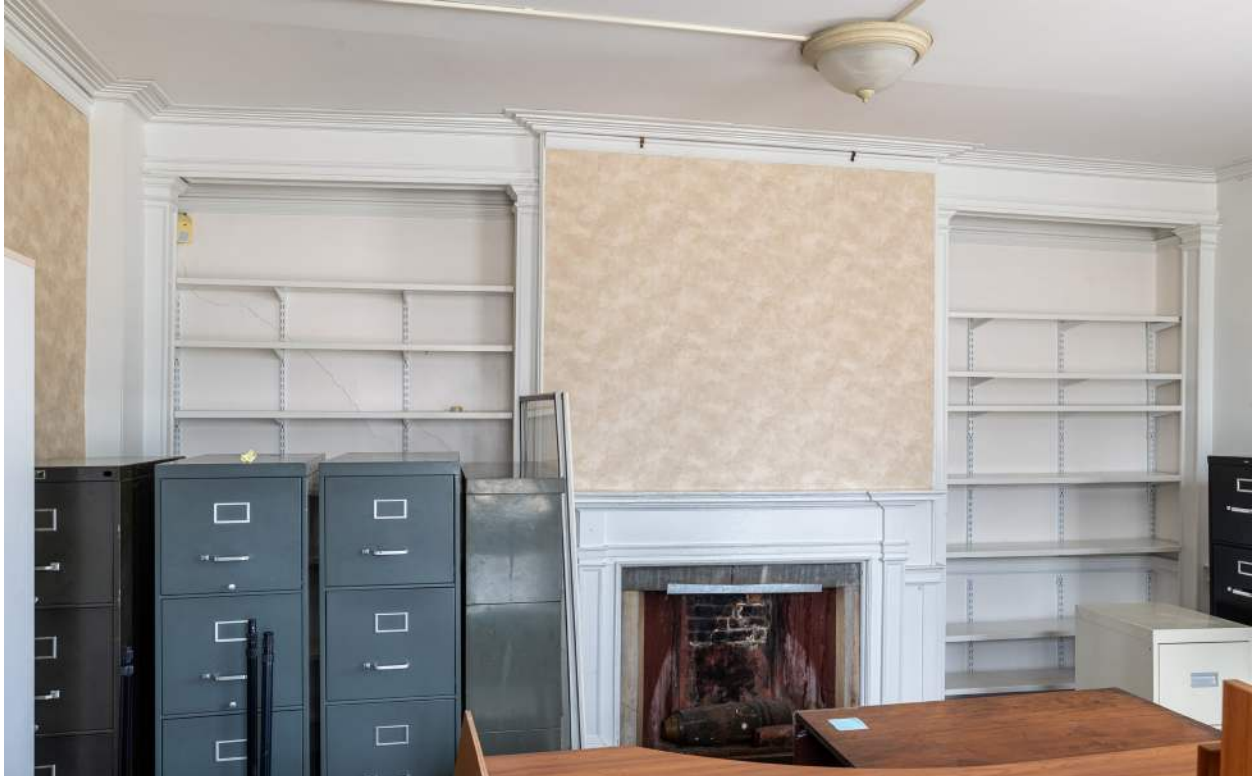
*Figure 41. Shepherd House parlor (room 102).*

The room on the right side of the passage has always been the largest on the ground floor, at 16'-5 1/4" wide by 15'-6" deep, as measured from the chimney breast to the opposite wall (Figure 41). Because of its prominence and its size, it has always been a public reception room. With the dining room identified as room 100, we see room 102 as the original parlor, a function it seems to have retained into the era of photography (Figure 42). Strengthening a reading of it as the most important public room for a long period is the fact that it has been substantially updated twice—first in the 1830s and again in the 1890s.

In a similar way, the cornice is built up from a combination of faceted elements and steeply projecting, relatively flat ovolos. Its upper moldings are currently hidden by modern drywall, but early photographs indicate that this is terminated with a cavetto and ovolo (see photo 30 in the SPNEA report). We take the cornice, like the mantel, to have been installed in period II.

This room was reworked for a second time in the late 19<sup>th</sup> century, when its doorway was widened to open it up to the passage, and new niches were created on either side of the fireplace opening. The new strip oak flooring in this room is cut around these new elements and must postdate them. The pilasters and entablature on the double opening from the passage are all of a relatively conventional Colonial Revival character, with pilasters formed from flat panels framed with slender backbands, and capitals similarly formed from built-up moldings. There is no attempt, in short, to make the pilasters resemble proper classical columns. They are, like the settle and bookshelves in the dining room,

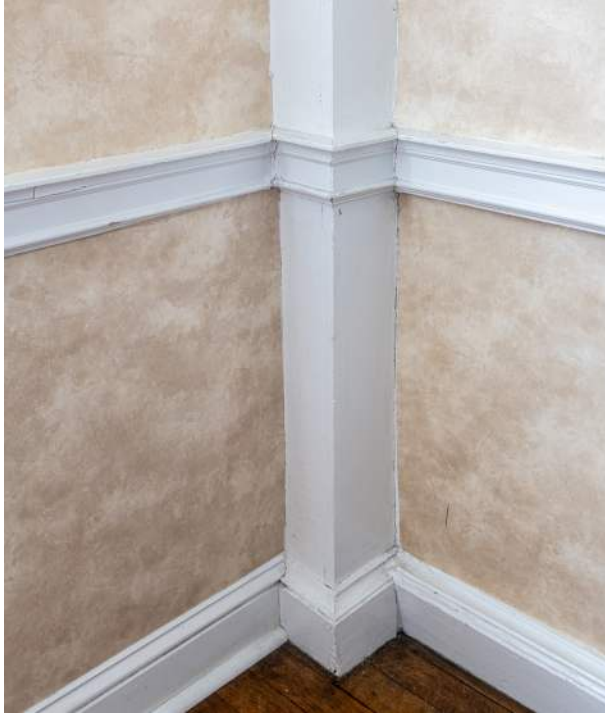
*Figure 43. Shepherd House parlor (room 102), detail of southwest corner post with early dado cap.*

Those cycles of improvement were thorough. The only woodwork that may remain in this room from the 1790s is its surbase, or dado cap. This is composed of a cavetto with an astragal above a plain board terminating in a torus. It is relatively simple compared to the corresponding member in the dining room but is likewise derived from Roman profiles (Figure 43). Perhaps nearly as old are the window casings, which are composed of quirked cymas with astragals, denoted type C in the casings diagram (Figure 44). If these are as early as 1798, they would be the most advanced woodwork in the house, but it is conceivable that they were installed around 1810, when we suggest that the kitchen and rear bedchambers were finished. The sequence of this material and its relationship to the later

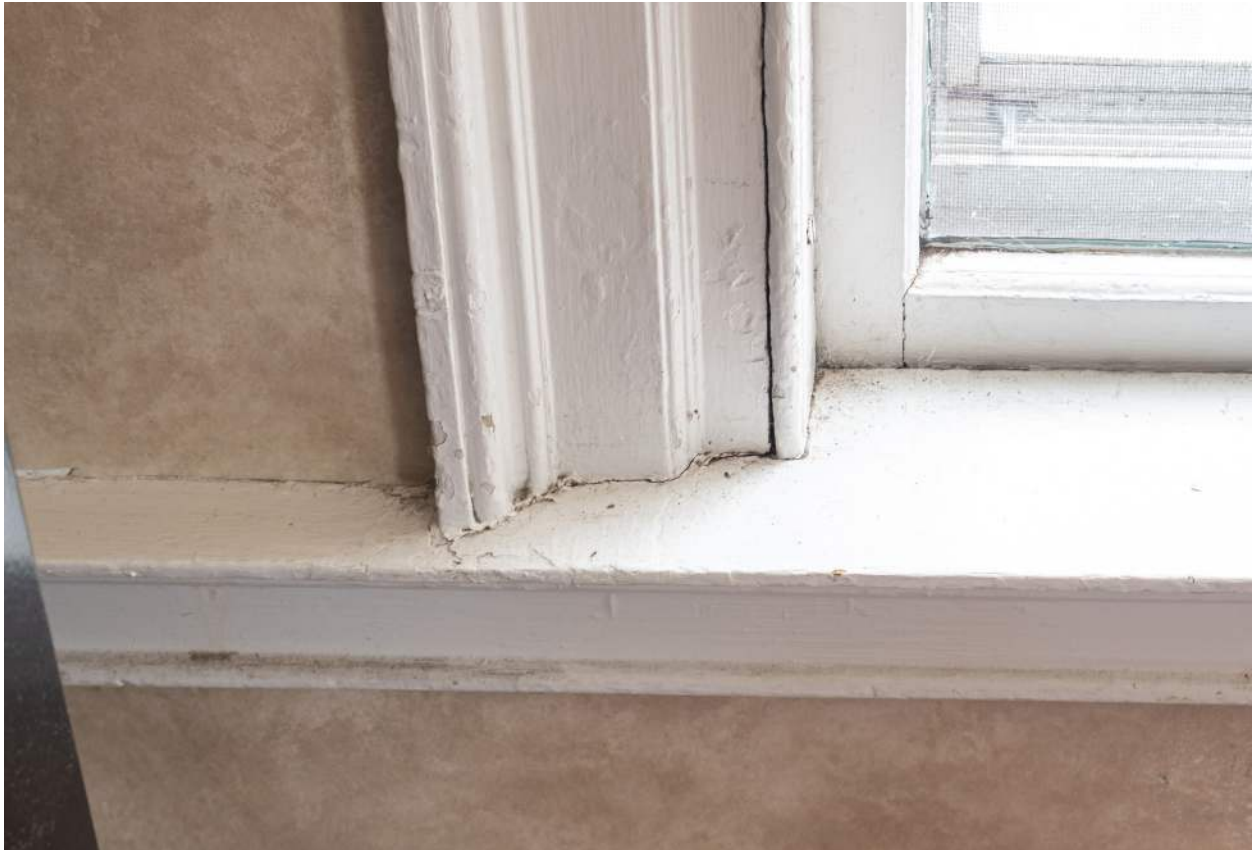
*Figure 44. Shepherd House parlor (room 102), detail of window casing and sill.*

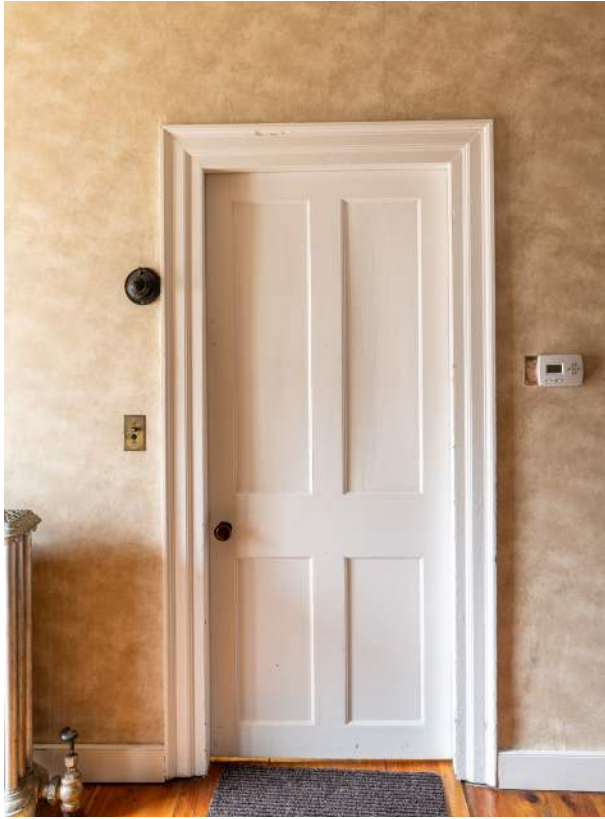
Figure 47. Shepherd House back passage, door to room 103.

The doors in this space that open under both the front and back stair have simple surrounds, composed of a thin cyma applied to a plain un-beaded casing (Figure 46). The doors that lead to the kitchen and the right rear room are fitted with double architraves; these match those leading from the front passage to the dining room, as well as those leading from the second-floor stair landing to the two front bedchambers (casing type A). All of these are four panel doors with four flat panels secured by delicate applied moldings, similar to the one leading to the dining room closet (Figure 47).

There is a thin metal escutcheon, seemingly for an early light fixture, to the left of the door to the northeast room (Figure 47). This is the only sign of an early light fixture in this part of the house. A metal casing for a doorbell is mounted above the door to the cellar stair. In the early 20<sup>th</sup> century, the rear passage was heated with a cast column radiator with an ornamental top like that in the parlor.

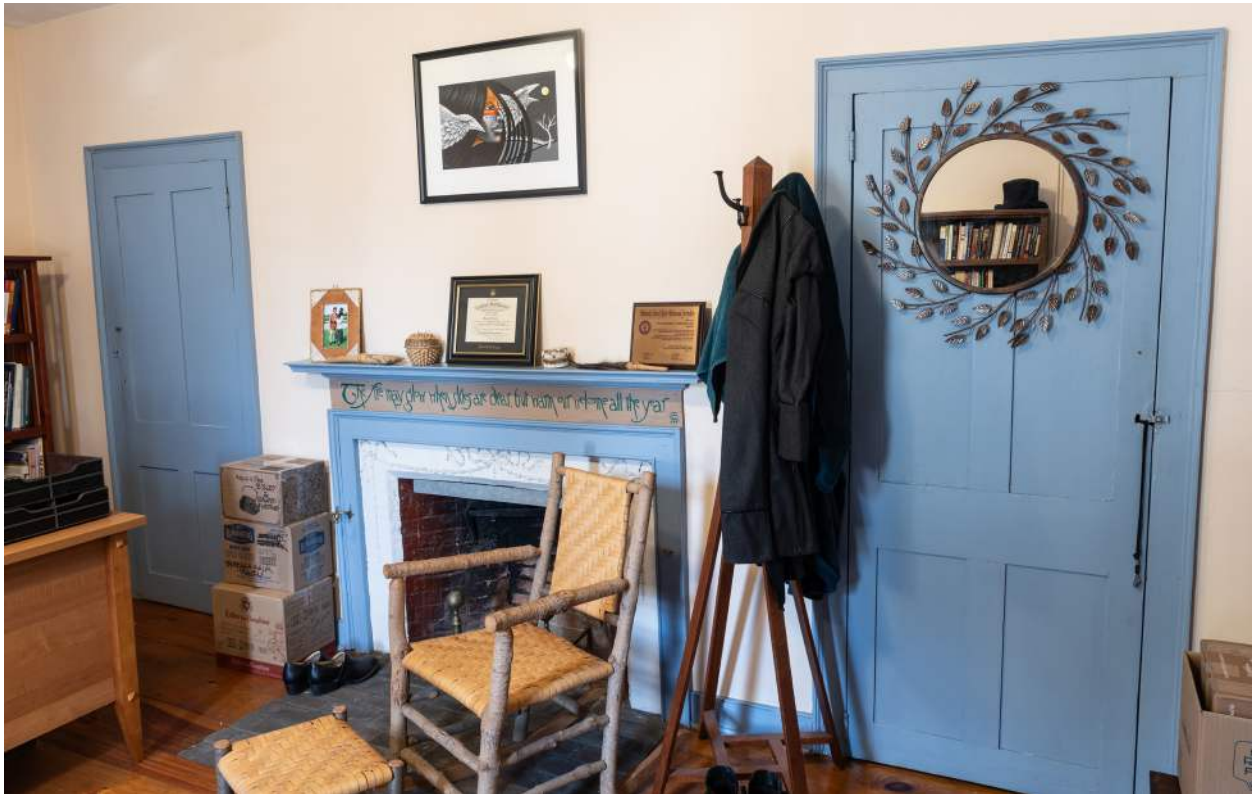
Figure 48. Shepherd House family dining room (right rear, room 103).

This room is only accessible from the back passage, through a four-panel door in a double-architrave surround. It is the most private room on the ground floor. Its function in the early phase of the house's occupation is ambiguous but its position and scale suggest that it was of secondary importance, perhaps an office or a low-status bedroom (Figure 48).

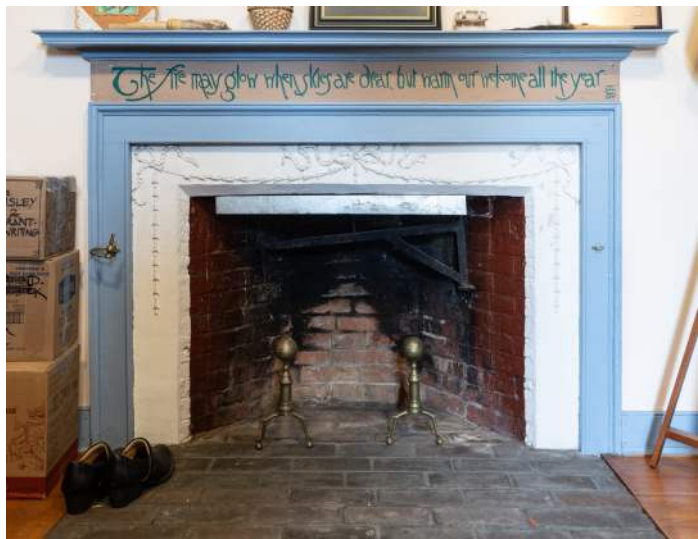
Figure 50. *Shepherd House family dining room (103) mantel.*

but handsome, cased with the same single-architrave surround observed throughout the rear rooms of the house, with an ovolo backband with an astragal (type E). It retains its painted motto (Figure 50).

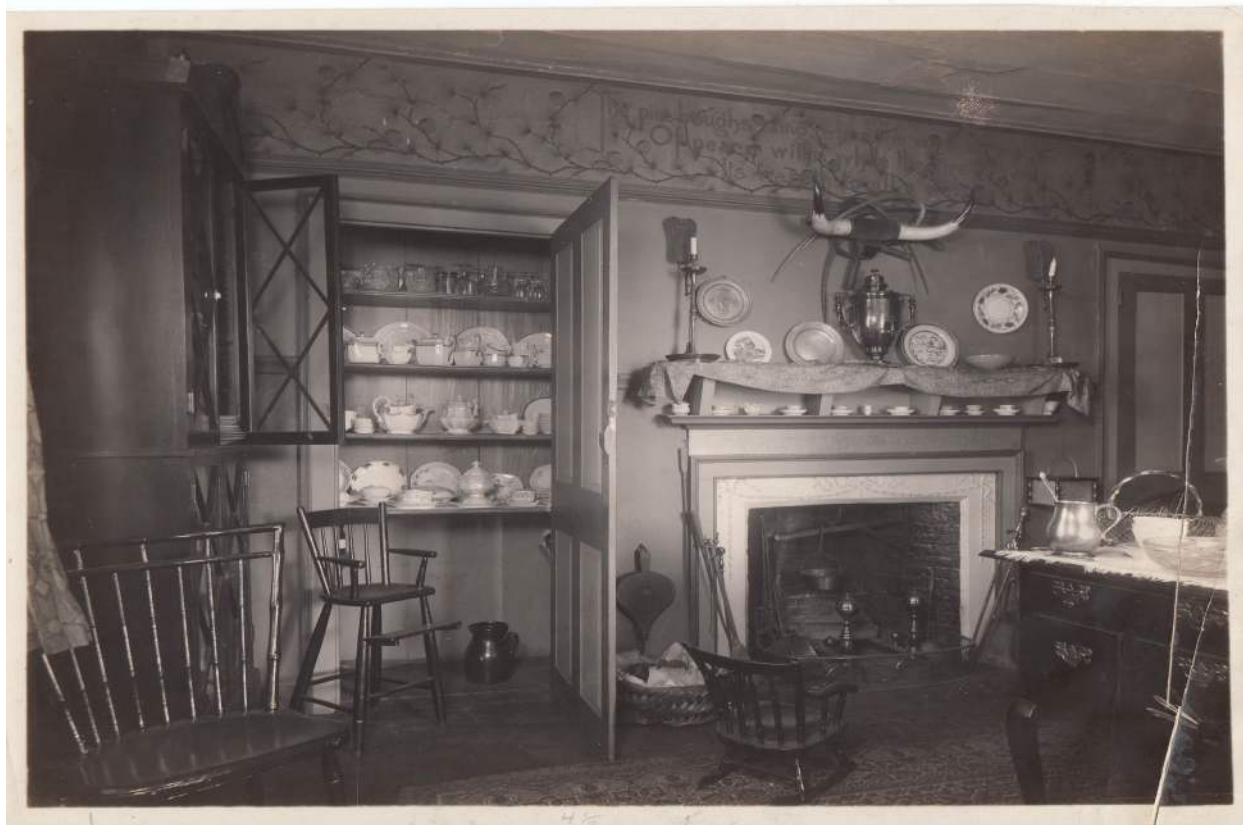
Figure 51. Shepherd House family dining room (103) fireplace wall. c. 1916 photograph from collections of Historic Northampton.

Two closets flank the fireplace (Figure 51). Both have flat four-panel doors hung on cast iron butt hinges. These are nicely made reproductions, which have been distressed to give the appearance of antiquity. With

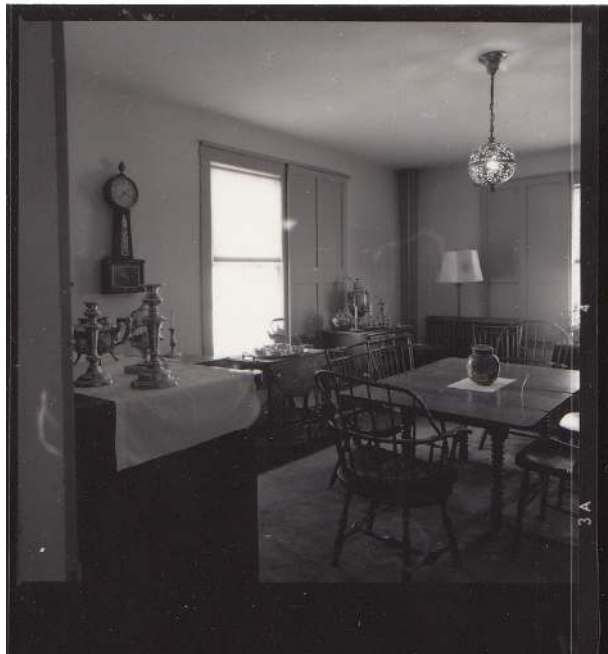
Figure 53. Shepherd House family dining room (103), 1976 photograph from collections of Historic Northampton.

Certainly, the room had been completely repainted by 1976, removing all of the mottoes except for the one on the mantel (Figure 53). Posts in the northeast and northwest corners of this room are covered with machine-planed casings that are secured with wire nails. These, too, are an artifact of the mid- to late-20<sup>th</sup> century refurbishment of this space, but likely conceal original structural elements.

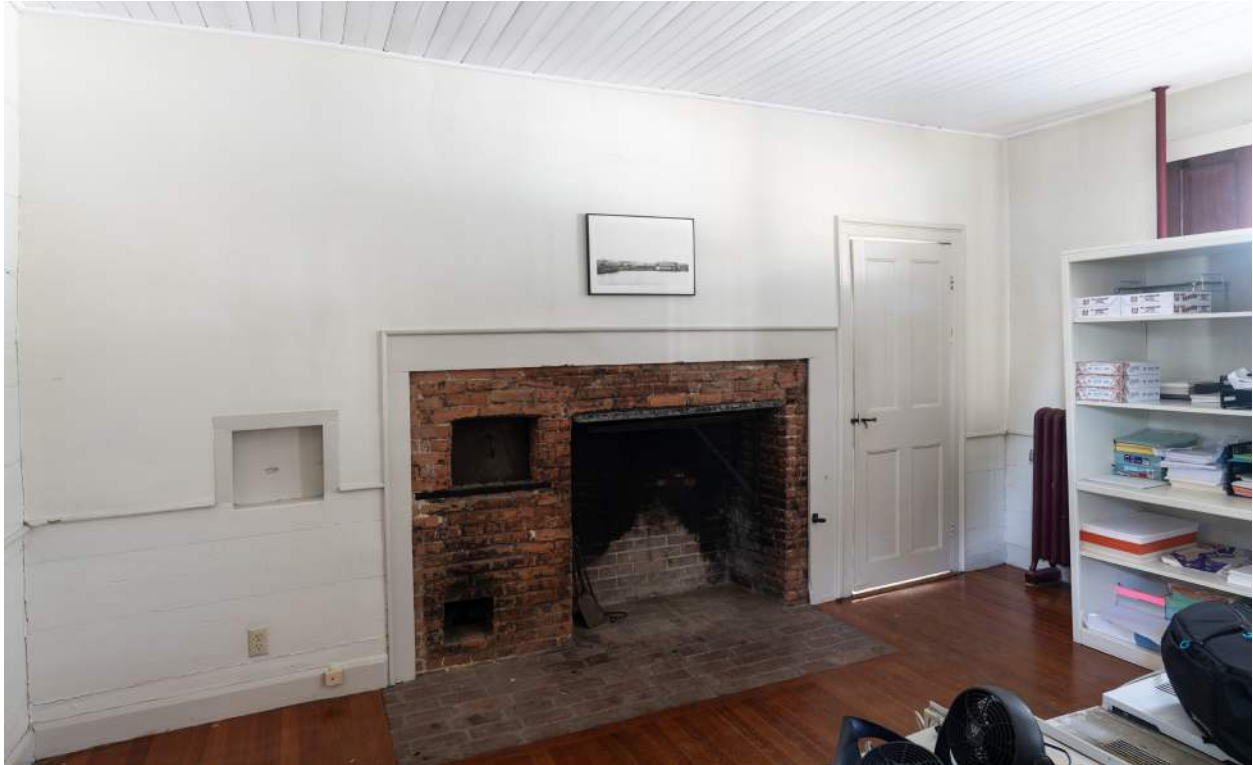
*Figure 54. Shepherd House kitchen (room 105), view of fireplace wall. Note bake oven and sliding door to left of fireplace, providing access to dining room closet beyond..*

The kitchen survives with its original finishes largely intact, though its bead-board ceiling was added around 1900 (Figure 54). Three walls are covered in plaster above the window sills, with board sheathing below; on the stair (east) wall, the boards run to the ceiling. The back stair rises from the northeast corner of the room, which is its only point of access on this level. A very tall, six-panel door once hung on butt hinges in this opening, but it was removed sometime after 1976 (Figure 11). There are signs throughout the house that suggest that it was, for a time, subdivided to accommodate tenants. One such piece of evidence is an eyelet driven into the inside of the north jamb of this door. This eyelet was likely placed here to receive a hook mounted to the inside face of the door, allowing it to be secured from the inside. This closed off the stair and the secondary bedchambers from people on the ground floor.

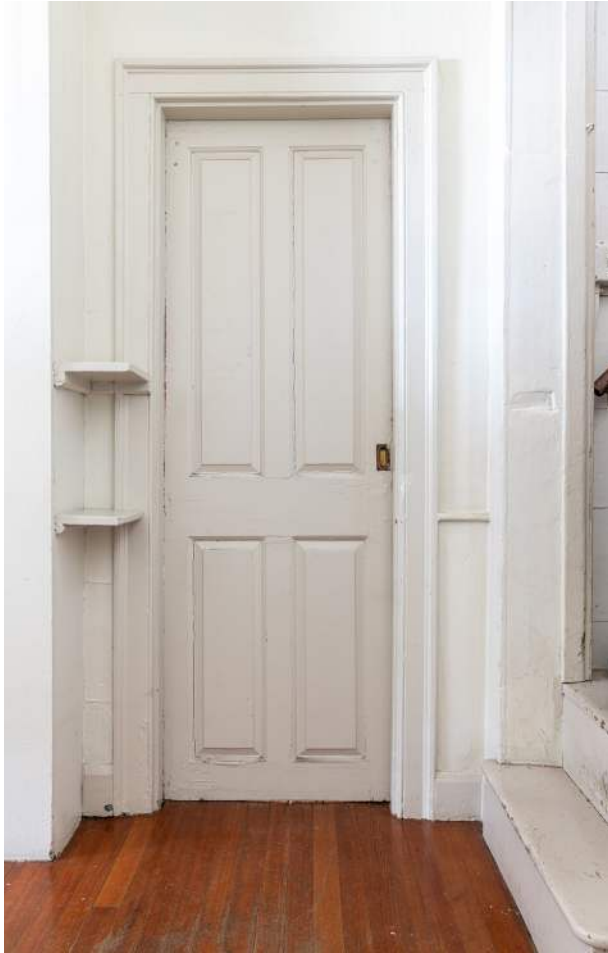
*Figure 56. Shepherd House kitchen door to pantry (107), originally hung on H-L hinges, reset as pocket door c. 1900.*

The two doors at the back of the kitchen have both been re-set in pockets. These are in good early frames with single architraves and a backband with an ovolo and astragal (casing type E). Only the east (right-hand) door is currently operational. This is an original four-panel door with raised panels, the only extant raised-panel door in the house (Figure 56). It was originally hung on H-Ls on the left jamb. A paint line shows where this was mounted on both the door leaf and on the casing. Both this door and the adjoining one originally swung into the room. On the right-hand door, we can see that this was operated by a thumb latch. The west door is inoperable, but it appears to be the same as the east door. The west door is 2'-7 1/4" wide and the east door is 2'-3 3/4" wide.

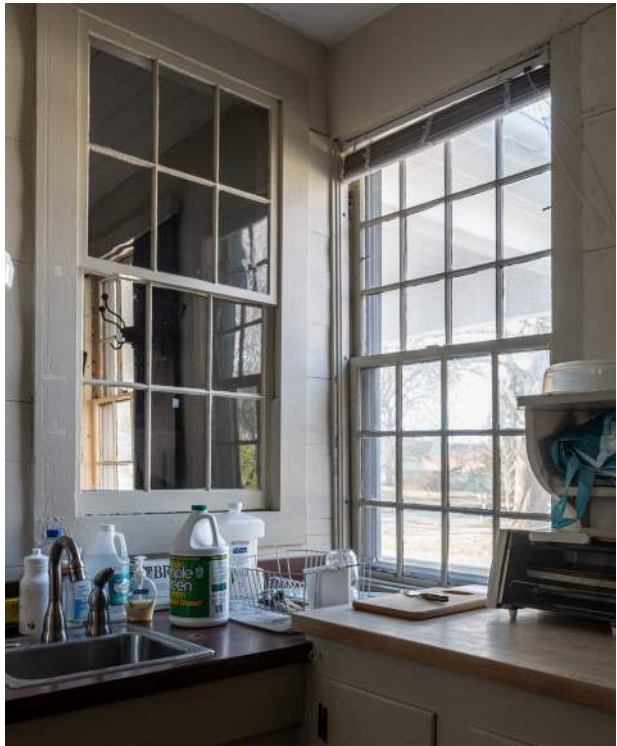
*Figure 57. Shepherd House service room (107) behind kitchen, detail of early 12/12 window and inserted 6/6 rob light.*

In addition to the two doors in the north wall, there is also a sash window. This has the knife-edge muntins found on the gable windows in the attic and is surrounded by a plain, unmolded casing (Figure 57). We take it to have been installed around the time that the roof was raised in 1845 to bring light into the kitchen. The only source of light before this was the single window in the west wall. This is currently closed with a pair of sliding shutters that have been stripped, sanded, and varnished on their inside (secondary) face. They are nicely finished on their superior face, with molded stiles and rails that are similar in character to those on the best early doors in the house. These were previously hung on butt hinges and set in modern jambs, the latter still in place. Their original assembly is not clear. The present rails in which they

The west door in the north wall of the kitchen leads to a large unheated room in the rear lean-to. This is 9'-2 1/2" deep by 10'-11 1/2" wide and was likely a buttery or a dairy; it certainly had some cooking-related function (Figure 57). There is an early shelf on an ogee bracket in the southwest corner, abutting the window, but there are no other extant early fixtures or fittings. The north end of the shelf is secured to a cased post in the northwest corner.

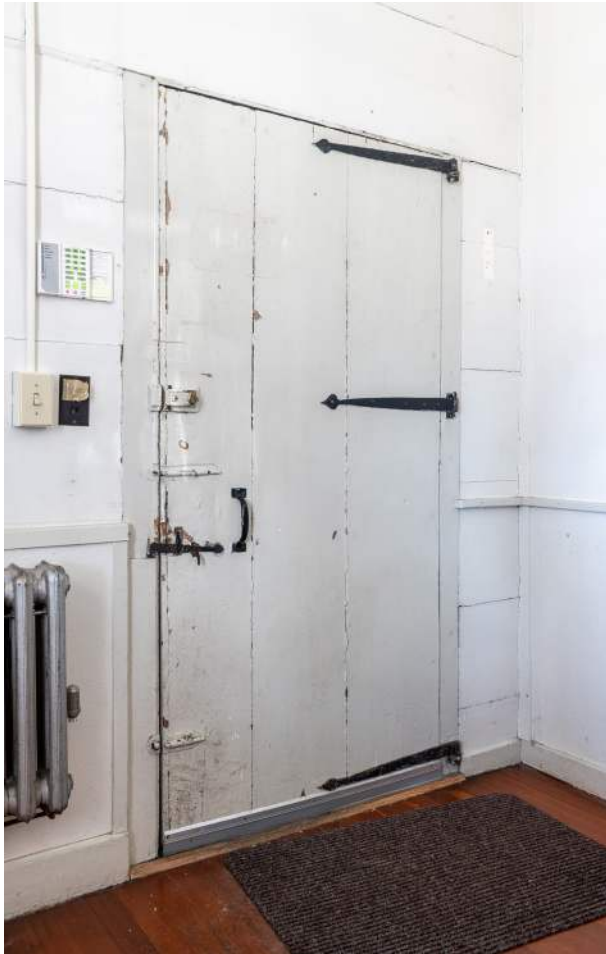
Figure 58. Shepherd House, service room (107) behind kitchen, detail of double-sheathed door to rear porch. Middle hinge modern.

An early double-sheathed door in the north wall, with vertical boards on the inside and raised panels on the exterior, opens into the rear shed (Figure 58). It was originally hung on a pair of 1'-7 3/4" long strap hinges with decorative terminals. These were reinforced in the 20<sup>th</sup> century with a third reproduction strap hinge of the same design.

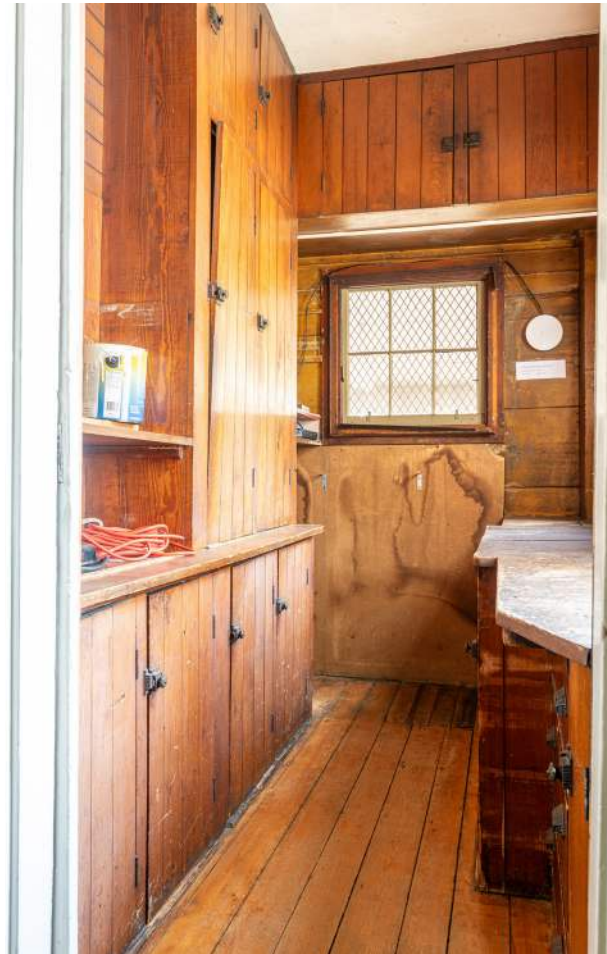
Figure 59. Shepherd House pantry (106) behind kitchen with 1897 cabinets.

Adjoining this large store room is a smaller pantry that is only accessible through the east kitchen door. It is 5'-3" wide by 9'-3 1/4" deep. All fittings in the pantry, as well as wall sheathing and window wash, were installed around the turn of the 20<sup>th</sup> century. Most of the work in the pantry likely dates to 1897 (Figure 59).<sup>109</sup>

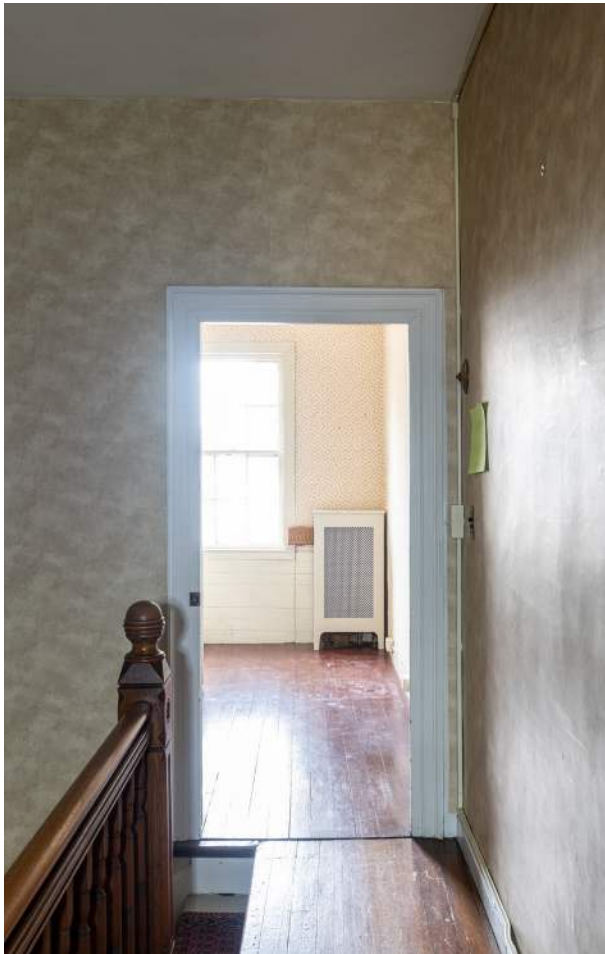
*Figure 60. Shepherd House second floor stair landing looking toward back passage.*

The principal front stair rises fashionably to a narrow second-floor landing that provides access to the two front bedchambers, the rear passage, and a little unheated room over the entry (Figure 60). The stairwell is protected by a handrail and balusters of the same form that decorates the stair itself, all of unpainted oak and installed around the turn of the 20<sup>th</sup> century. All four doors are cased with identical late-Georgian double architraves, (casing type A) with Roman cymas for backbands (Figure 61).

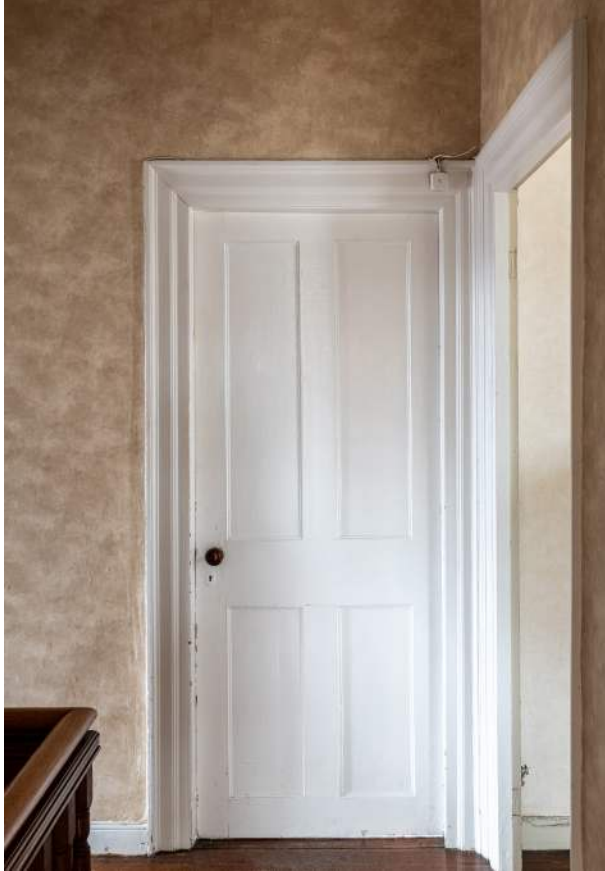
Figure 61. Shepherd House, second floor passage, door to parlor chamber (202).

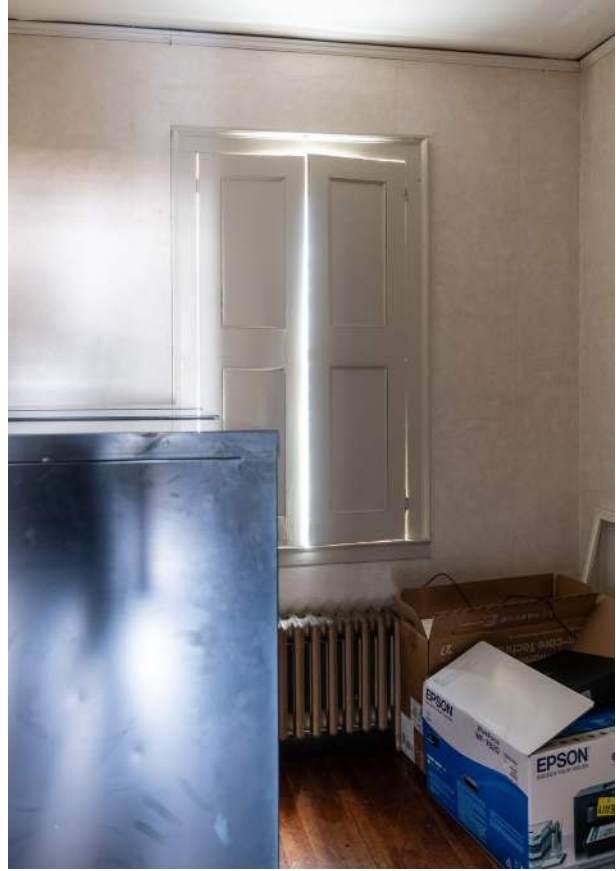
Figure 62. Shepherd House, room over the entry (201).

The room is lit by a single six-over-six light window in the front wall (Figure 62). It is finished by an original single-architrave casing with Roman cyma backbands and framed with a pair of paneled shutters hung on butt hinges. When open, the shutters' finished face is a raised panel, but the stiles and rails are unmolded. The shutters are made of hand-planed material and clearly original (Figure 63). They are the only extant shutters on the second floor. Their superior face is exposed when closed, with applied molded stiles and rails using a very slender torus, a fillet, and a cavetto, all with Roman profiles. The outer leaf retains a slide bolt that can be secured into a mortise in the sill. Other than its sash, which was replaced as part of the 1830s work in the house, this window opening remains in its original form.

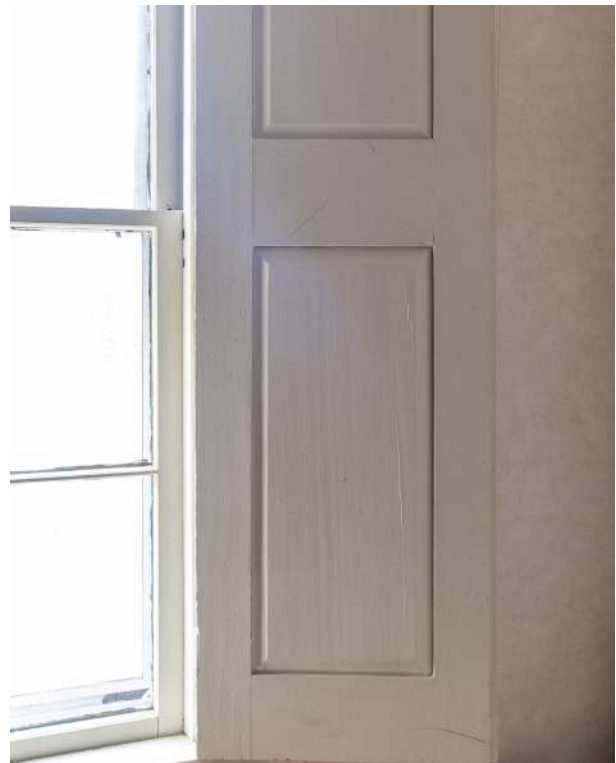
Figure 63. Shepherd House room over the entry (201), shutter detail.

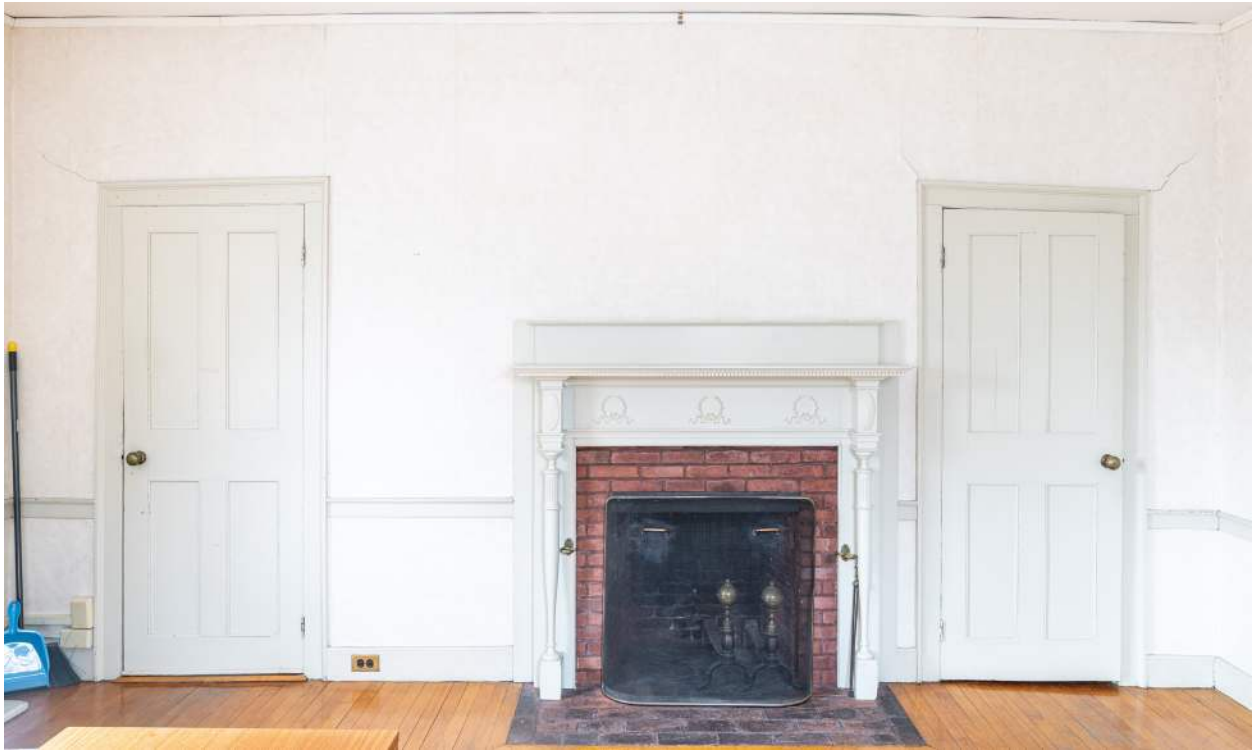
*Figure 64. Shepherd House, dining room chamber (201), view of fireplace wall.*

Like the other heated front rooms, this one is brightly lit and large (Figure 64). It is 16'-6" wide by 14'-6" deep, with two windows in the front wall and one in the side. It was likely well finished originally and retains its surbase and base, the latter 5" tall with a 5/8" bead. All openings are cased with single architraves with a relatively slender backband with a Roman cyma (casing type G). They have a 3/16" bead on their inside edge.

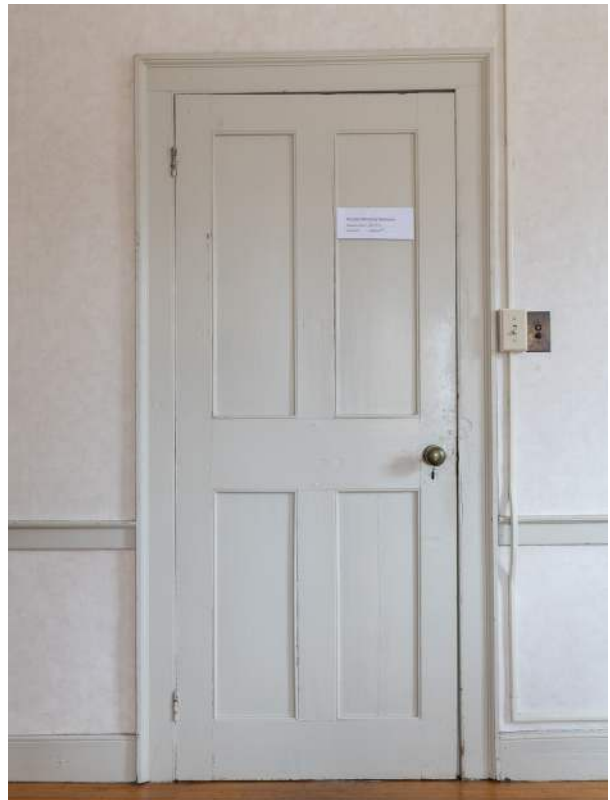
*Figure 65. Shepherd House, dining room chamber (201), door to passage.*

thin stamped brass knobs on the room side (Figure 65). The door to the passage may have had a thumb latch originally. We see additional signs, in this room, of the house having been let to boarders for a time as there is evidence for two different types of interior locks on the door to the passage, one a slide bolt.

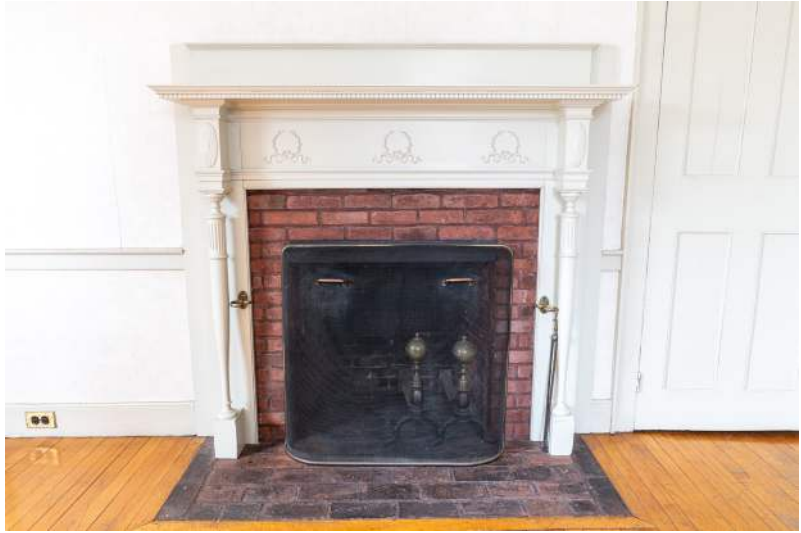
Figure 66. Shepherd House, detail of dining room chamber mantel, installed c. 1900.

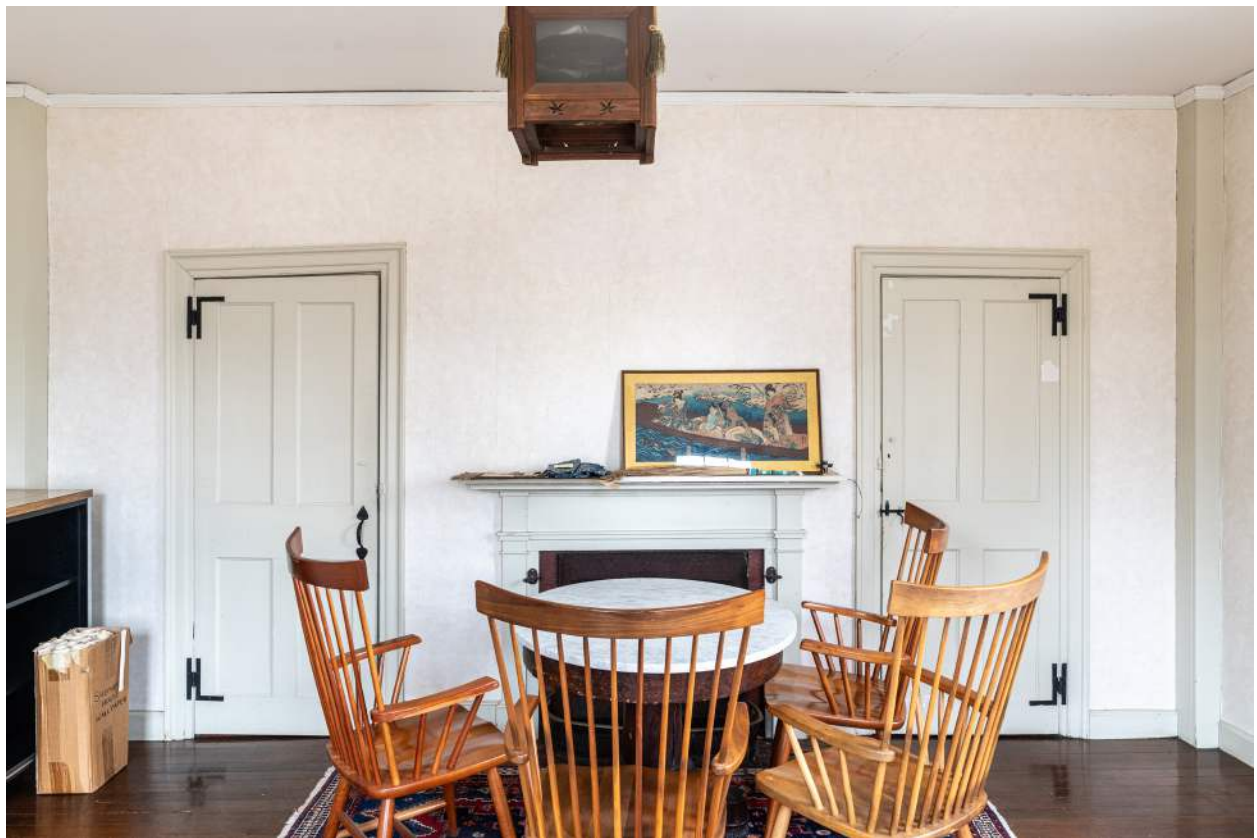
Figure 67. Shepherd House parlor chamber (202).

Like the bedchamber over the dining room, the one over the parlor is generously lit by two windows in the front wall and one in the east. It is 16'-5" wide and 15'-1 1/2" deep, its additional depth partially achieved by leaving all four posts exposed in the room (Figure 67). The casing of each post has a very slender bead along one of the boards. They are not flared.

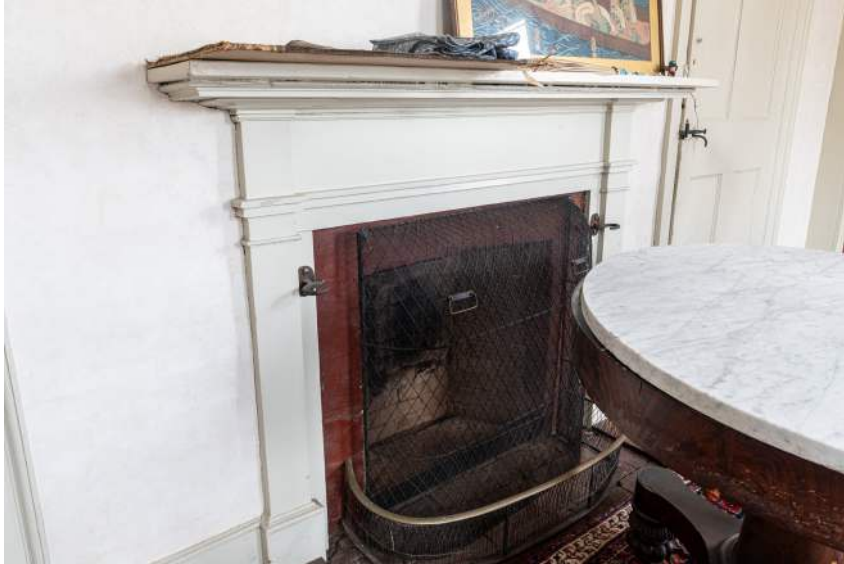
Figure 68. *Shepherd House, detail of parlor chamber (202) mantel.*

This room, too, is decorated with a fine mantel that is not an original element. Here, its proportions and configuration are consistent with a turn-of-the-nineteenth century installation, but the moldings on its mantel shelf likely postdate 1830, so we read this as part of the period II refurbishment that updated the finishes in the parlor below (Figure 68). There are very sharp, deep ovolos under the mantel shelf and a flared, tapered molding under the frieze that seem very modern for the early 1800s. There is a 20<sup>th</sup>-century mantel shelf above an earlier one.

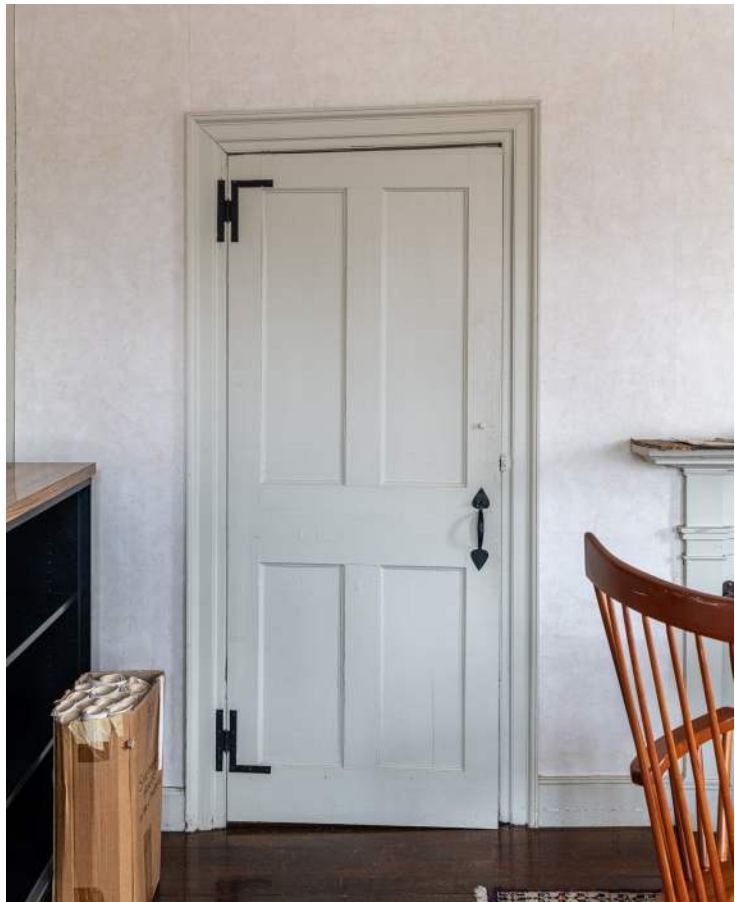
Figure 69. *Shepherd House parlor chamber closet door.*

All three doors currently have reproduction H-L hinges and thumb latches that were added sometime after 1976. The two closet doors were originally operated with a delicate pull and secured with a small turnbuckle (Figure 69). The door to the passage is currently operated by a mid-19<sup>th</sup>-century mineral knob with a mortise lock below. We can see signs of a turnbuckle to hold the door closed but this has been removed. There seems to be a slot for a thumb latch, but we do not see any of the usual corresponding evidence for this type of hardware.

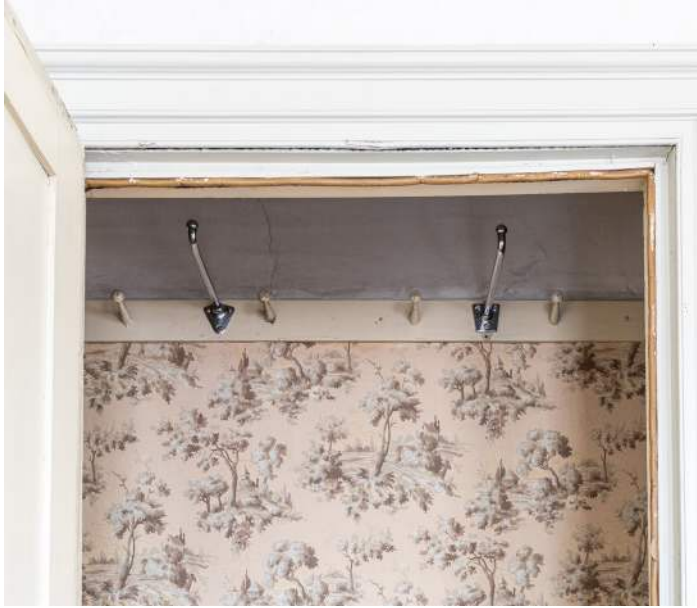
Figure 70. Shepherd House parlor chamber closet with early peg rail.

As originally configured, this room had two closets flanking the fireplace. The right-hand one now provides access to a bathroom behind it, but the left-hand closet is substantially intact. Its floor is covered with an early linoleum and there are wallpaper fragments in the northwest corner, below a low shelf. The walls are finished with flat, unmolded baseboards. There is a peg rail on the north, south, and west walls with many surviving turned pegs with mushroom terminals (Figure 70).

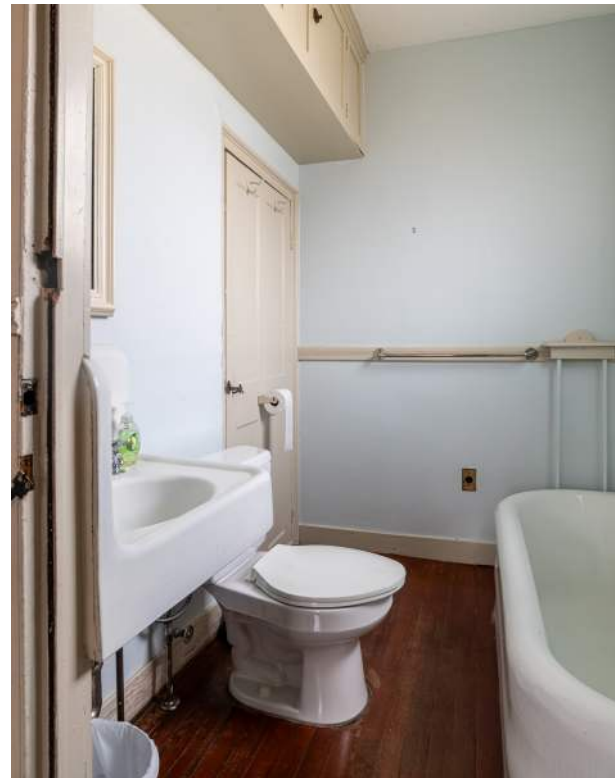
This little room was made by enlarging the closets east of the east chimney to intrude on the right rear bedroom (Figure 71). It was converted into a bathroom no later than the early 20<sup>th</sup> century. An early

Figure 71. Shepherd House, east bathroom, second floor. Note early door at back left, re-set so that its superior face is oriented to the bathroom.
