# SHEPHERD HOUSE HISTORIC STRUCTURE REPORT

NORTHAMPTON, MASSACHUSETTS

HISTORIC NORTHAMPTON

*FEBRUARY 5, 2026*

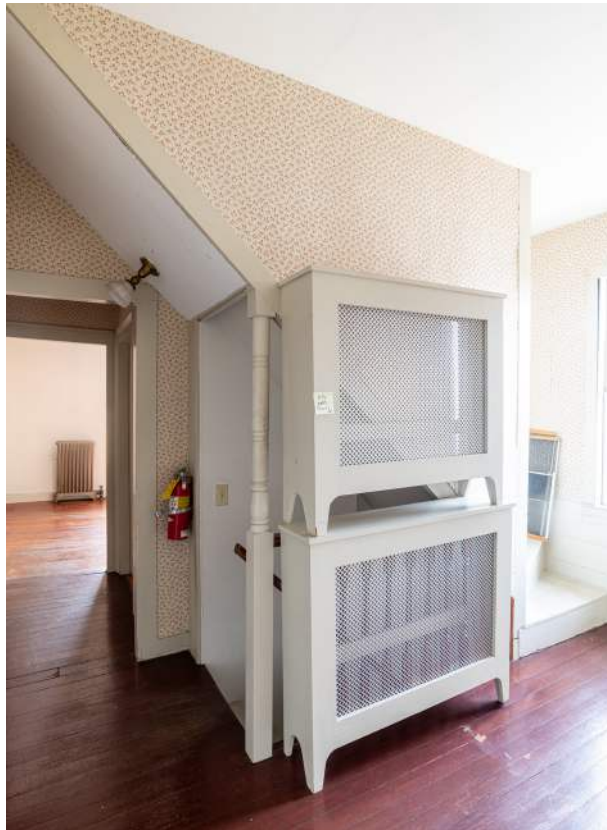
Figure 73. Shepherd House attic stair door.

the attic stair is installed on split lath, but we can only see this in fragments. In one location we can observe a cut-nail head. The stairs to the attic are assembled with mature cut nails with square heads. These begin with three winders up to a straight run and the door sits at the top of the third winder. This is a batten door assembled with wrought nails and operated by a thumb latch, which is clearly much older than the reproduction thumb latches installed elsewhere in the house (Figure 73). However, it is currently fastened with modern flat-head screws. It is hung on H-L hinges that are also old but these, too, are secured with screws. In all, material associated with the attic stair seems generally to survive from the middle of the 19<sup>th</sup> century, when the roof was raised and the attic stair inserted.

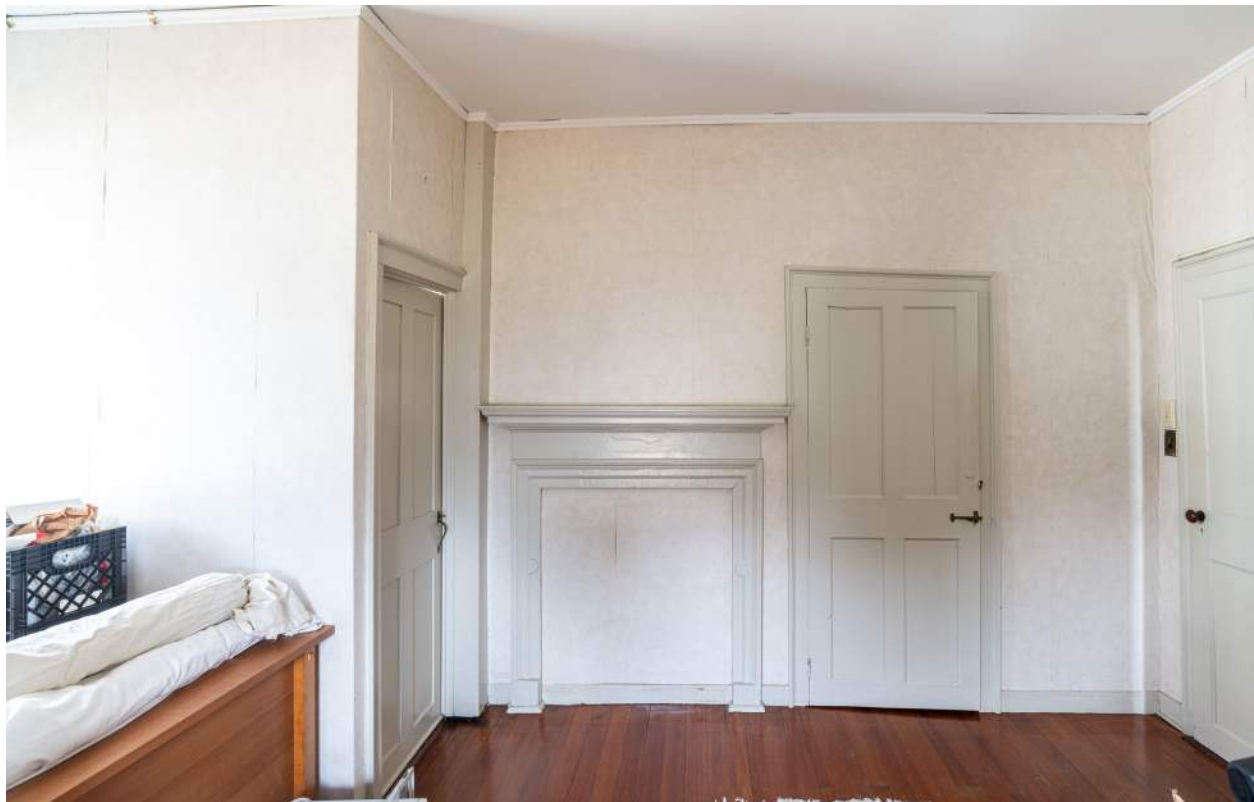
The right rear room is 16'-6" wide by 12'-7" deep at its largest point. It has always been one of the smallest rooms in the house and its size has been further encroached upon by the east bathroom. Though it is fitted with a mantel, it appears that this room was not originally provided with a heat source (Figure 74). It is, however, reasonably well lit, with a lit with a single window in each of the north and east walls. Posts in the corners along the north wall are both exposed and cased.

Figure 74. Shepherd House, right rear chamber (204). Note encroachment by bathroom at left.

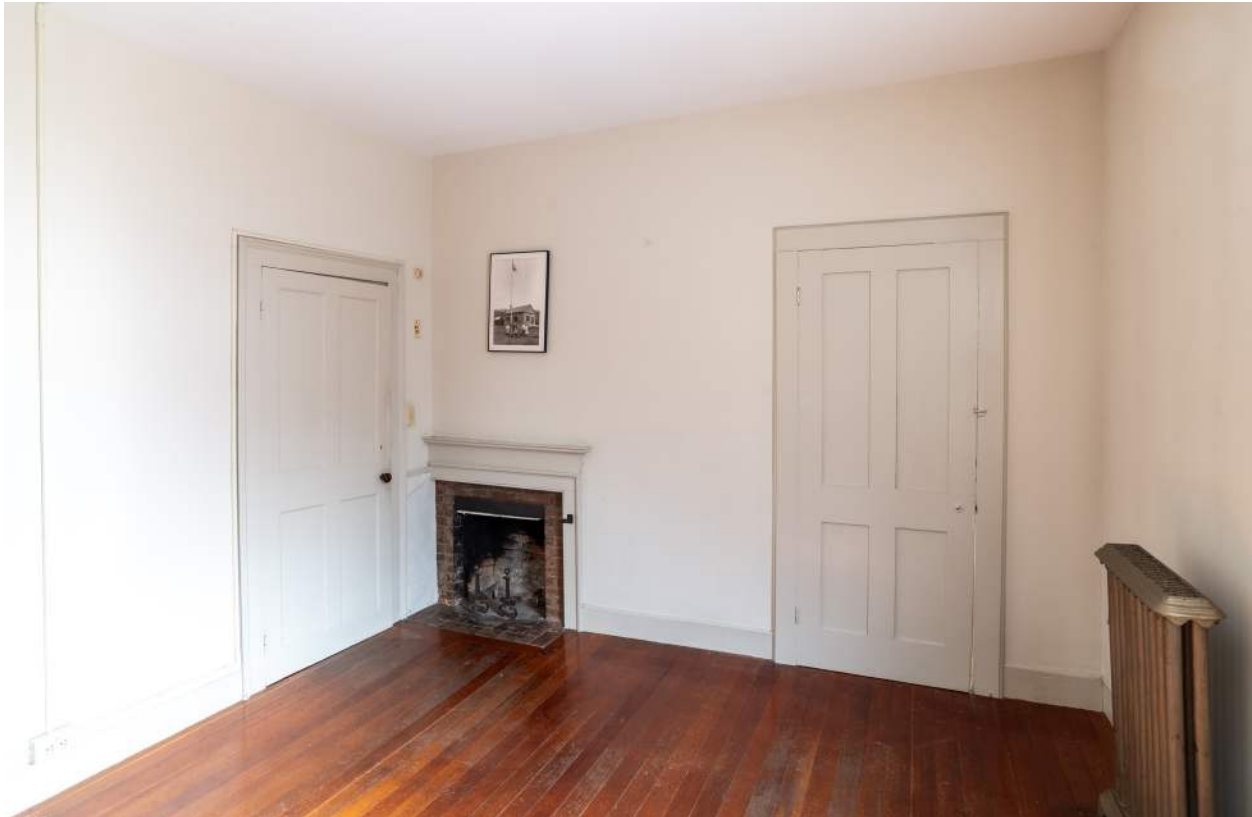
The left rear (northwest room) chamber was originally 16'-6 1/2" wide by 12'-11" deep and accessed by a door at the top of the rear stairs (Figure 75). The shed roof rising in this location makes it impossible to have full-height windows in the north wall of this room. There is a small window lighting the bathroom but no window in the north wall of the bedroom. The only window in this room is in the west wall.

Figure 75. Shepherd House, kitchen chamber (208).

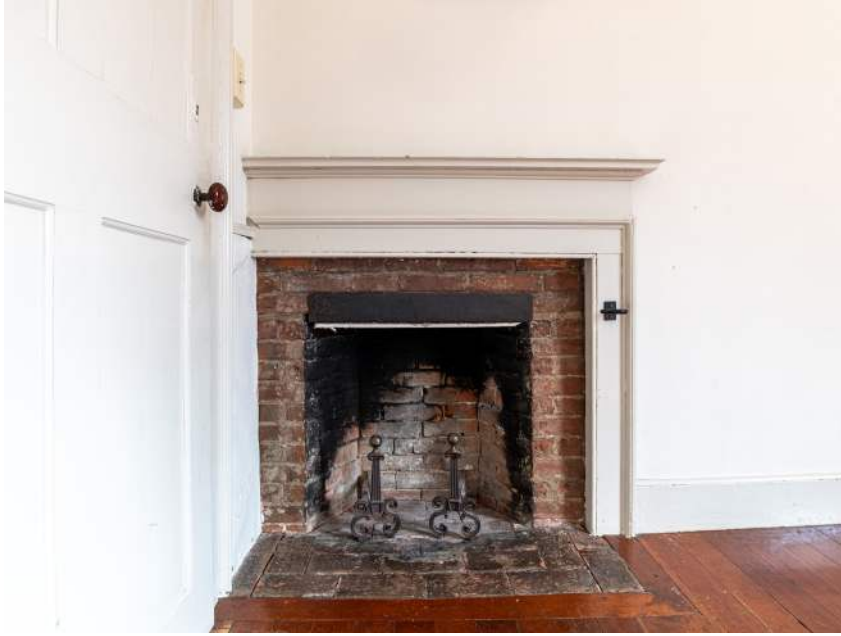
Figure 76. Shepherd House kitchen chamber mantel.

The early mantel in this room is modest compared to its mate in the opposite bed chamber but still refined (Figure 76). It has a delicate single-architrave surround with a quirked-ovolo backband with a slender astragal, matching the profiles of the doors and windows

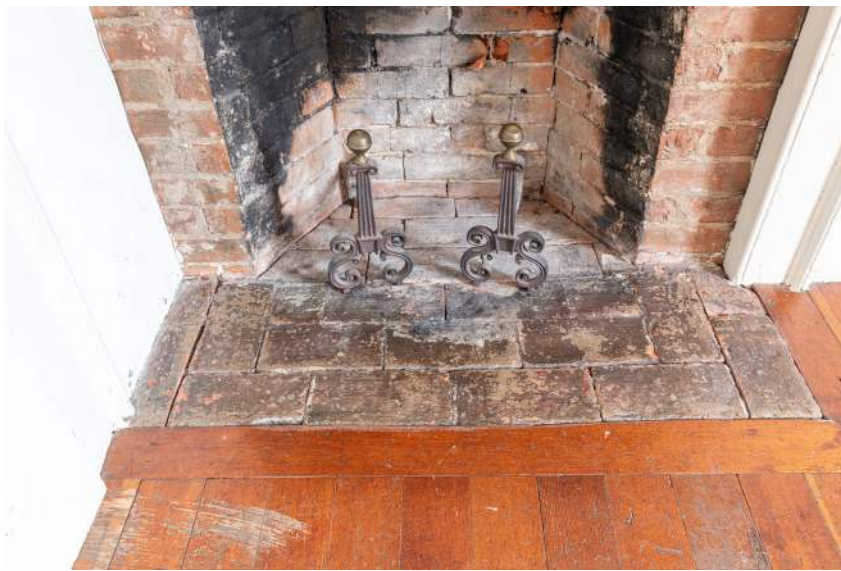
Figure 77. Shepherd House kitchen chamber, detail of firebox, hearth, and andirons. Note early flooring.

in this room (casing Type E). The cavetto-molded shelf is supported on a shallow bed mold and held with t-headed nails. The firebox and hearth survive well and there are a pair of cast iron andirons, stamped with “WILSONS P<sup>T</sup>. I” (Figure 77). This is the only room in the house where early flooring remains visible. It is a tight-grained heart pine of relatively even widths, and is blind-nailed.

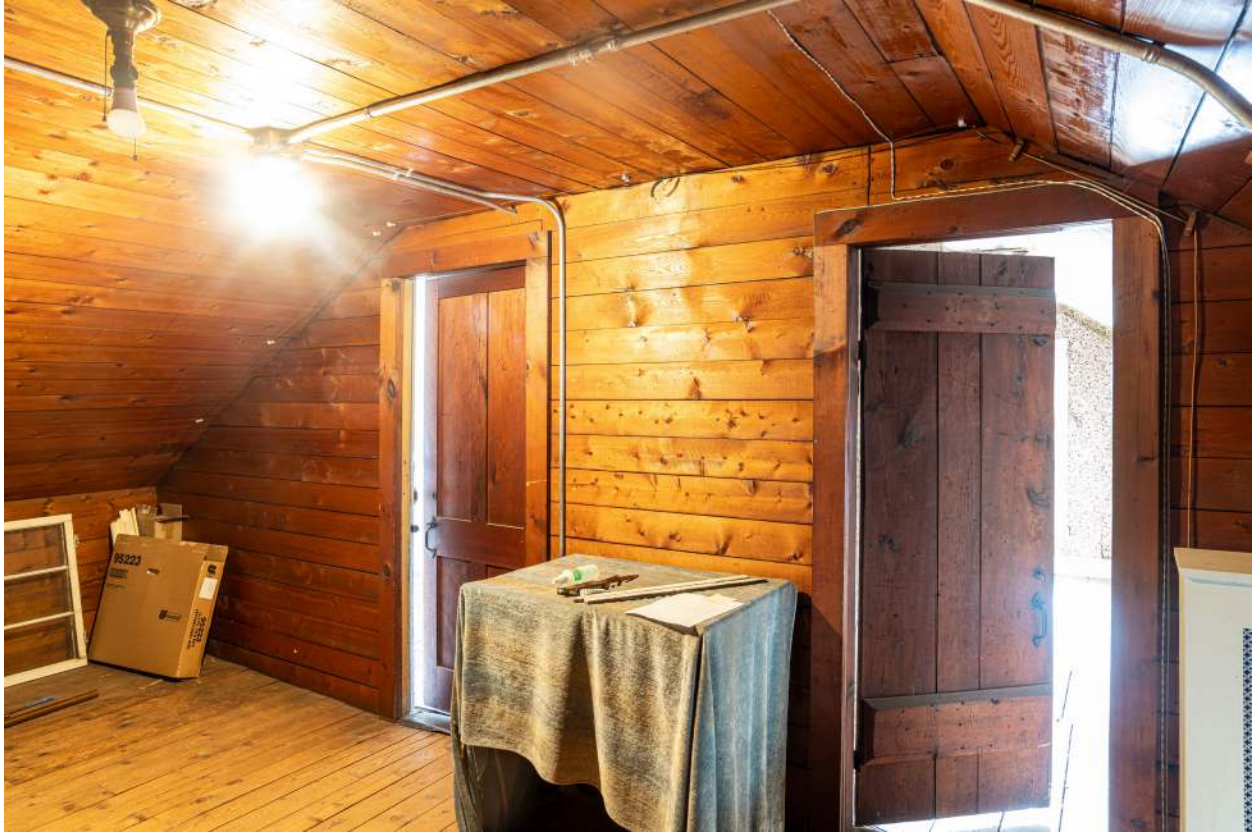
*Figure 78. Shepherd House attic stair landing (301).*

that date before c. 1900 (Figure 78). All wall finish and flooring is 5" wide tongue-in-groove knotty pine, wire-nailed to the associated framing. There is a simple newel and rail to protect the edge of the open stairwell that is also assembled with wire nails. The flooring runs east to west. From the top of the attic stair, we can see boards below running north to south. One of these is at least 18" across and may be a relatively early attic floor board, in place at least by 1845.

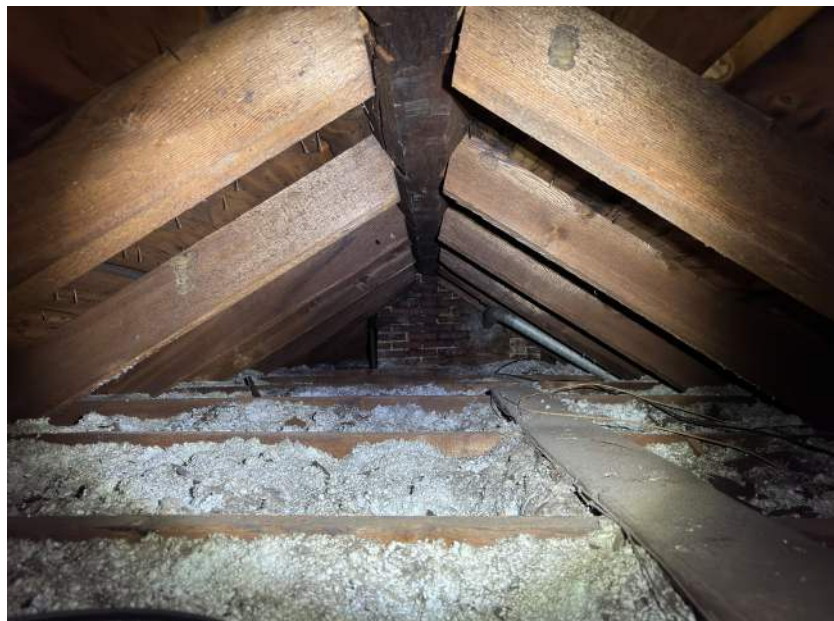
A door in the south knee wall and a hatch in the ceiling give access to the roof. This is framed with hemlock common rafters that are sash-sawn and 2 ¾" to 3" wide by 5 ½" to 6" deep, set roughly 26" on centers. They are joined at their apex to a heavy 5-sided pine ridge that

is hewn and sash sawn (Figure 79). A similar member was used to frame the raised roof of the Stebbins House in Deerfield in 1837. Collar ties are 1 ¾" to 2" wide and 7" deep and secured to the face of the rafter pairs. White cellulose insulation prevents close

*Figure 79. Shepherd House attic, view of rafters and ridge beam.*

inspection of these materials and their joinery, but the collars are not let into the rafters. Roof sheathing is random-width pine or hemlock,  $\frac{3}{4}$ " to 1" thick. They are closely spaced but not butted or cyphered together. We can see a mixture of cut nails and wire nails coming through the sheathing, consistent with a mid-19<sup>th</sup> century installation.

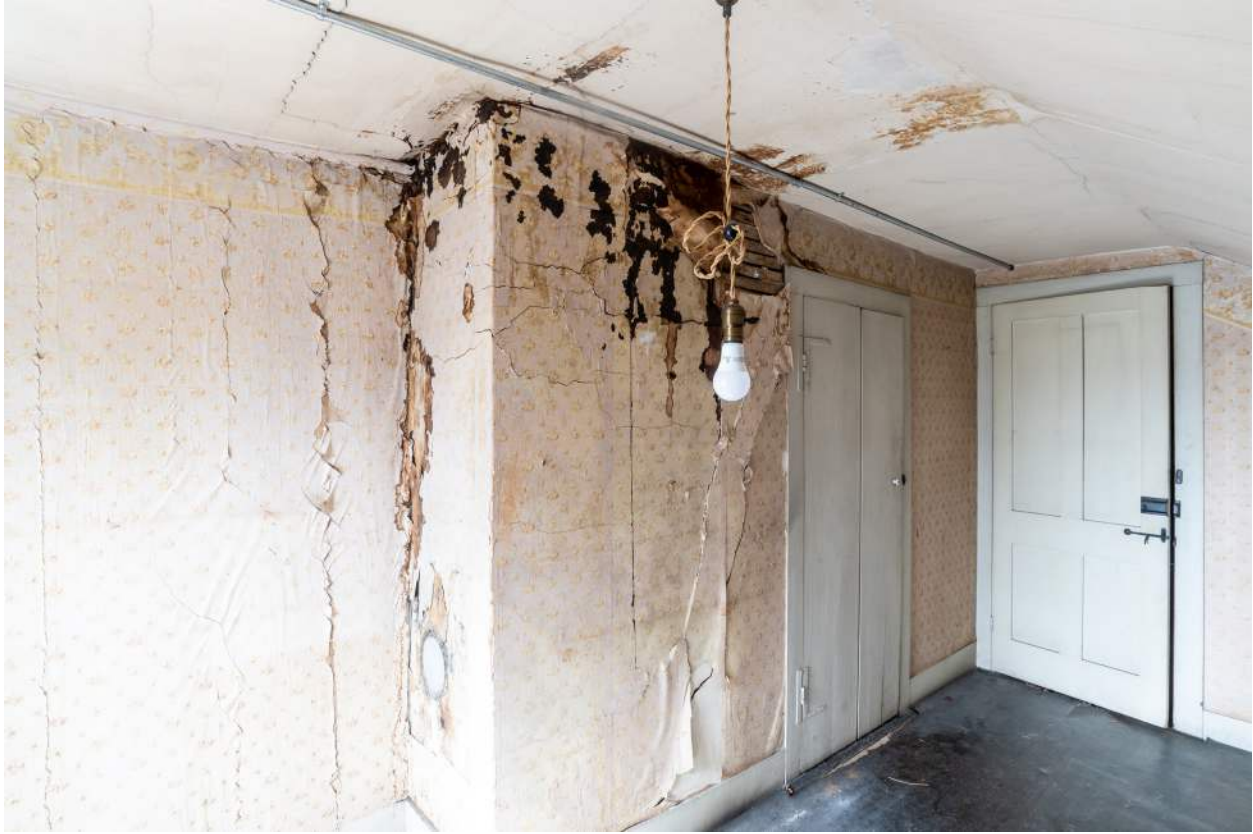
*Figure 80. Shepherd House, large attic chamber (room 305).*

This room was finished as a bed chamber in the middle of the 19<sup>th</sup> century, but seemingly sometime after the roof was raised. It is 15'-3" wide by 11'-8" deep, measured from the kneewall to the partition that splits the chimney in half (Figure 80). This partition is a single thickness of plank wall that is secured to a cleat on the floor of the adjoining room and a cleat on the ceiling in this room. It is covered in wallpaper that is adhered to a thin, coarse textile. There is just one generation of wallpaper in this room. Elsewhere, this paper is laid on plaster on circular-sawn lath that is secured with cut nails (Figure 81). The floor is currently covered by an early linoleum backed in burlap. This is a single

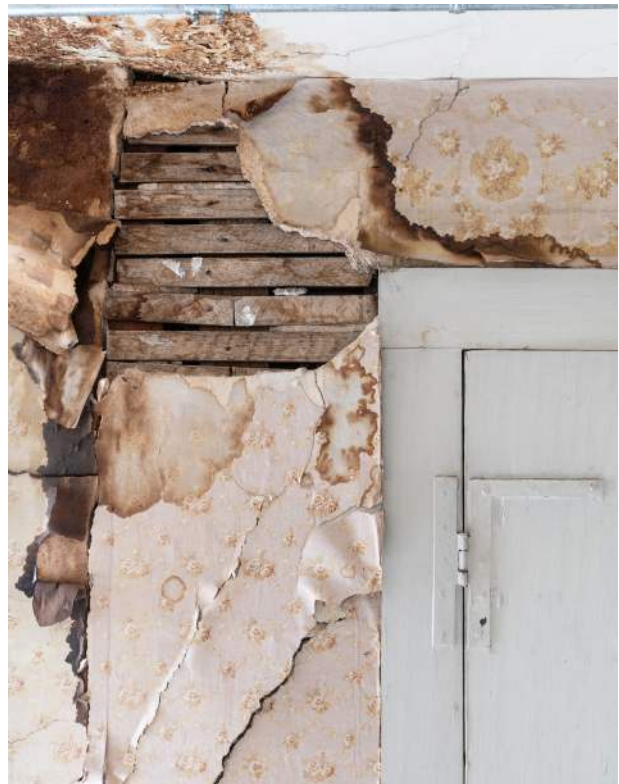
*Figure 81. Shepherd House, attic chamber (305), detail of cut-nailed, circular-sawn lath and H-L hinge secured with flat-head screws.*

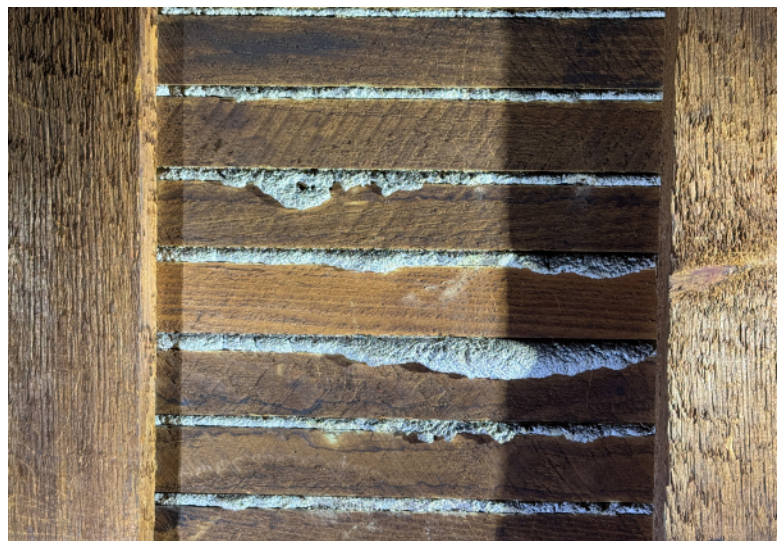
Figure 82. Shepherd House, attic, view of circular-sawn lath for room 302, visible in storage closet (room 303).

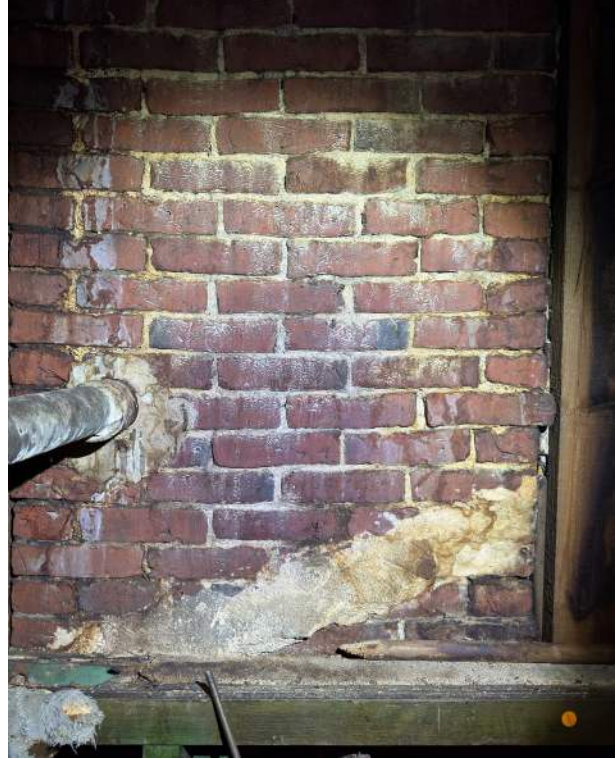
Figure 83. Shepherd House attic, view of rear of east chimney showing evidence for earlier roof in mortar flashing and projecting flashing course.

The building envelope – roofing, siding, windows and doors – are in good condition and preventing water from entering the building. The east chimney has a deteriorated area of brickwork within the attic area with a complete loss of brick, opening the space to the weather. In an effort to control runoff and prevent it from entering the house, a subsurface, perimeter drainage system should be installed. The possibility of tying into the public drain lines in Bridge Street should be looked into to dispose of runoff given the grade issues surrounding the house. Two of the more concerning issues affecting the exterior of the house are the bulge observed at the east end of the north elevation and the condition of the paint finishes. The exact cause of the bulging wall unknown and needs further study. The exterior paint is beginning to show signs of deterioration on all elevations. The house is in need of repainting.

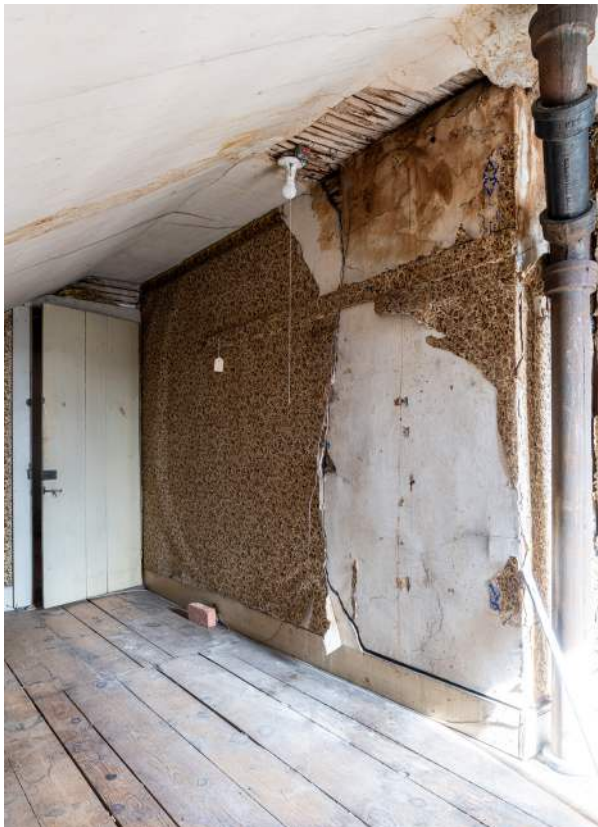
splits the chimney in half (Figure 84). This partition is a single thickness of circular-sawn plank wall that is secured to a cleat on the floor of this room. It is covered in two generations of wallpaper that is adhered to the board sheathing. Elsewhere, this paper is laid on plaster on circular-sawn lath, secured with cut nails. The floor is bare wood, composed of random-width pine boards ranging from 4 1/2" to 12 3/4" across. They are face nailed to the joists with mature cut nails and this is likely the original flooring for this room.

Figure 84. Shepherd House rear attic chamber (304) with circular-sawn lath in ceiling and cast iron plumbing vent pipe.

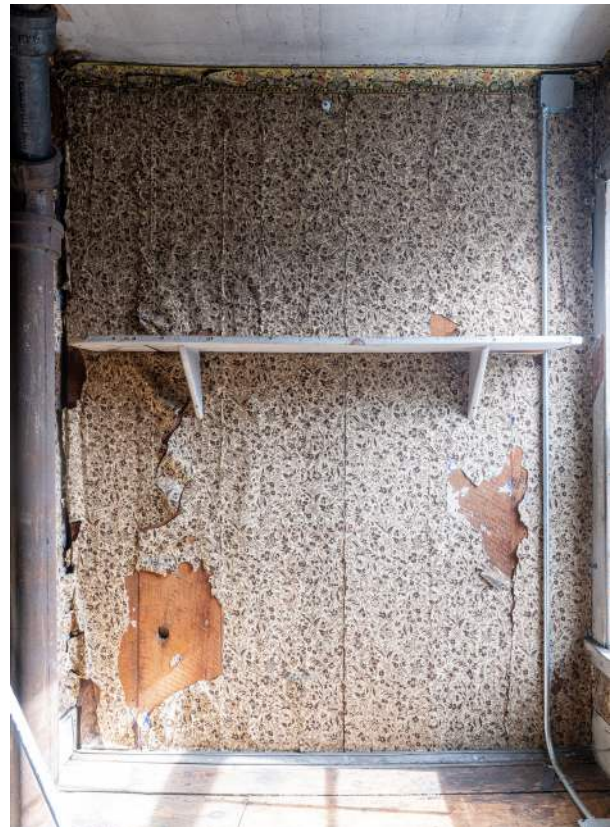
It has never been heated with a stove or a radiator. The wallpaper in this room is applied directly to plaster or circular-sawn vertical boards. A wooden shelf is secured to the board partition in the southwest corner of the room, near the window (Figure 85). It is neatly by simply made and supported on a pair of triangular brackets. A cast iron vent pipe rises to the left of the shelf, stamped with "Somerville Iron Works."

Figure 85. Shepherd House attic chamber (304), with wallpaper applied to circular-sawn boards and cleat for boards on floor.

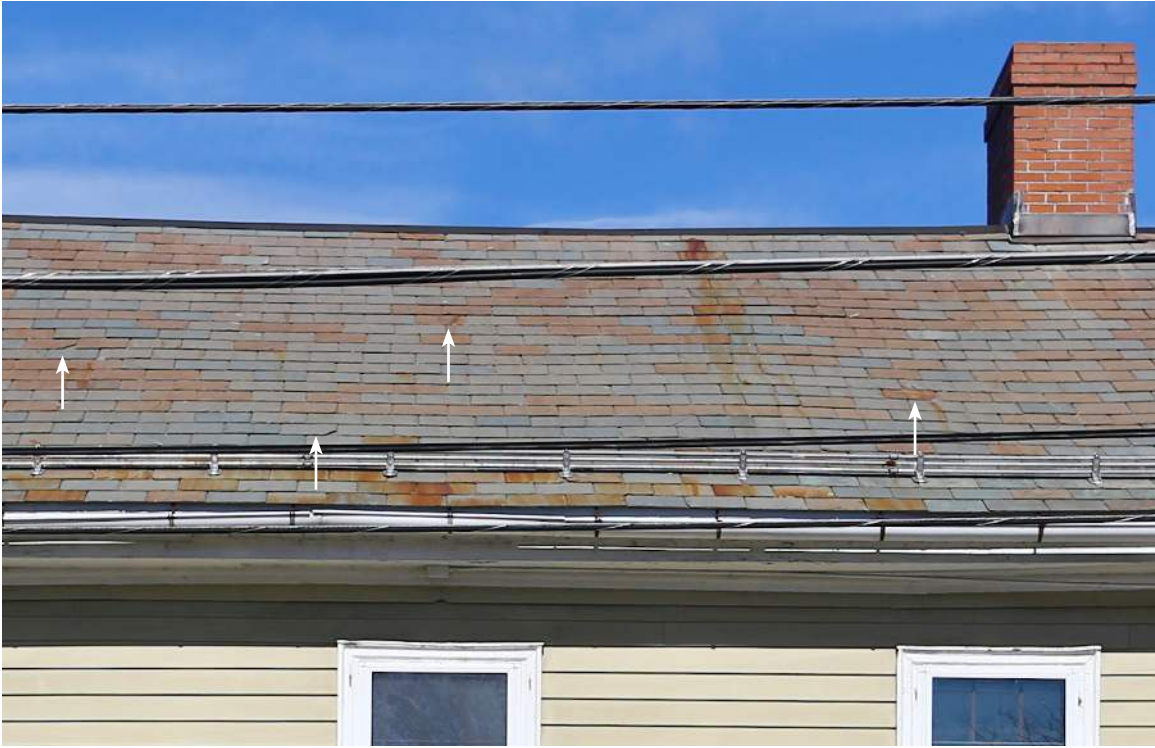
*Figure 90. Detail of the south slope of the slate roof. The white arrows identify slates in this area that have broken corners, but are otherwise sound. The east chimney has an area of rotted brick at the attic level.*

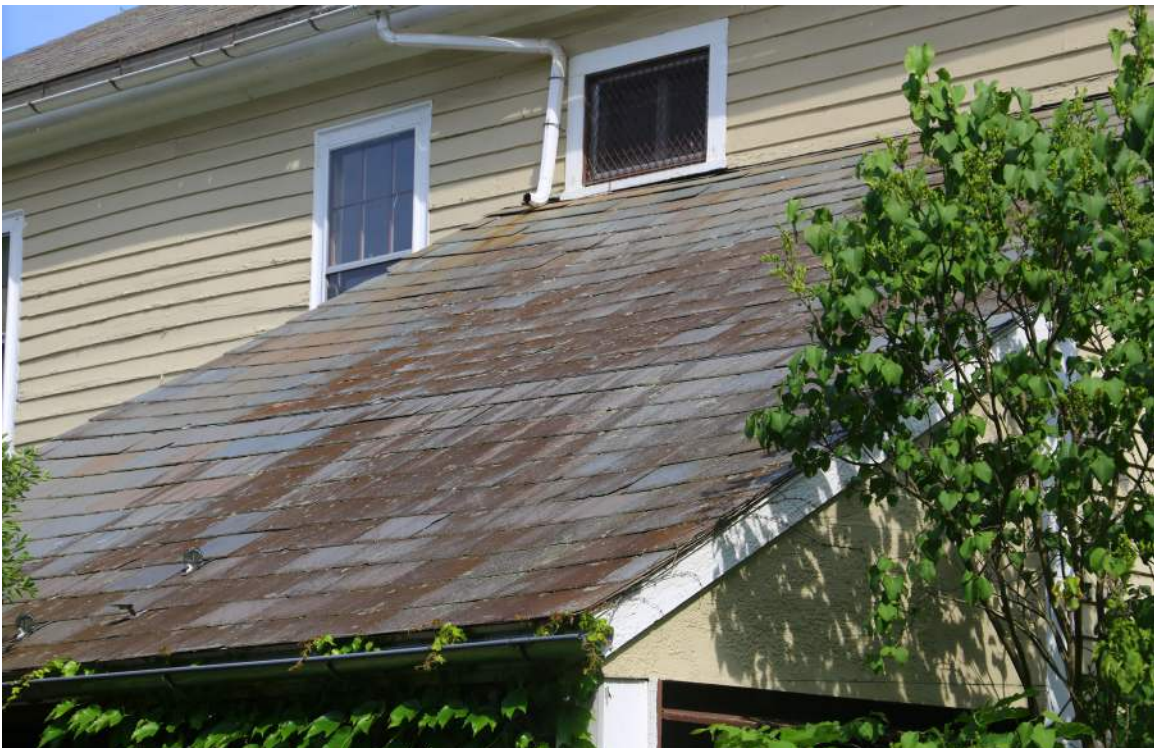
*Figure 91. The slate roof on the lean-to is in good condition. A small amount of biological growth covers a portion of the slates. This can easily be removed using a mild detergent, light scrubbing and low pressure water.*

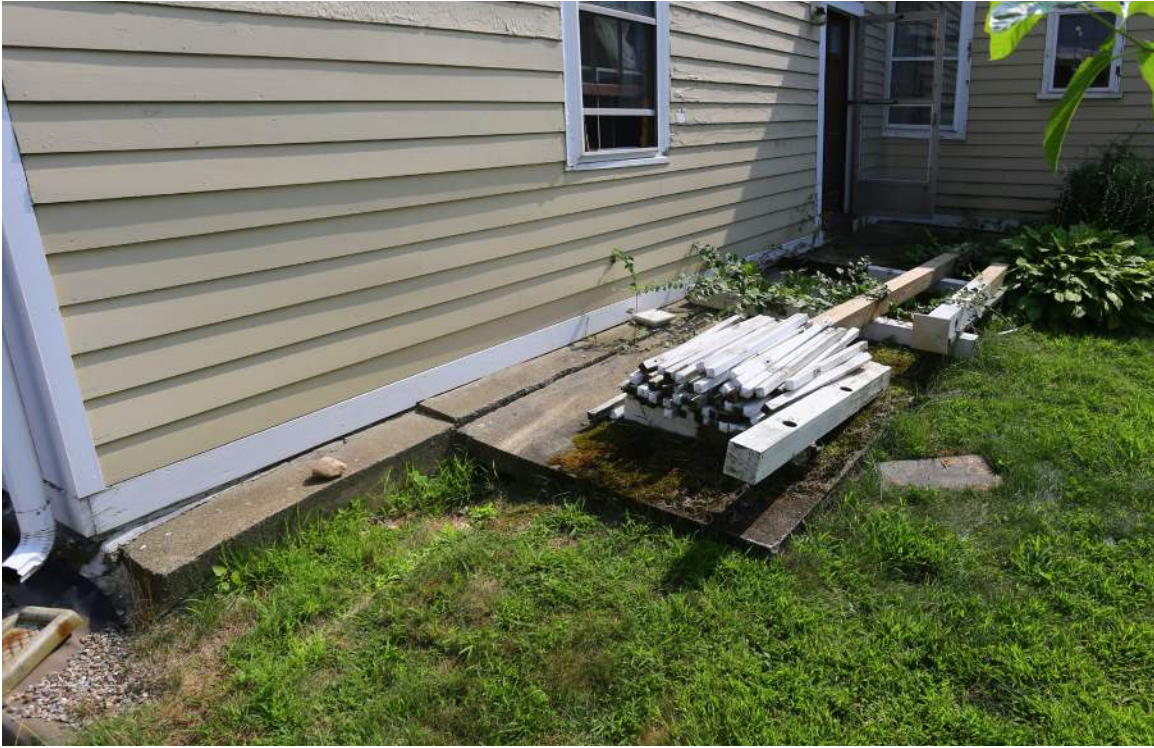
*Figure 92. North elevation, east corner. The purpose and function of the concrete slabs and curbs poured against the foundation is not clear. They may be the remains of a patio area and/or to help buttress the stone foundation in this area. The concrete is unsightly and should be removed in combination with either regrading or improving the landscape in this area.*

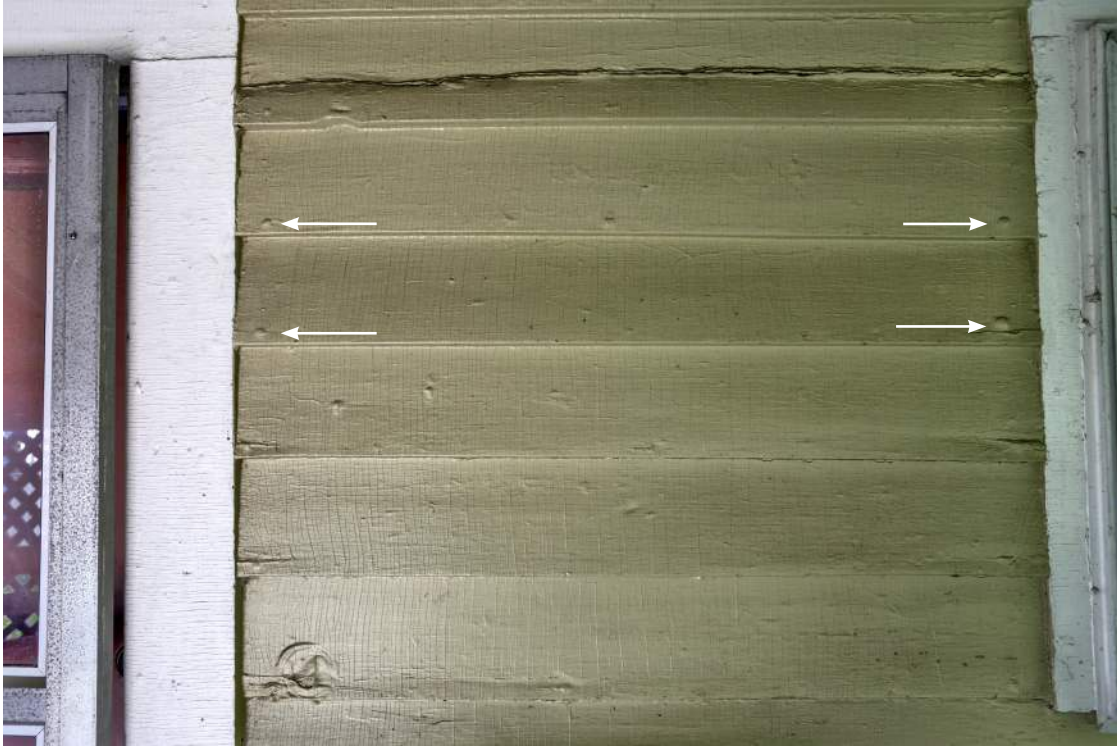
Figure 94. Original clapboards on the north elevation within the lean-to. Arrows point to the painted over heads of wrought nails used to fasten the clapboards to the building.

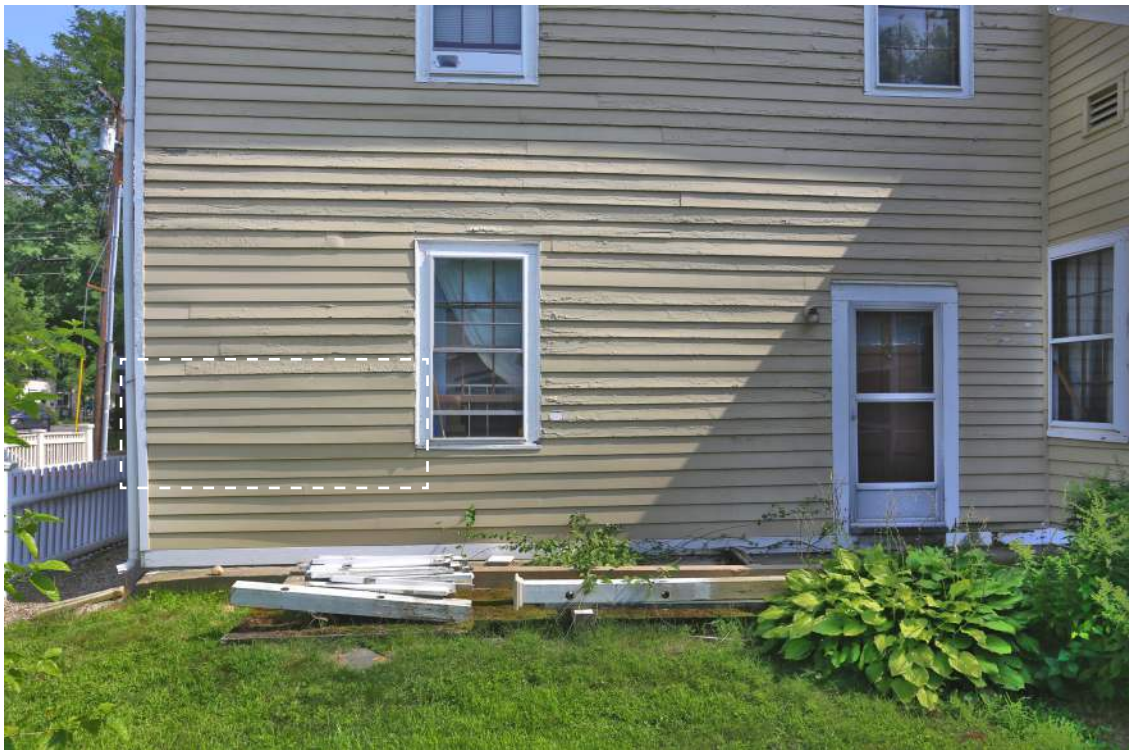
Figure 95. North elevation, east corner showing location of outward bulge found in the wall.

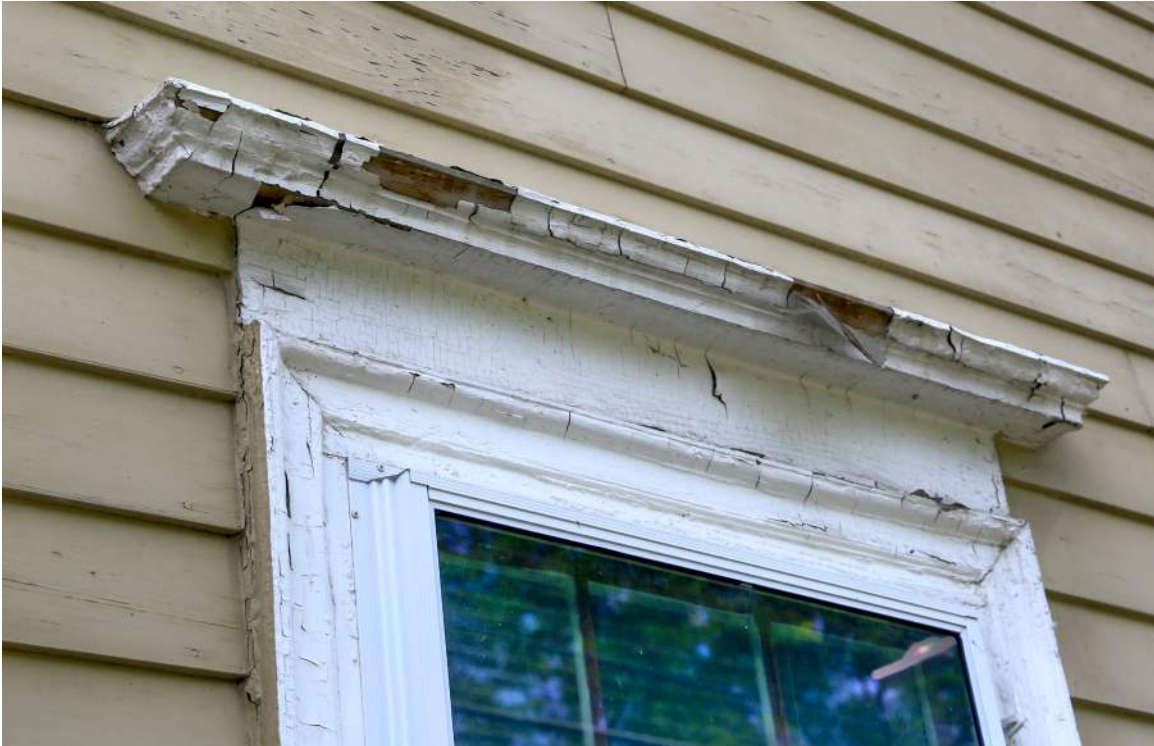
*Figure 96. Representative example of failing paint finishes on the window frames. Original and early wood elements, such as the window frames and clapboards have heavy accumulations of paint buildup. This has reached a point where the surfaces no longer hold paint and are failing to bare wood.*

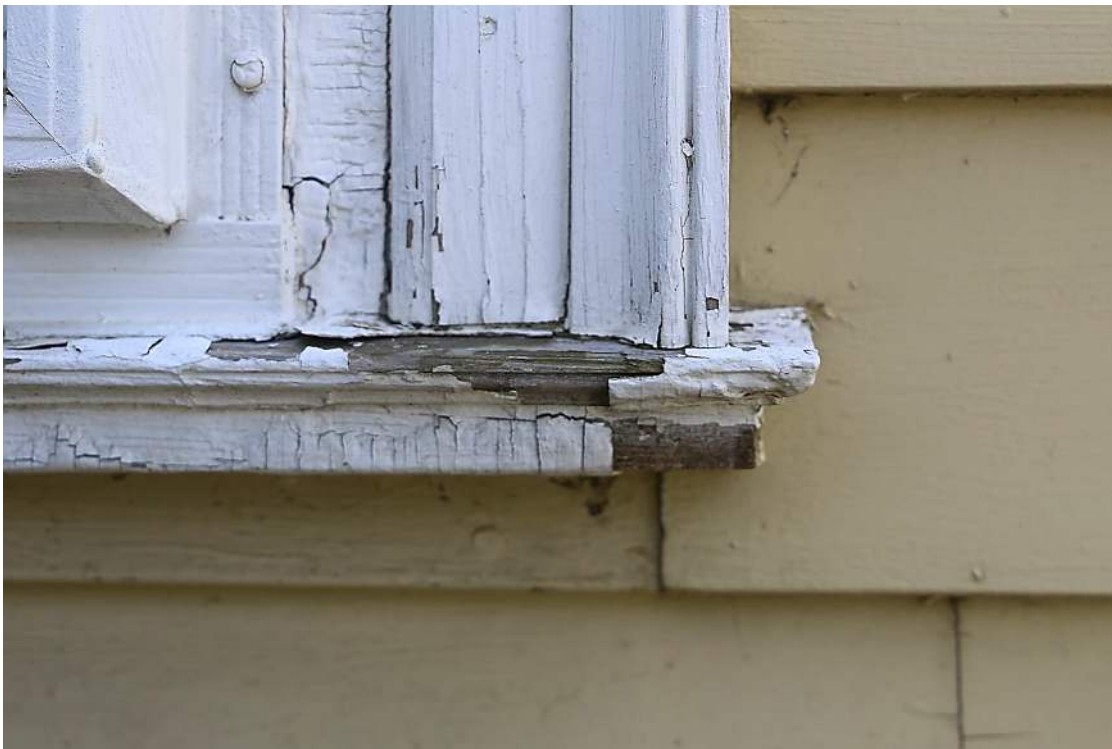
*Figure 97. Detail of failing paint on exterior window sill. The window frames are original to the construction of the house and contain many fine molding profiles. Special care must be taken not to damage the molding profiles when the woodwork is prepped prior to painting*

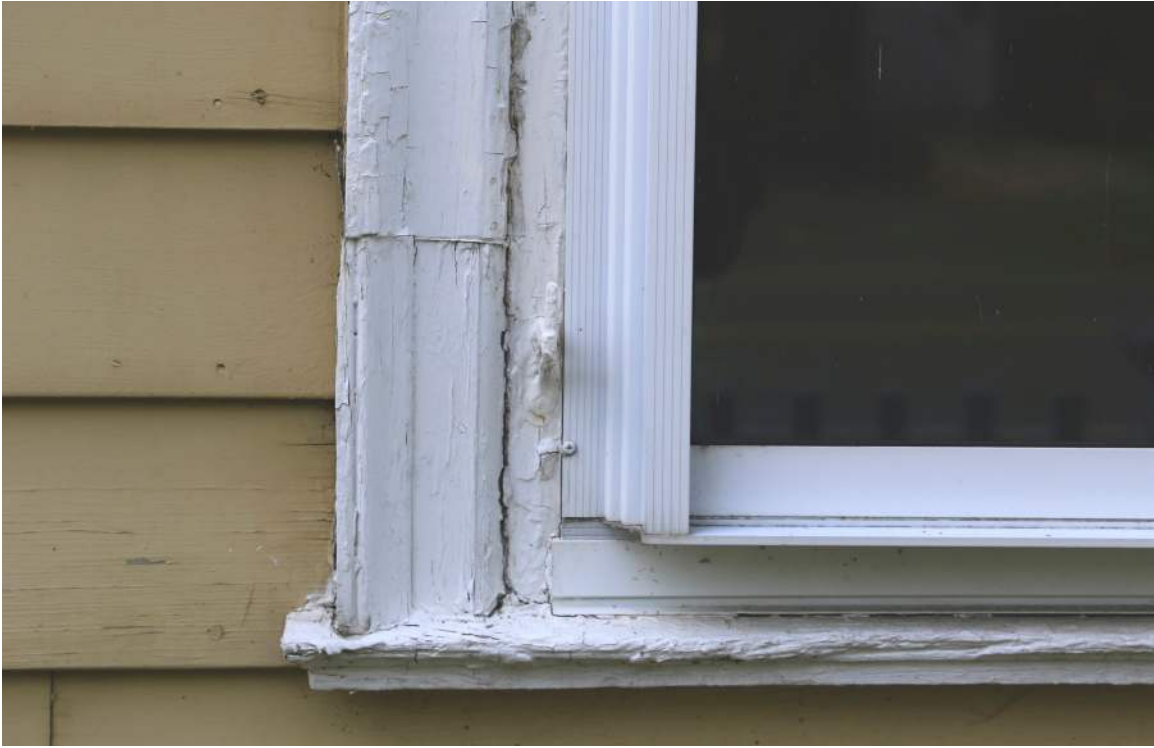
*Figure 98. The window frames and other woodwork will likely need isolated repairs to deteriorated areas of woodwork and to correct past repairs where necessary.*

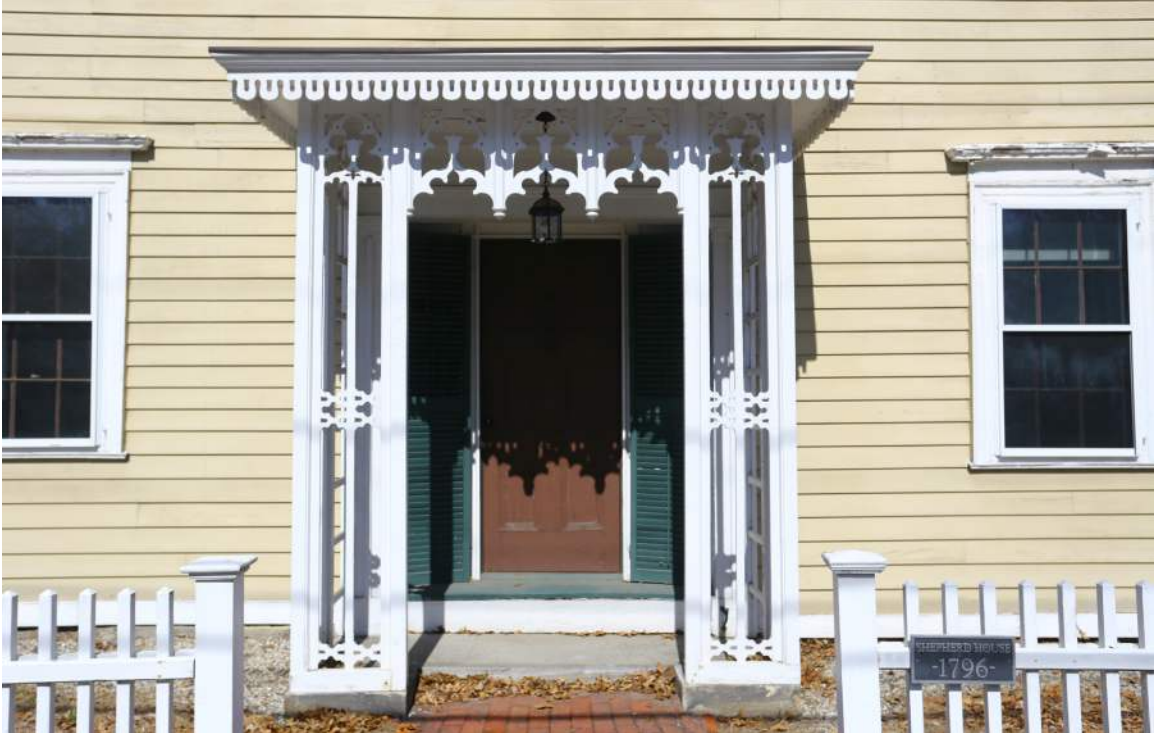
*Figure 99. The south entry and portico are in good condition and only need minor repairs and repainting as shown in the following photographs. Note the failing paint on the window caps.*

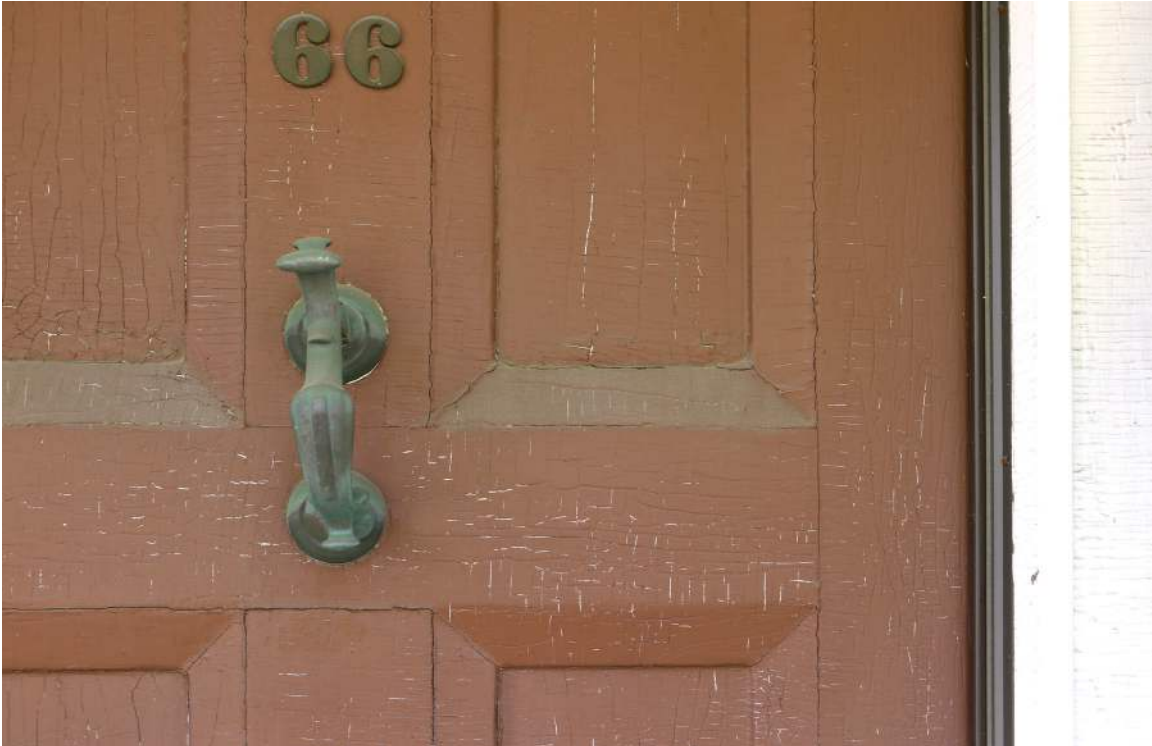
*Figure 100. Detail of the south door showing crazing of the paint finish. The door retains good examples of hardware from the second quarter of the nineteenth century including the knocker, numbers and name plate (not shown).*

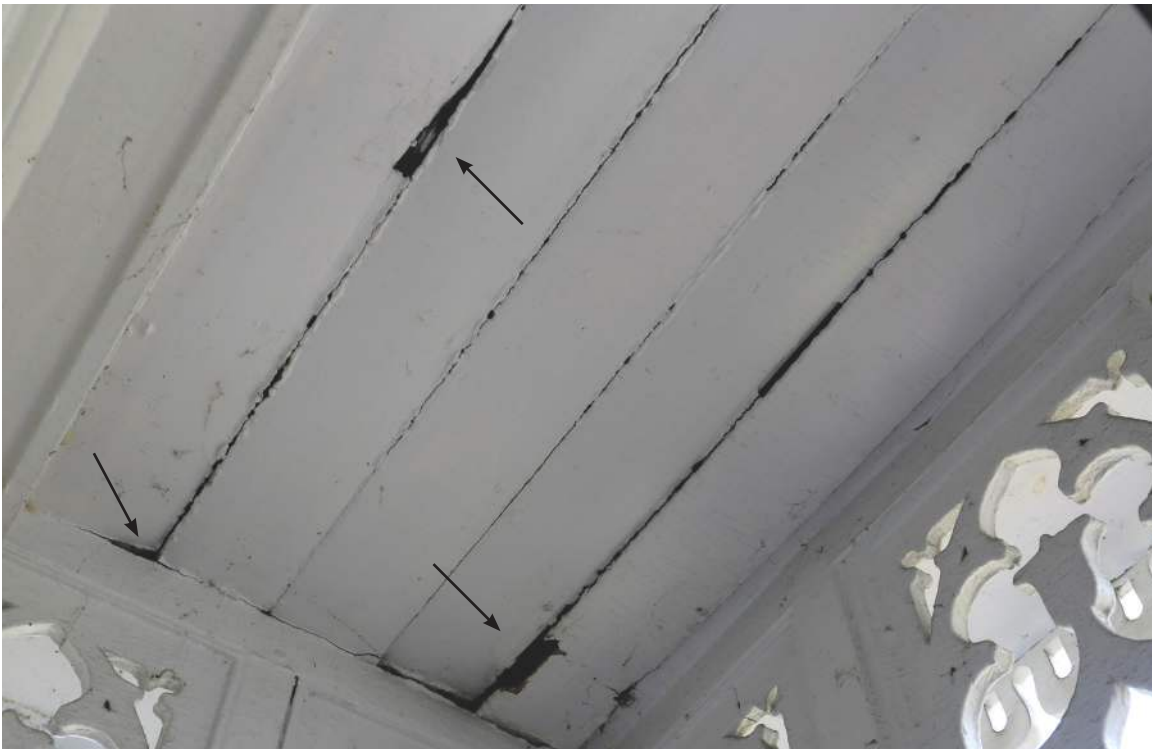
*Figure 101. Cracks and openings in the board ceiling should be filled and patched to prevent insects and vermin from entering/ nesting in spaces within the building.*

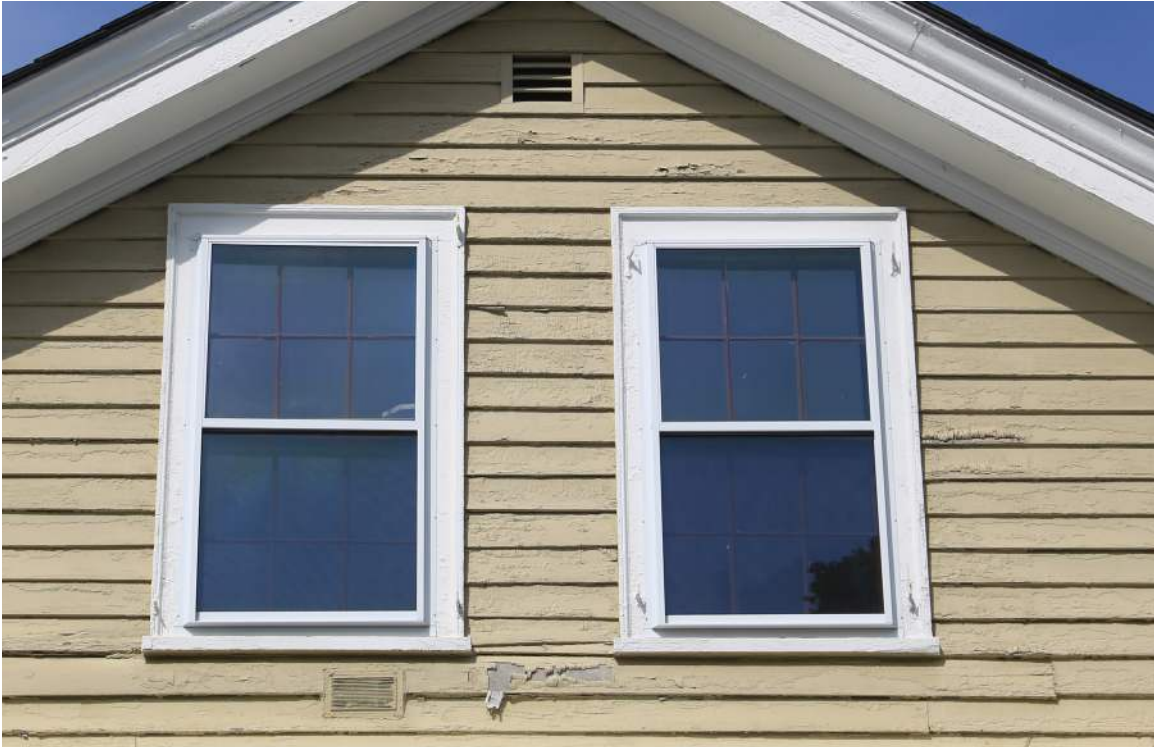
*Figure 102. Detail of the west gable showing deteriorated and failing paint finishes on the clapboard siding.*

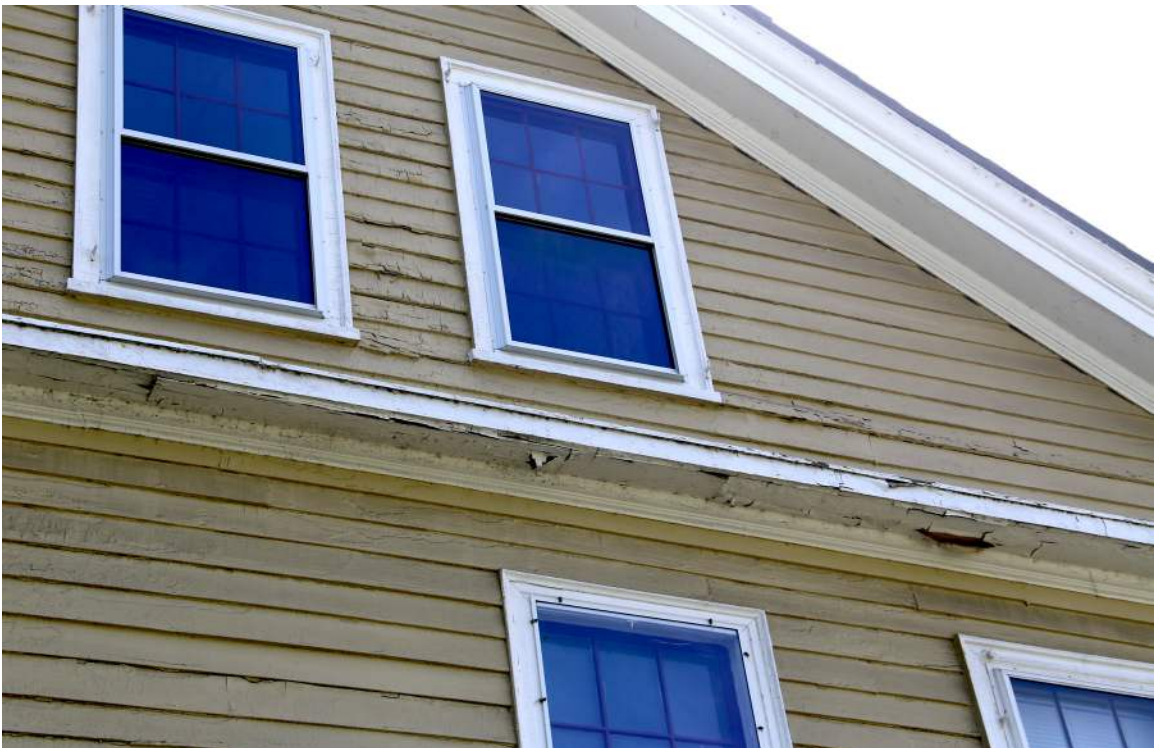
*Figure 103. Detail of the east gable showing failing paint finishes on the clapboard siding and horizontal cornice.*
