# SHEPHERD HOUSE HISTORIC STRUCTURE REPORT

NORTHAMPTON, MASSACHUSETTS

HISTORIC NORTHAMPTON

*FEBRUARY 5, 2026*

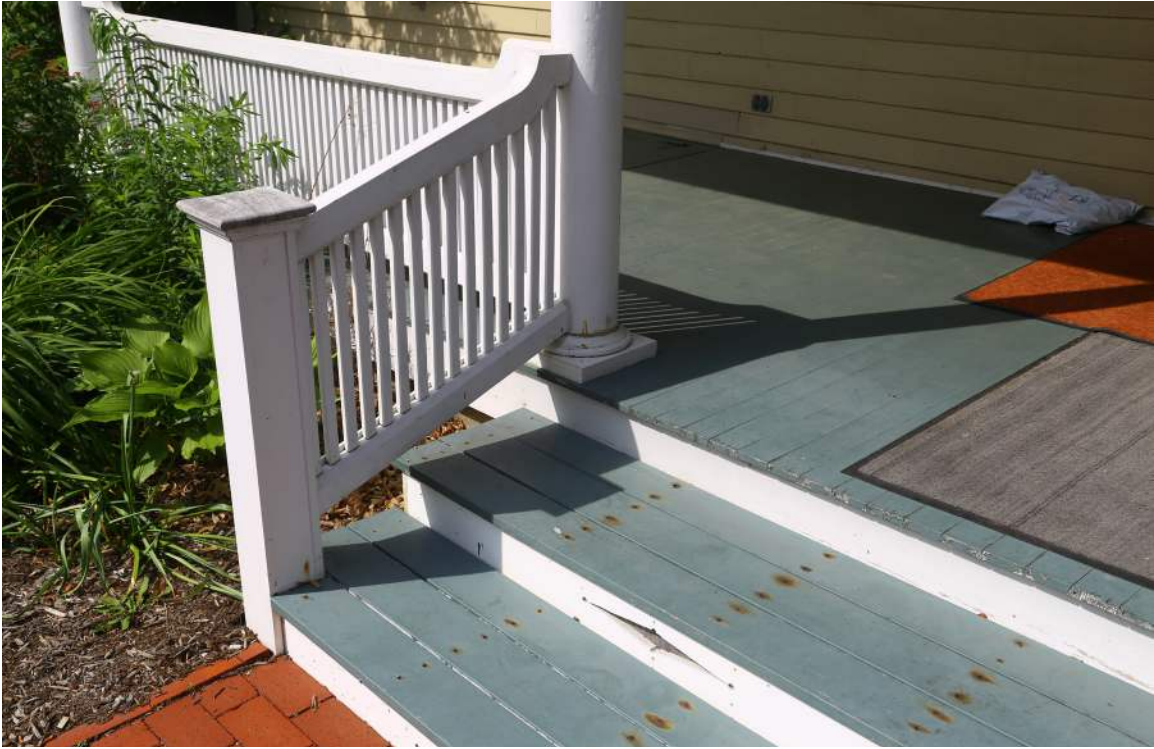
*Figure 104. Representative area of the west porch showing typical paint issues, including failing paint at the nosing of the decking, rust stains at nail heads on stair treads, bare wood exposed on caps of newels, and caulking/epoxy repairs left unpainted (below).*

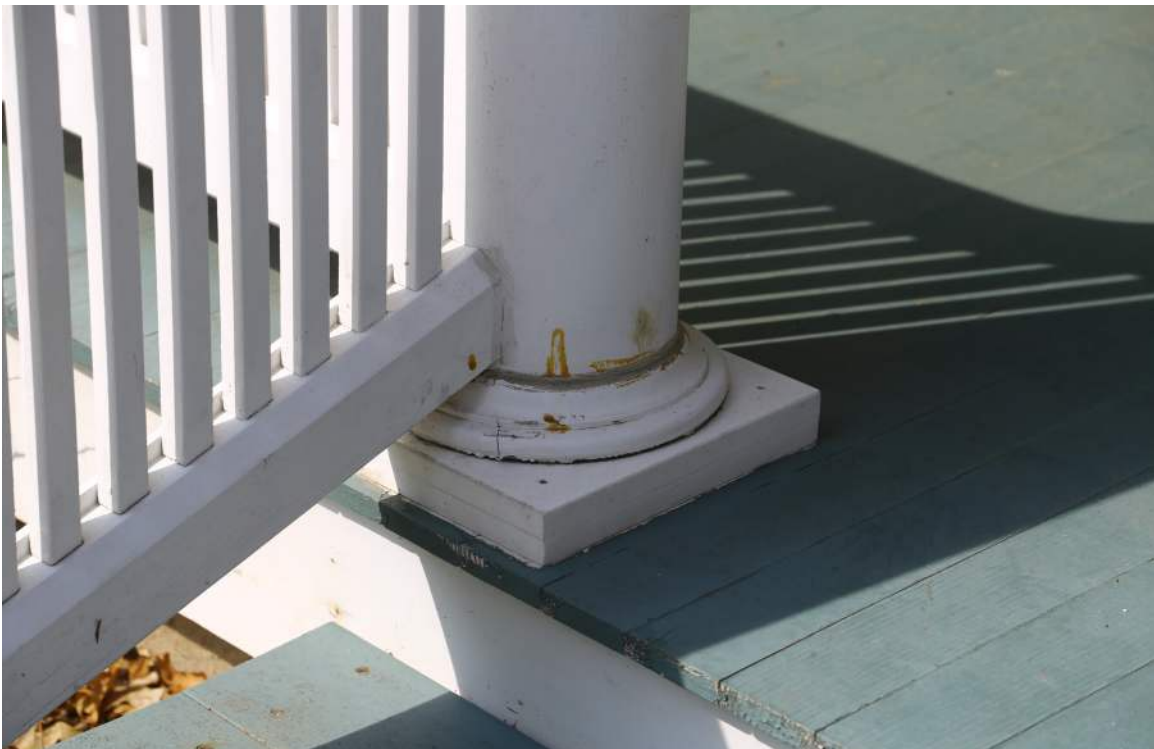
*Figure 105. Detail of unpainted caulk/epoxy repairs to column base.*

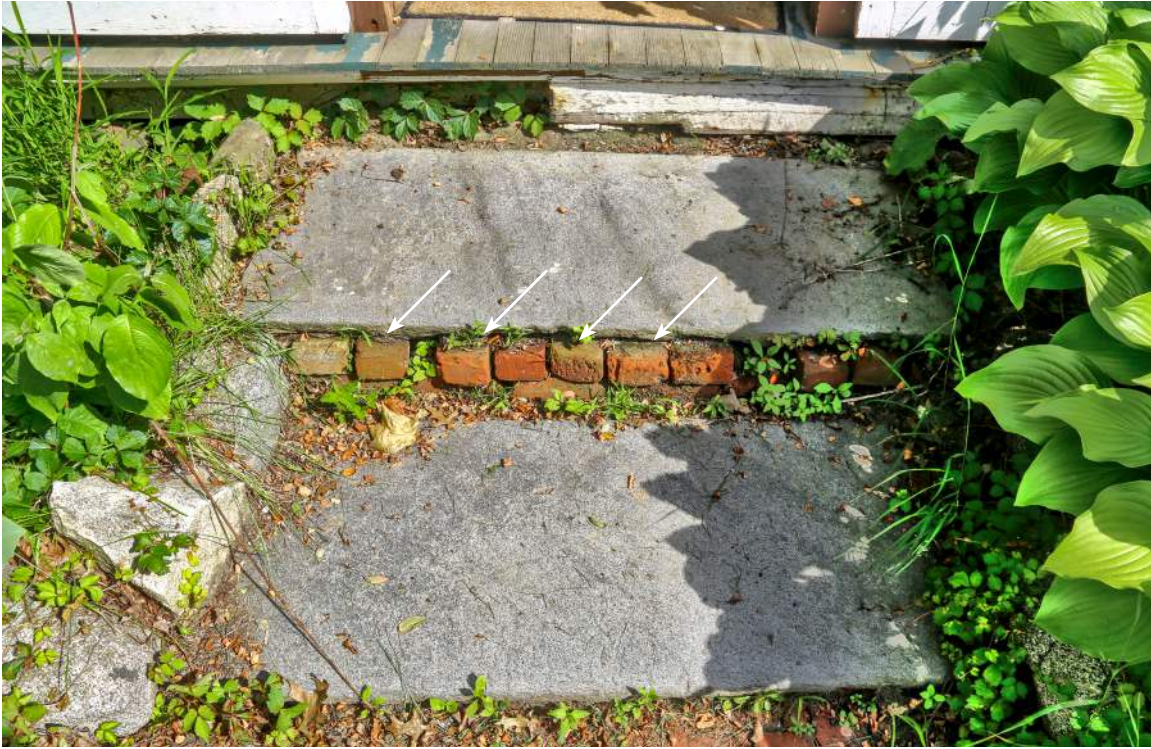
*Figure 106. Steps to Lean-to. The bricks supporting the stone step are dry laid and have worked their way out from under the tread. They project out beyond the edge of the tread, posing a tripping hazard.*

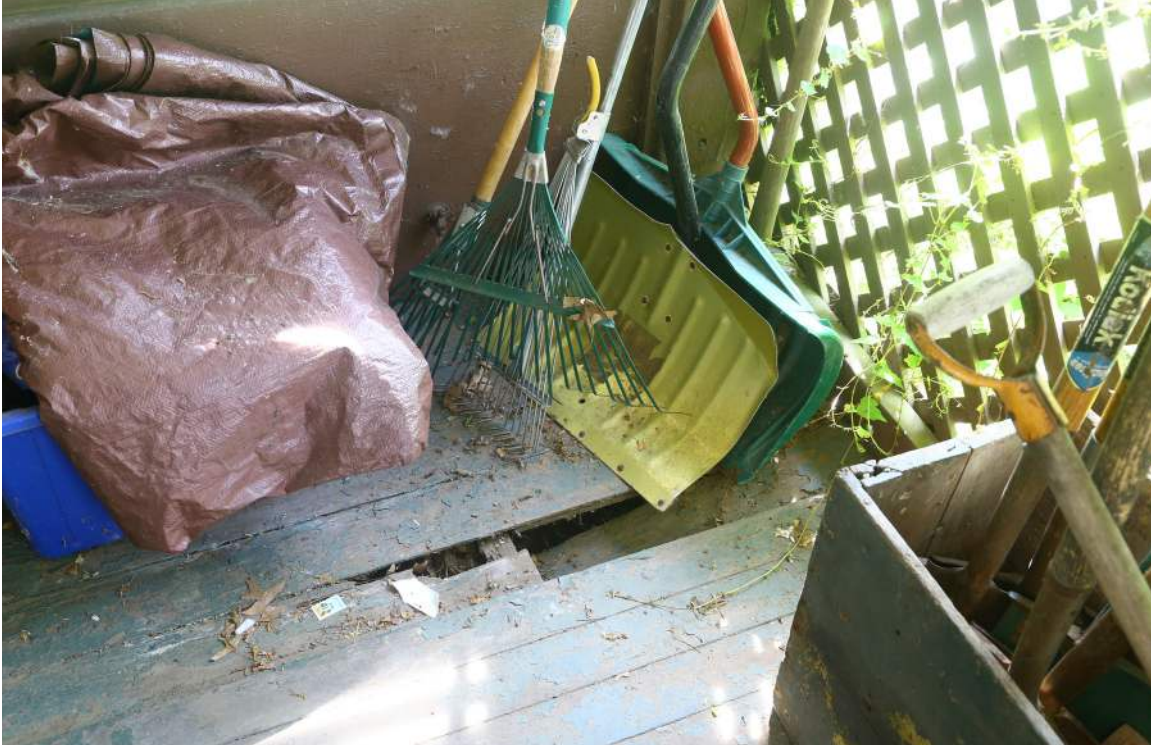
*Figure 107. Rotted and broken flooring in the lean-to.*

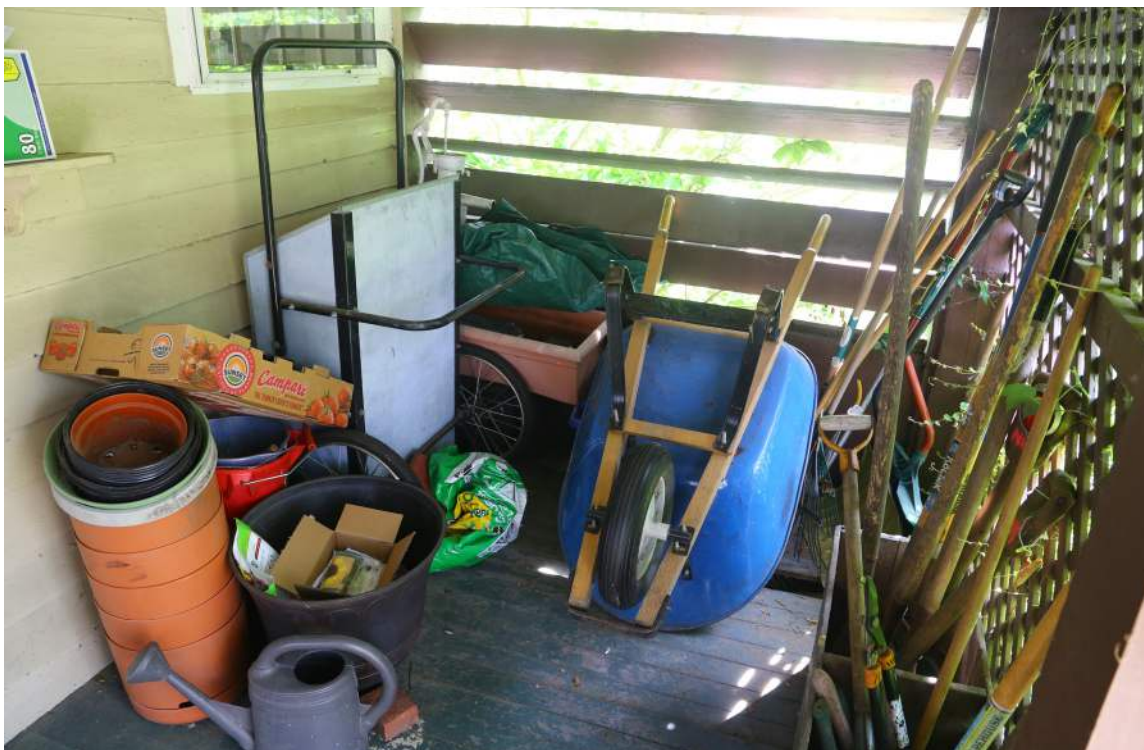
Figure 108. Lawn and gardening tools stored in lean-to.

The lean-to is filled with a mix of garden tools, trash cans, recycling containers and other materials used around the site (Figure 108). The space should be cleaned out and organized. If this space is to continue serving these functions, the addition of shelving and storage solutions is recommended to help improve the organization of the space.

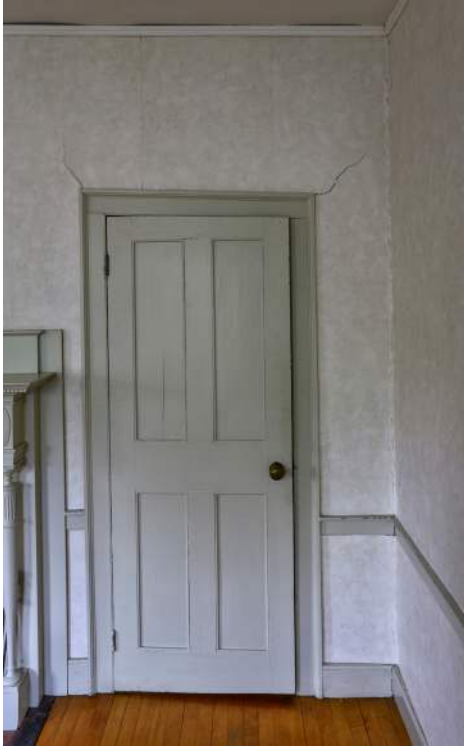
*Figure 109. Room 210, Library Chamber, east closet door. Note how the top of the door opening slopes down on the right side towards the passage.*

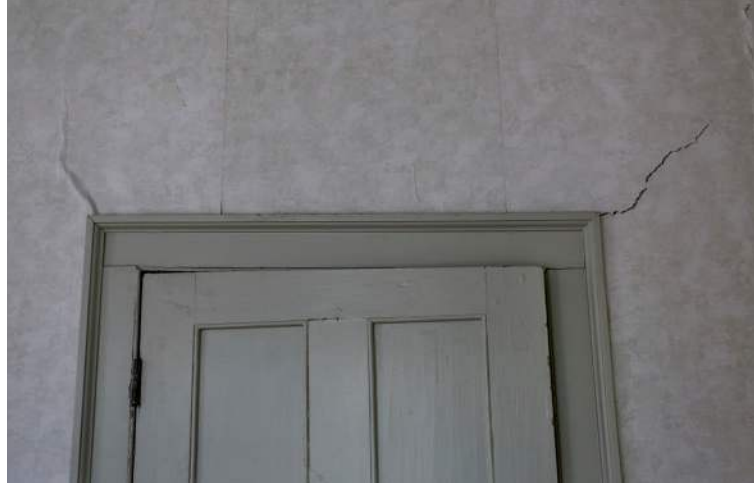
*Figure 110. Detail of the top of the closet door opening in previous photo. The cracks in the plaster have occurred after the wallpaper was applied c. 2007 in preparation for Mass Humanities move into the building.*

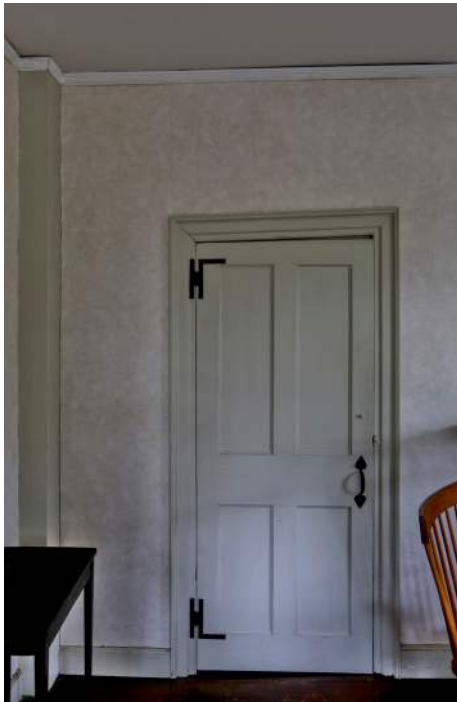
*Figure 111. Room 202, Parlor Chamber, west closet door. The top of the door opening slopes down on the left side, towards the passage.*

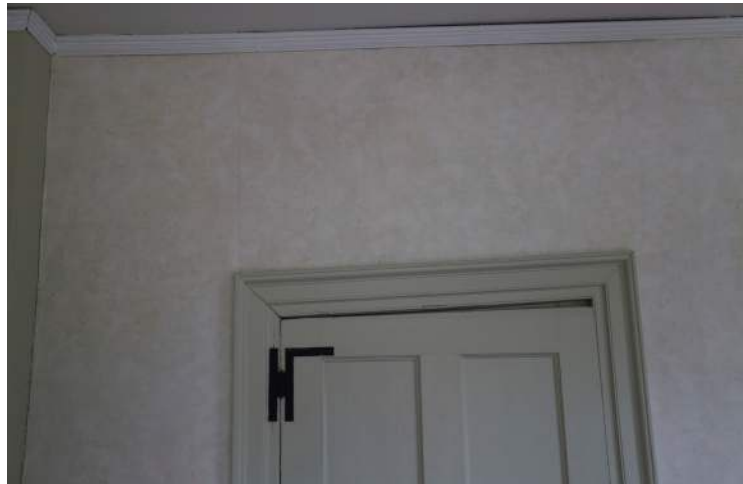
Evidence of settlement is visible in the center passage. This is most apparent in the floor and finishes of the rooms flanking the passage, where the heads of closet door architraves nearest the passage pitch toward the stair (Figure 109, Figure 110, Figure 111, Figure 112). The condition is evident at both the first- and second-floor levels. Diagonal cracks in the plaster of the fireplace walls further suggest settlement in this area (Figure 113).

*Figure 112. Detail of the top of the closet door opening in previous photo.*

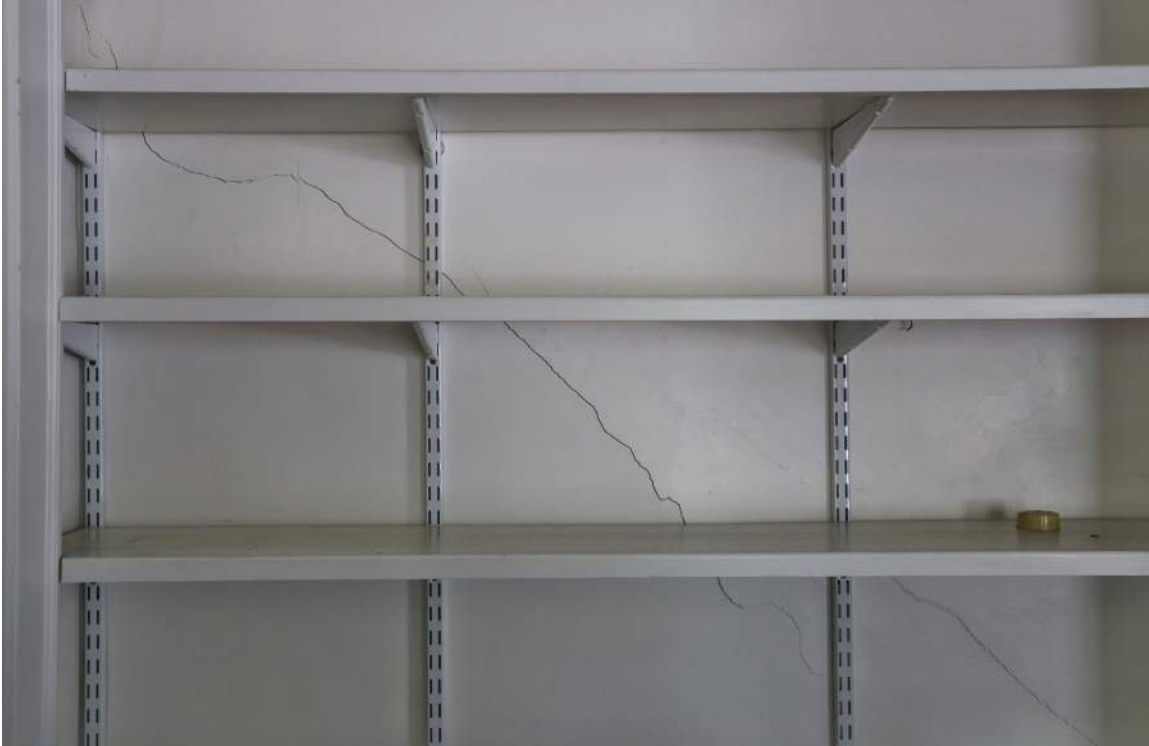
Figure 113. Room 102. North wall, west of the chimney. Settlement of the framing in the vicinity of the center passage, located opposite the left wall, has caused cracking in the plaster.

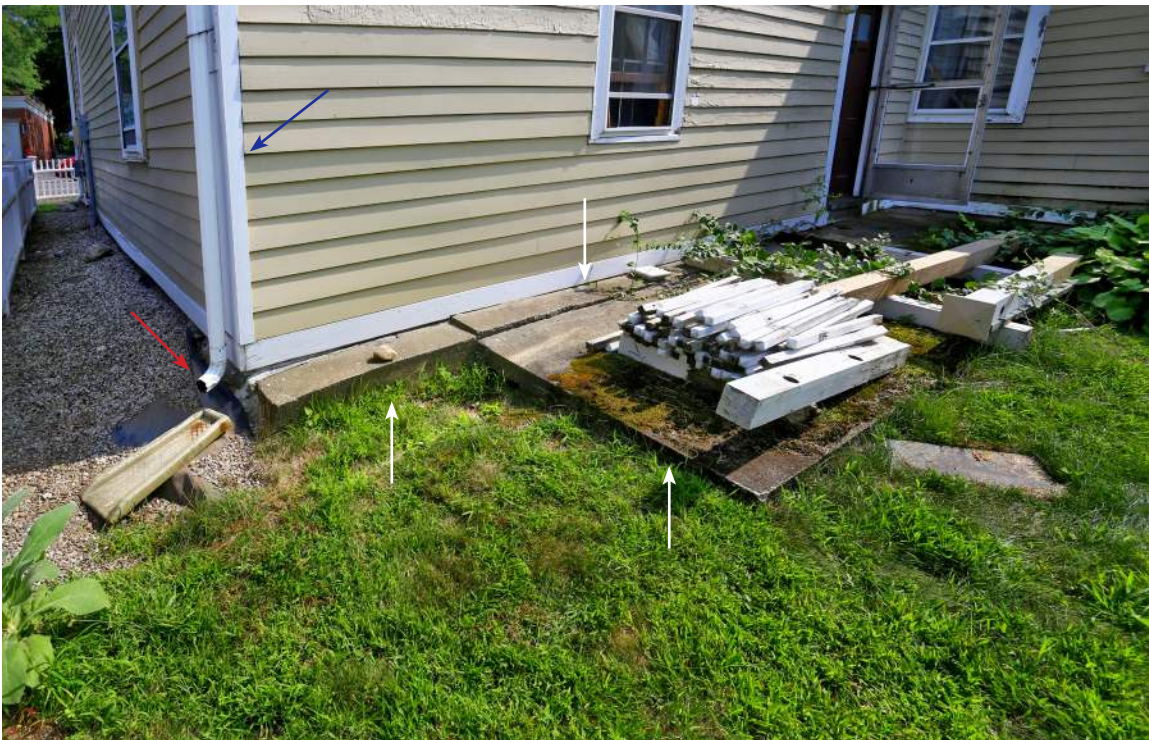
Figure 114. The concrete curbs and pads (white arrows) on the north side of the building should be removed. Ideally, leaders (red arrow) would tie into a subsurface drainage system connected to the municipal storm drains in the street to remove water from the perimeter of the building. The blue arrow identifies the location of the clapboards shown in the following image.

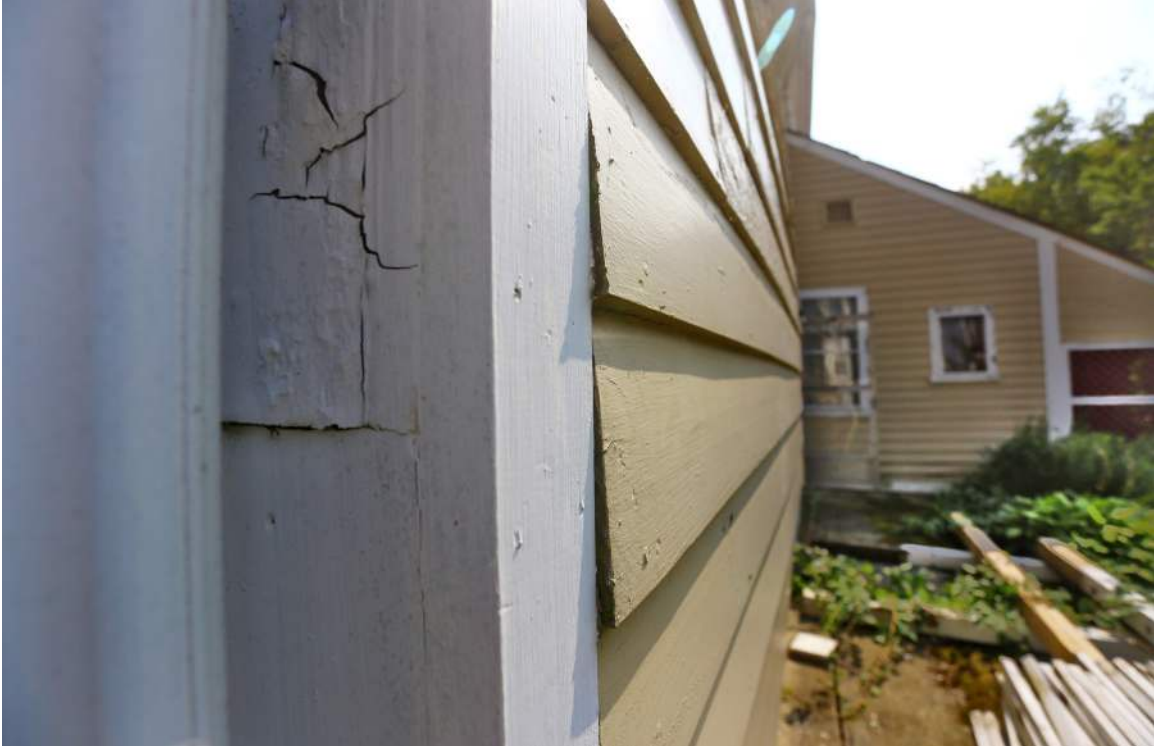
Figure 115. Northeast corner of the house, sighting towards the lean-to (west). A pronounced bulge in the north side of the wall is visible here. The butt ends of the clapboards (arrows) appear to have originally been installed flush with the face of the cornerboard. The bottom edge of the clapboards here are now approximately 1/4" proud of the cornerboard.

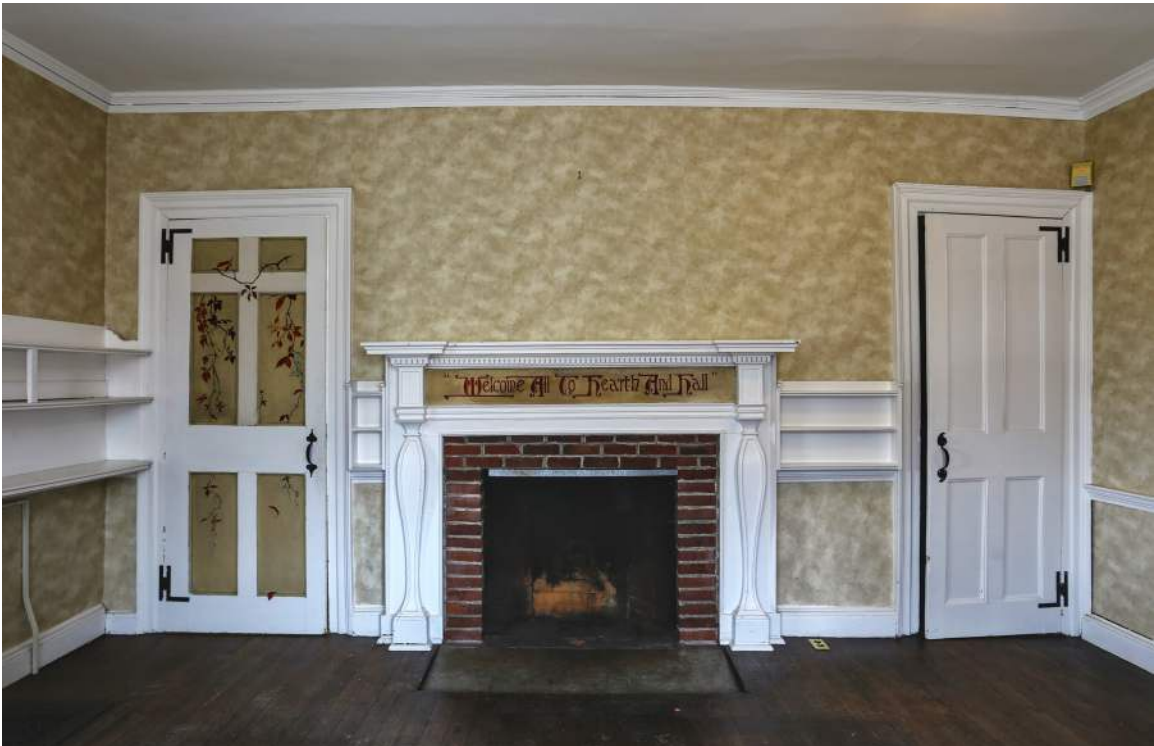
Figure 116. Room 109, former library. Early decorative paintwork from the Shepherd period has been preserved on the door and mantel, all other surfaces have received modern paint and wallpaper installed in c. 2007 when Mass Humanities occupied the building.

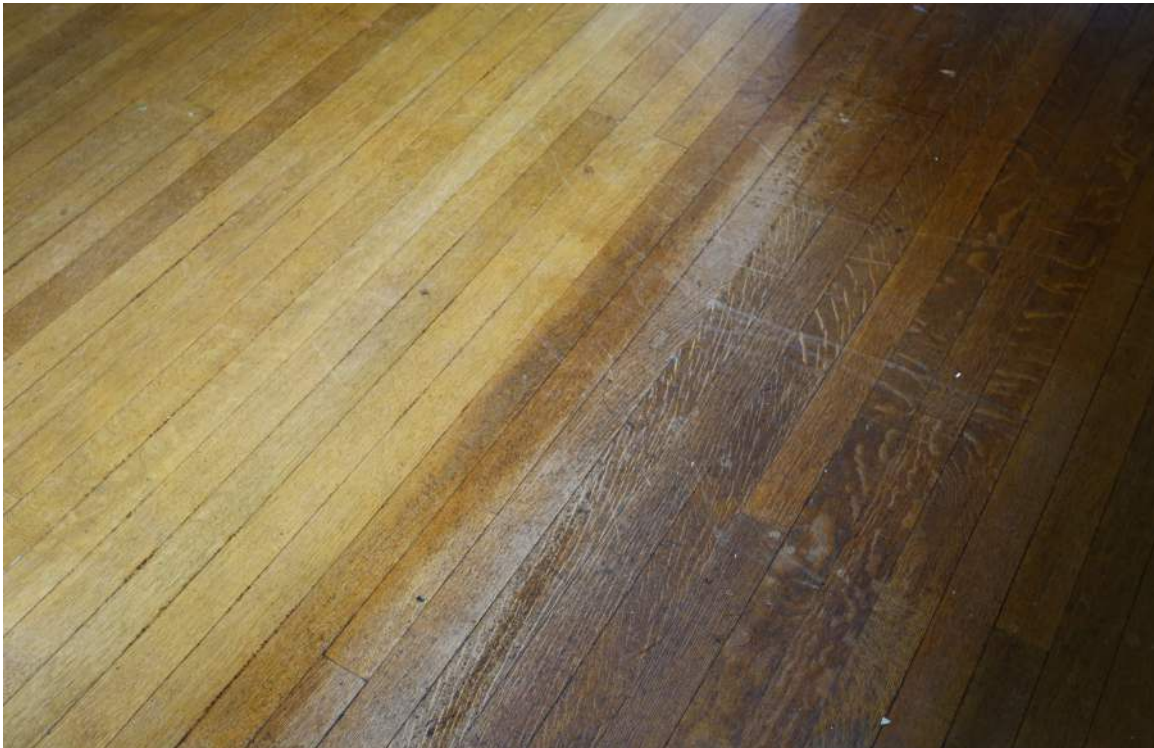
*Figure 117. Flooring in Room 102 showing aged finishes. The lighter flooring was covered and protected from sunlight versus the darker areas around the perimeter of the room that were exposed.*

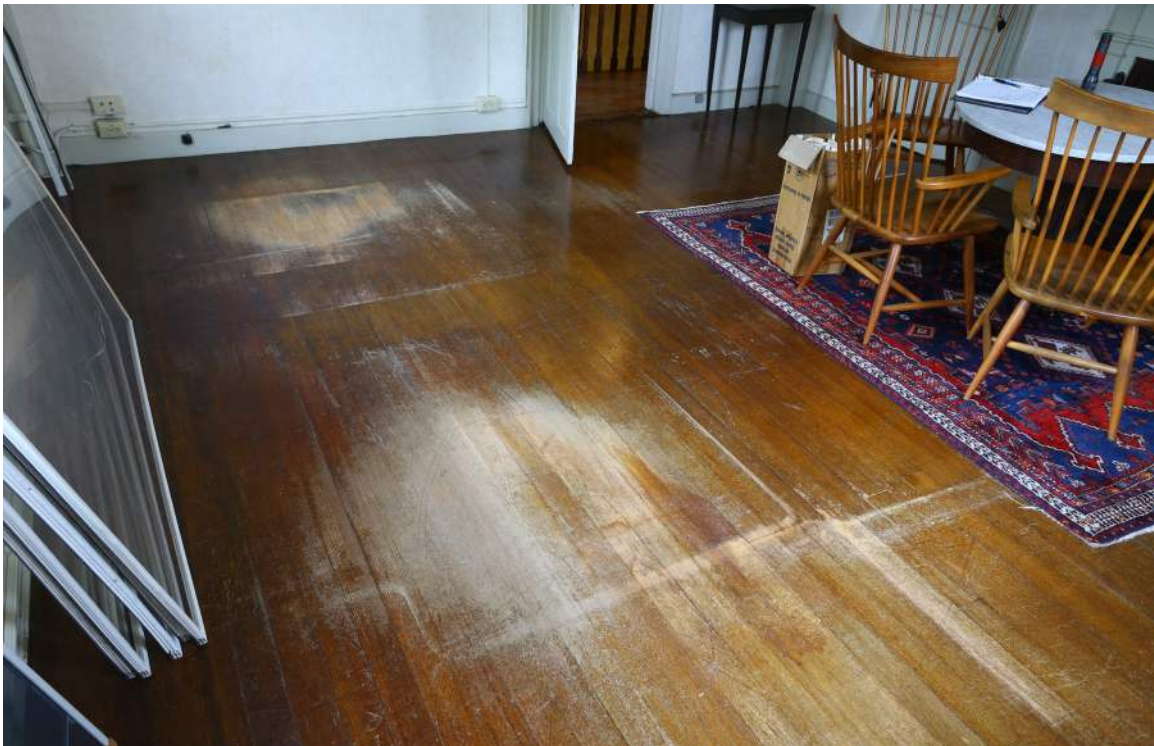
*Figure 118. Flooring in Room 202. The floor finish is worn from years of desk chair use. Note surface mounted outlets on wall.*

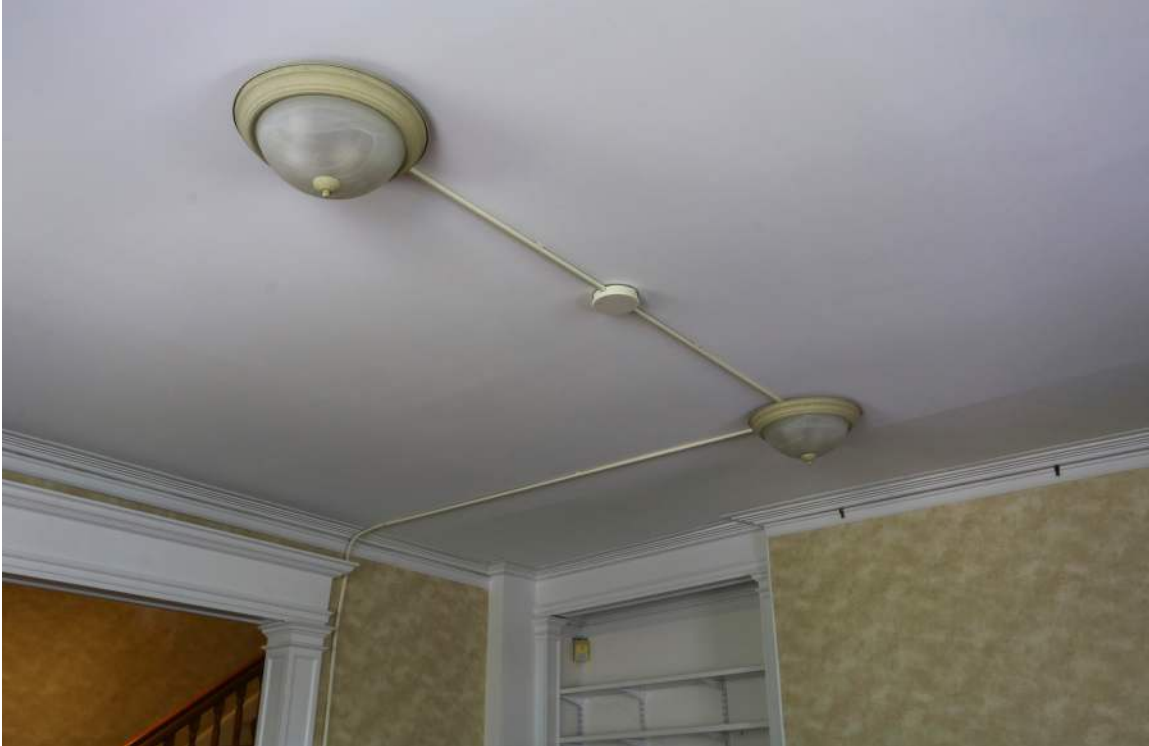
*Figure 119. Example of modern light fixtures and surface mounted wire mold found throughout the house.*

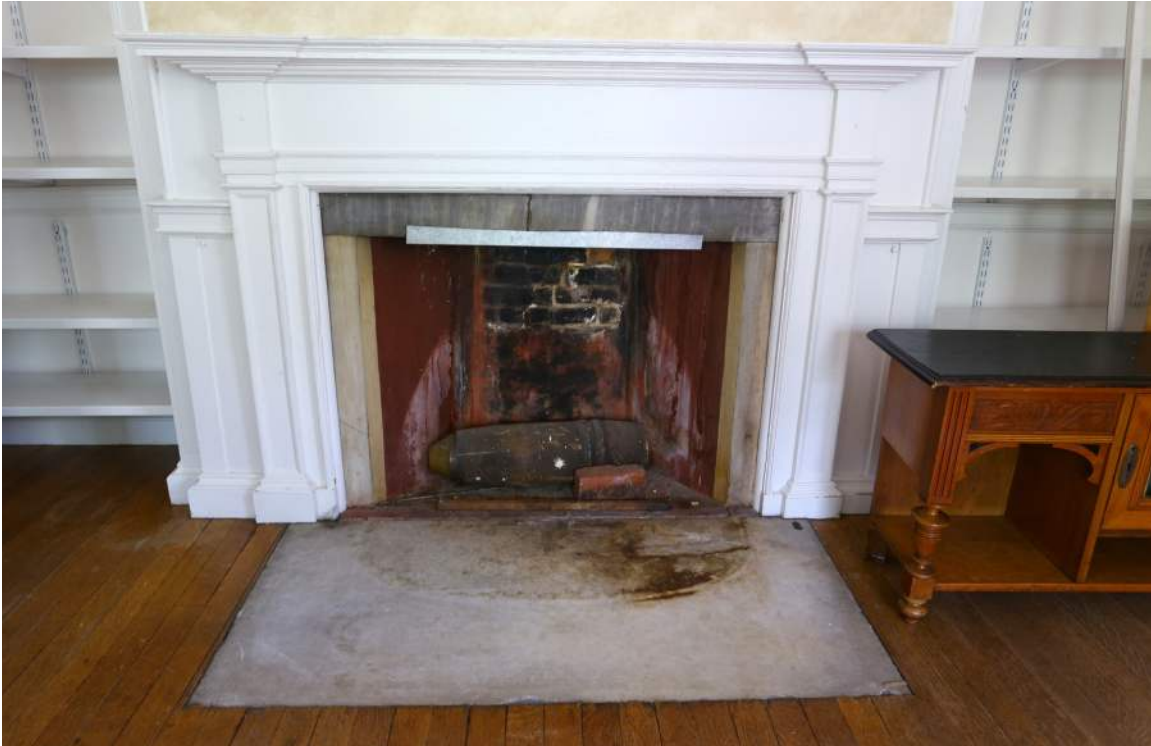
Figure 121. Representative example of the metal flange for the flue closures found at the fireplace openings. The profile of the stain on the hearth together with the ghosts on the jambs of the fireplace suggest a stove of some sorts may have once been located here. The stain on the hearth should be gently cleaned to remove surface soiling.

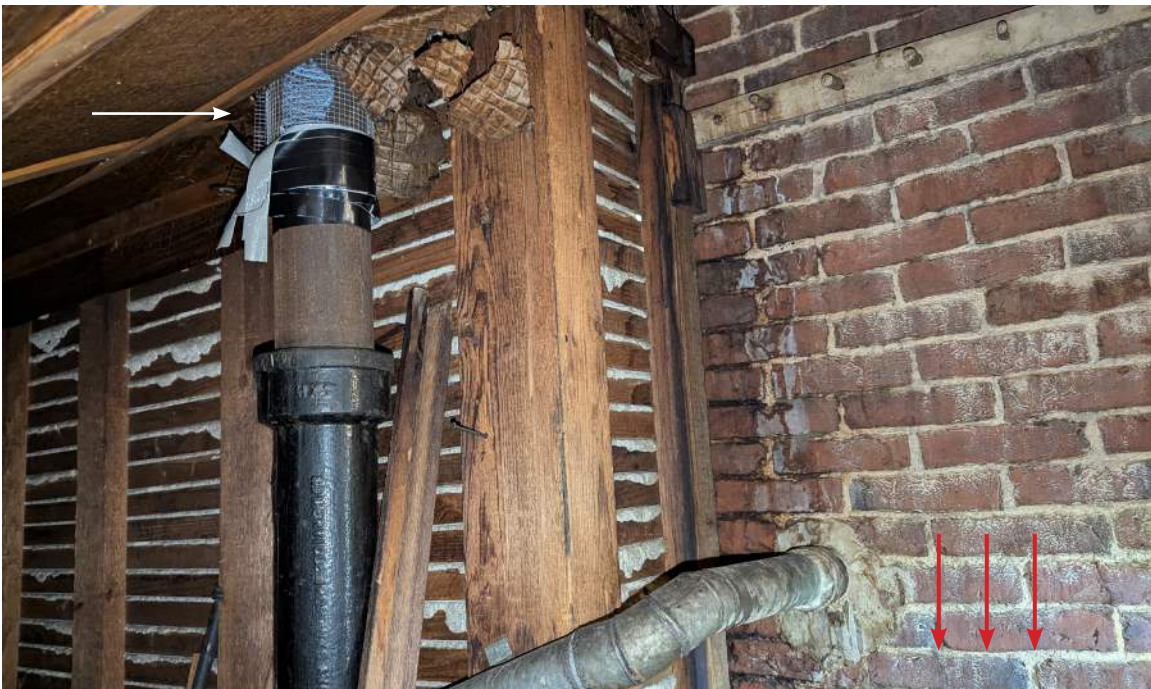
Figure 122. Attic, northeast room. A portion of the soil pipe is damaged and missing where it passes through the roof (white arrow). Not visible, but in this location, a portion of brickwork has deteriorated, creating a hole in the chimney (failures are in the direction of the red arrows). Daylight is visible in the hole, along with additional rotted brick dividing the flues.

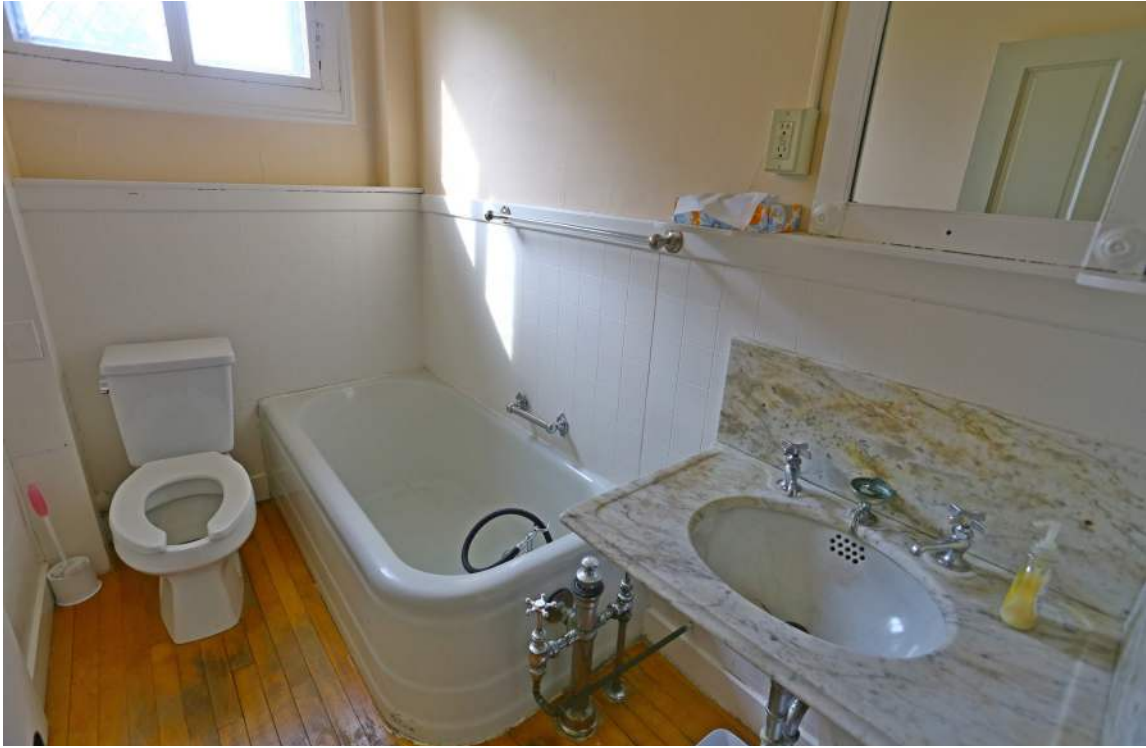
*Figure 123. Room 206, bathroom. Representative example of early fixtures and plumbing remaining in the bathrooms. Water to the plumbing fixtures still remains active and the toilets and sinks are in use.*

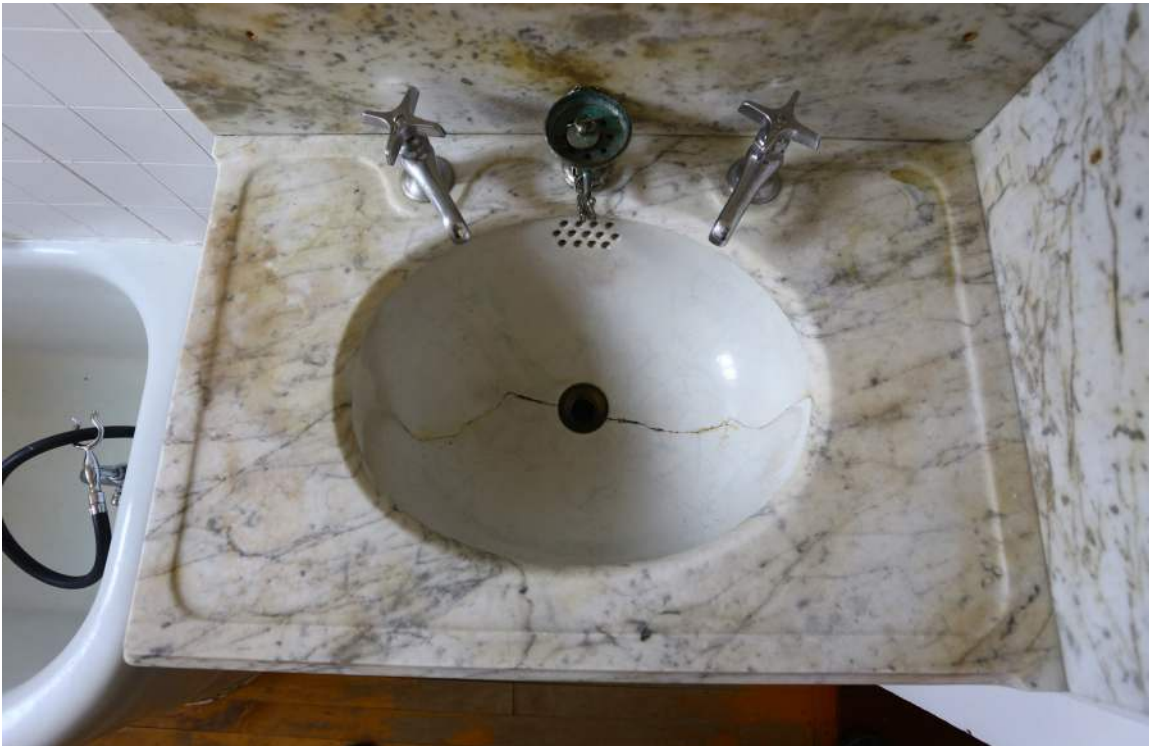
*Figure 124. The sink in Room 206 is cracked. The crack has been repaired, but a small leak remains. A waste bin has been placed under the sink to capture any water dripping from the crack.*

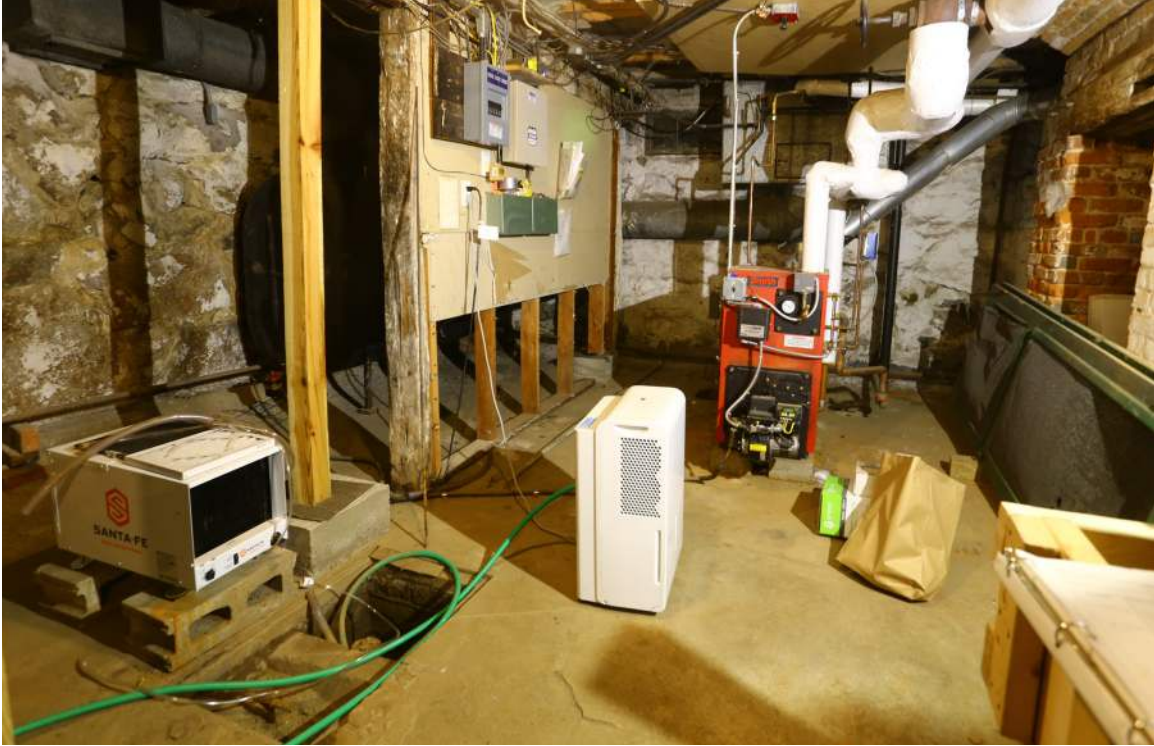
*Figure 125. Cellar. The boiler and related components of the heating system are located in the southwest portion of the cellar. The fuel oil tank is visible behind the partition to the left of the image.*

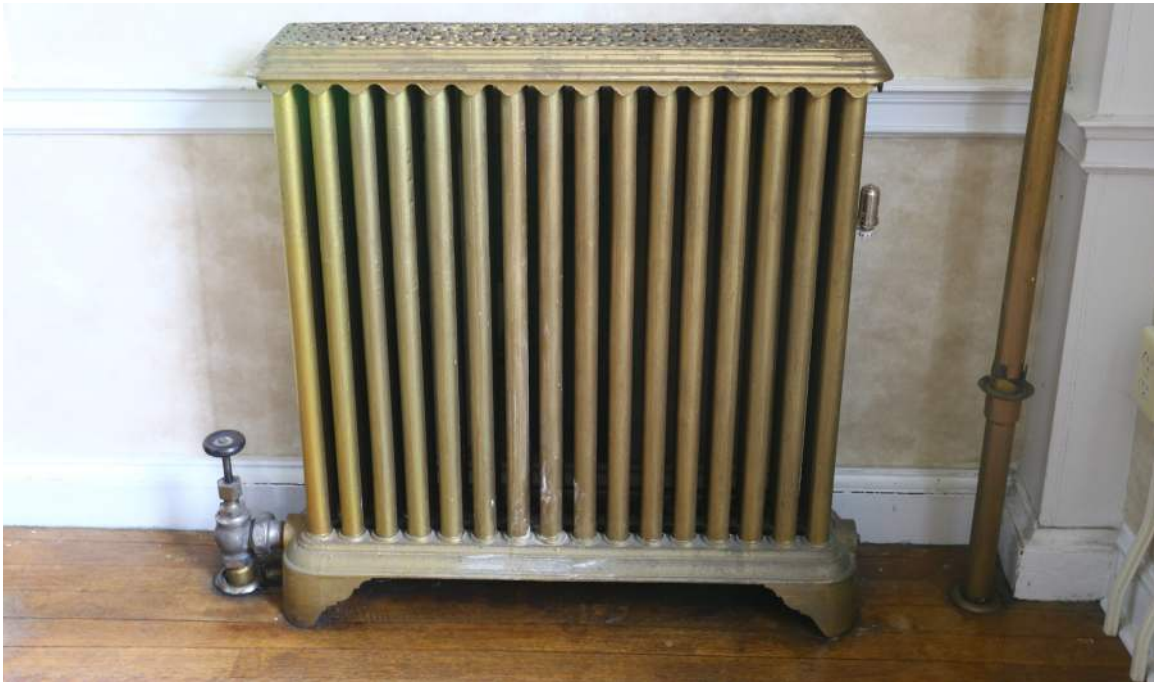
only to the first and second floors; steam lines were never extended to the attic rooms. Most spaces on these floors are heated by cast-iron radiators located within the rooms (Figure 126), with the exception of the southwest parlor. This room is warmed by a gravity hot-air system that delivers heat through a floor register. A radiator box mounted to the floor joists in the cellar below draws air through a return vent in the floor along the south wall, warms it, and allows it to rise naturally through the west register into the room (Figure 127). This arrangement eliminates the need for radiators in the space, preserving usable floor area. Domestic hot water is provided by a hot water hand connection on the boiler.

*Figure 126. Some of the earliest steam radiators in the house are believed to be these column style cast iron radiators. The decorative casting that forms the top of the radiator simply sits on the columns. If this was removed, you would see that each column shaft is independent of the other. Each column screws into the base of the radiator and is closed at its top.*

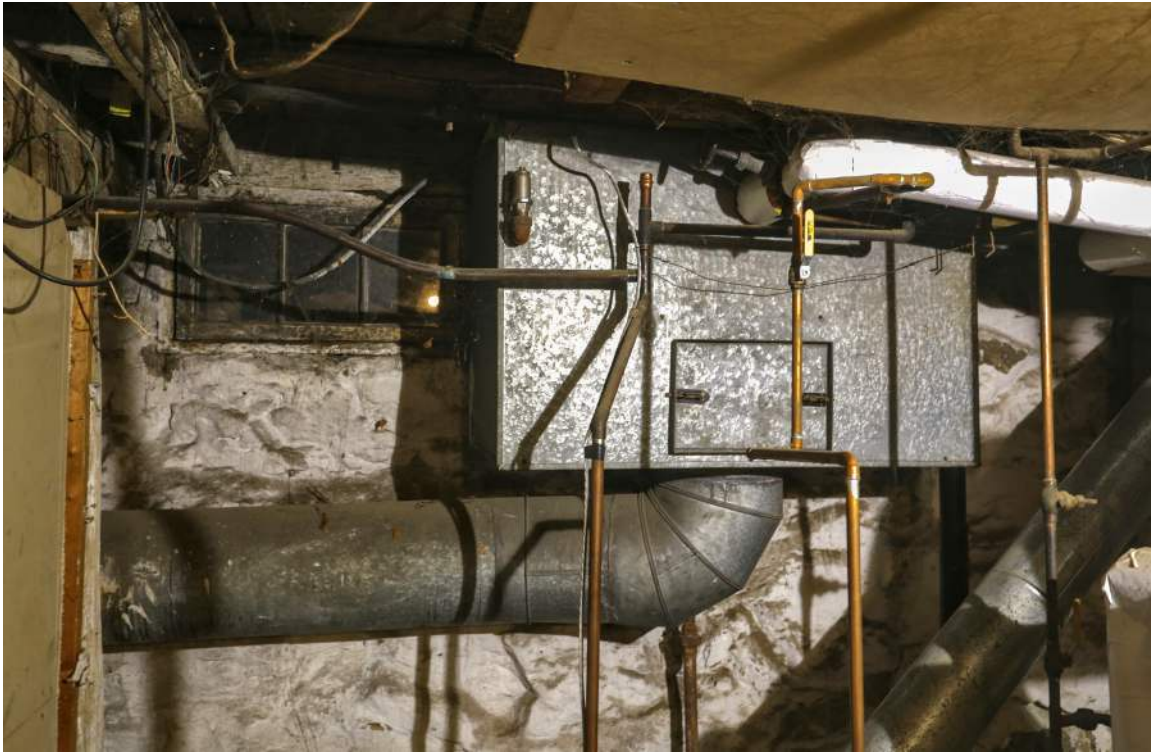
Figure 127. Cellar, west elevation. A ceiling mounted radiator box provides heat to Room 109. The box contains a radiator that warms air fed to it through the large duct entering from below. The duct is attached to the return air floor register on the south end of the room. This setup eliminates freestanding radiators within the room that take up floor space.

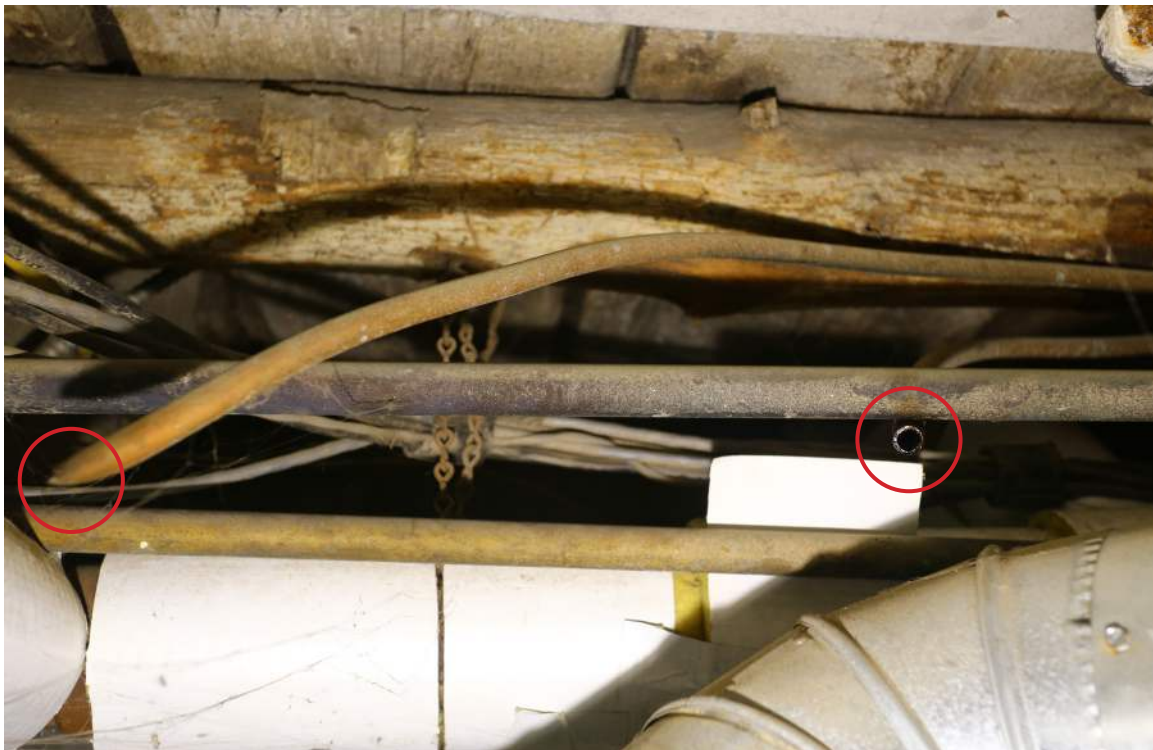
Figure 128. Cellar, west end above boiler. The red circles indicate the cut off ends of fuel lines from a previous fuel oil tank. The lines run to under the lean-to and exit the building underground to the west. These have every indication of serving a buried fuel oil tank. It is unclear if the tank has been removed or if it still remains buried under the yard or drive.

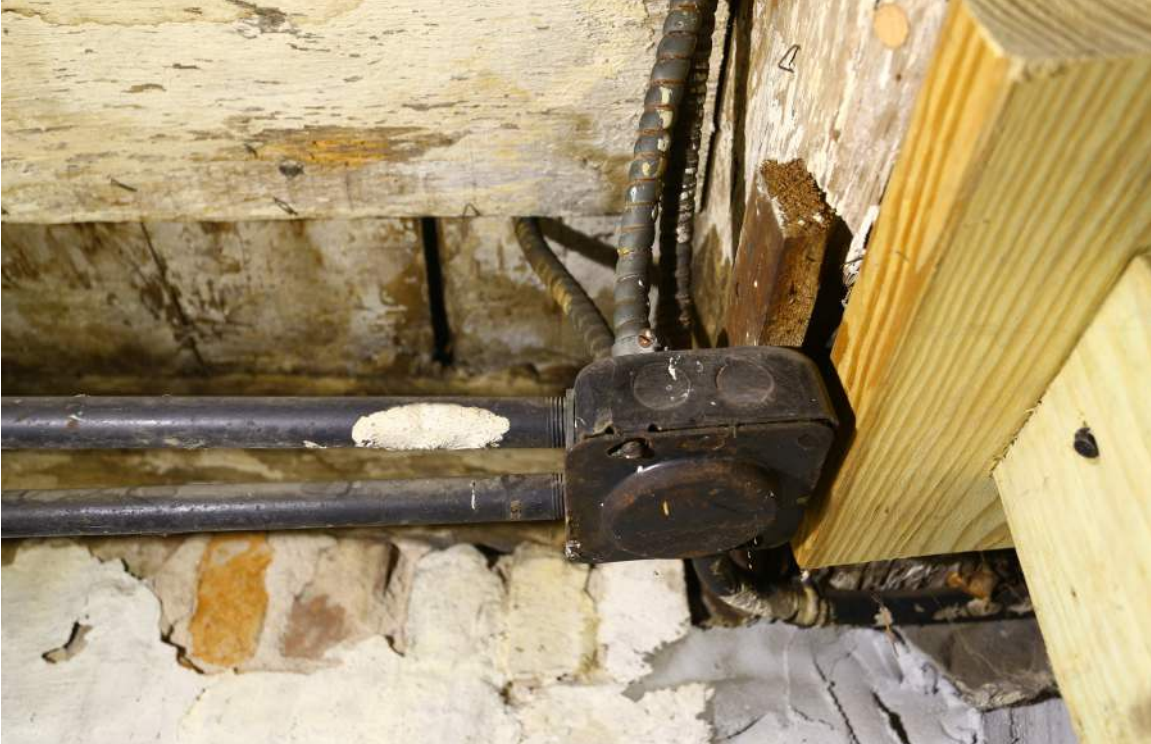
*Figure 129. Much of the early 20th century electrical service remains in place and active. In the cellar, this takes the form of cloth covered wiring run in conduit and BX (flexible metal cable) run up into the wall cavities. This wiring likely dates to the second quarter of the twentieth century when the house was wired for electricity.*

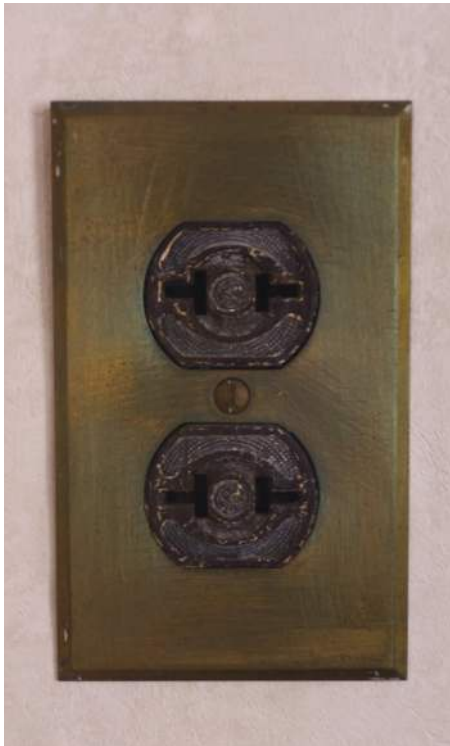
Notes in Historic Northampton's archives for the Shepherd house indicate the house was wired for electricity in 1916 with a lengthy, multipage receipt for extensive electrical work done in 1928 and another mention of work performed in 1949/50.<sup>112</sup> The earliest portions of the electrical system include BX (flexible metal cable) and cloth covered wiring run in conduit of the same vintage (Figure 129). The conduit exists in the cellar. Wiring of this vintage was observed running up into the walls of the building to outlets, ceiling boxes and elsewhere. Early outlets are a mix of grounded and ungrounded receptacles (Figure 130 and Figure 131).

*Figure 130. Early electrical outlets remain throughout the house, all of which, when tested were live and still providing power.*

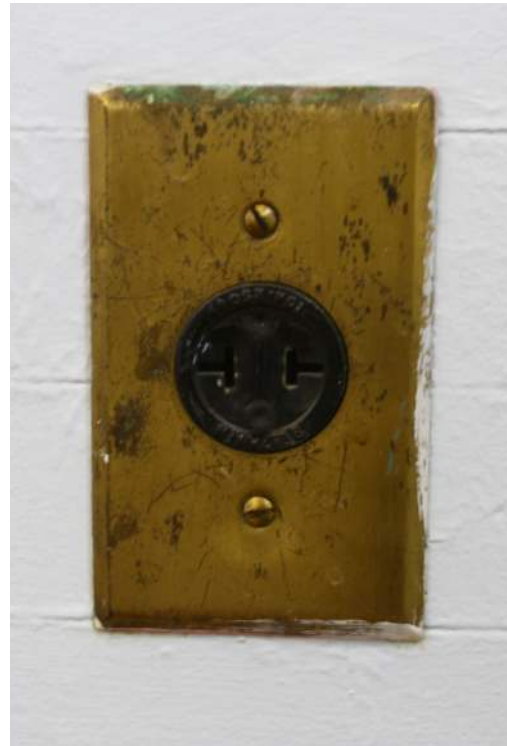
*Figure 131. These early electrical outlets are not grounded and should no longer be used. In many cases, modern, surface mounted outlets have been installed adjacent to these.*
