# SHEPHERD HOUSE HISTORIC STRUCTURE REPORT

NORTHAMPTON, MASSACHUSETTS

HISTORIC NORTHAMPTON

*FEBRUARY 5, 2026*

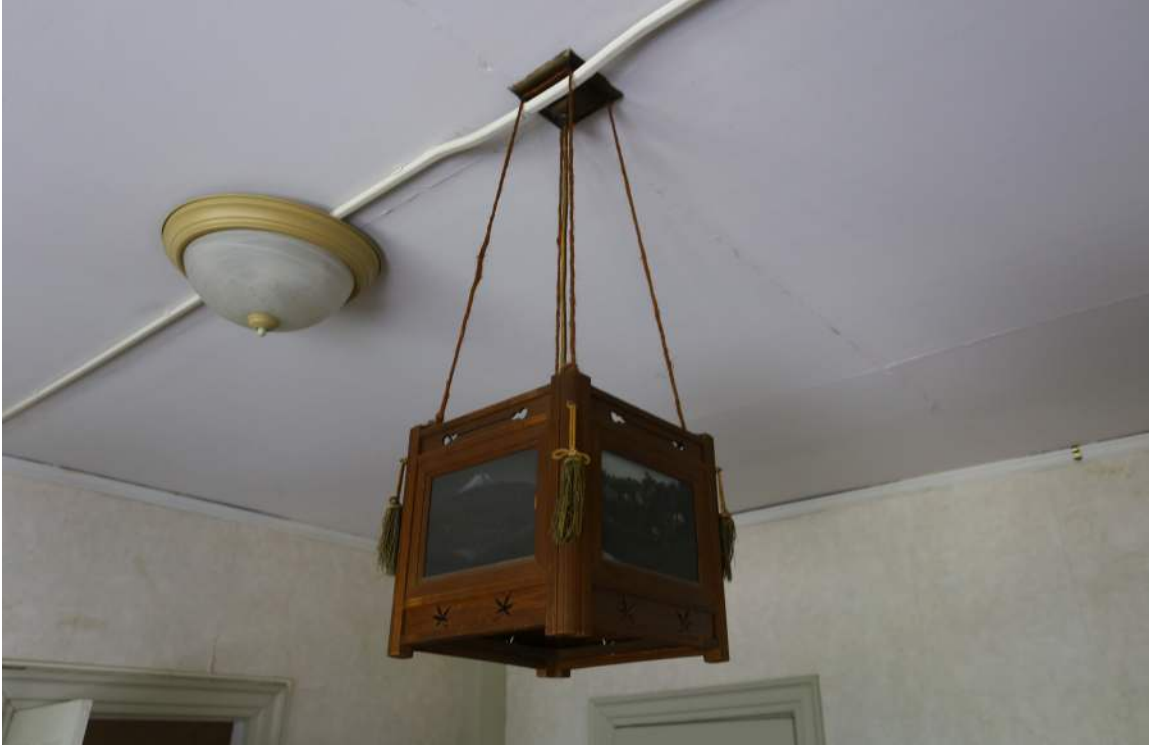
The historic light fixture in the southeast chamber tested live even with the fixture switched off (Figure 132). All old light fixtures should be rewired if they are to be continued to be used in the future.

*Figure 132. Room 202. This fixture showed power running to it with the light switch turned off when the wires and socket were probed with a voltage tester. All historic fixtures intended to be reused in the house must be inspected, updated and rewired to modern standards.*

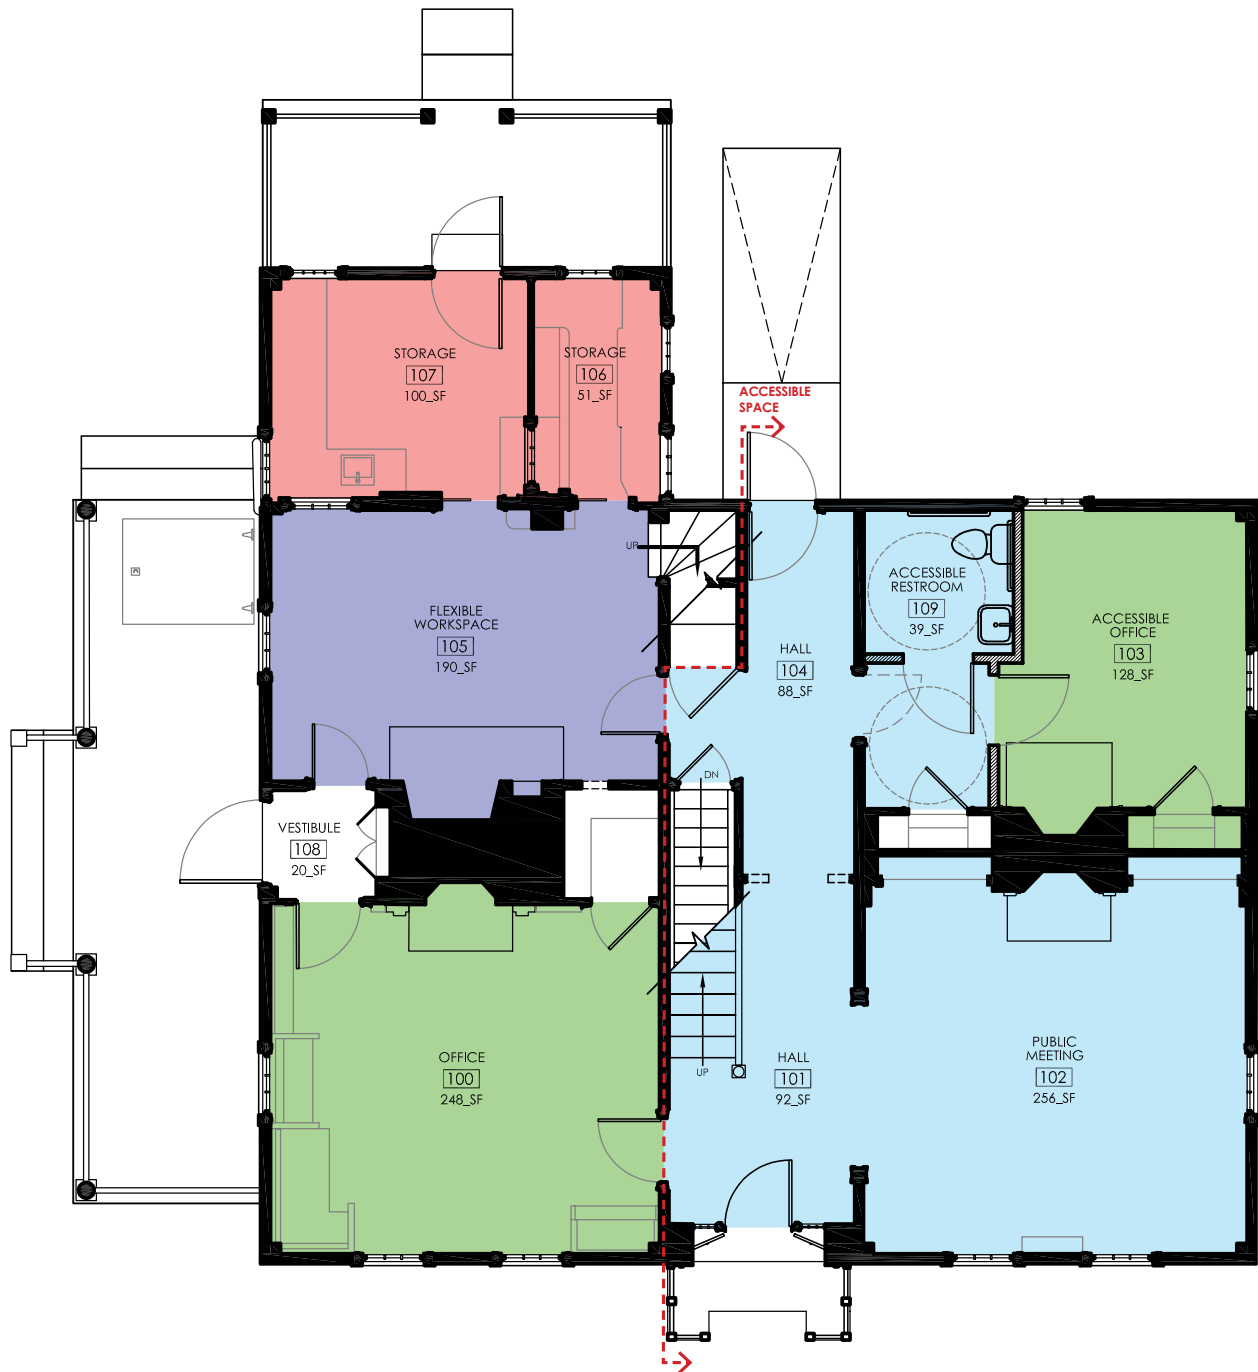
FIRST FLOOR

## SCHEME 1 - ADMINISTRATIVE OFFICES WITH PUBLIC SPACE

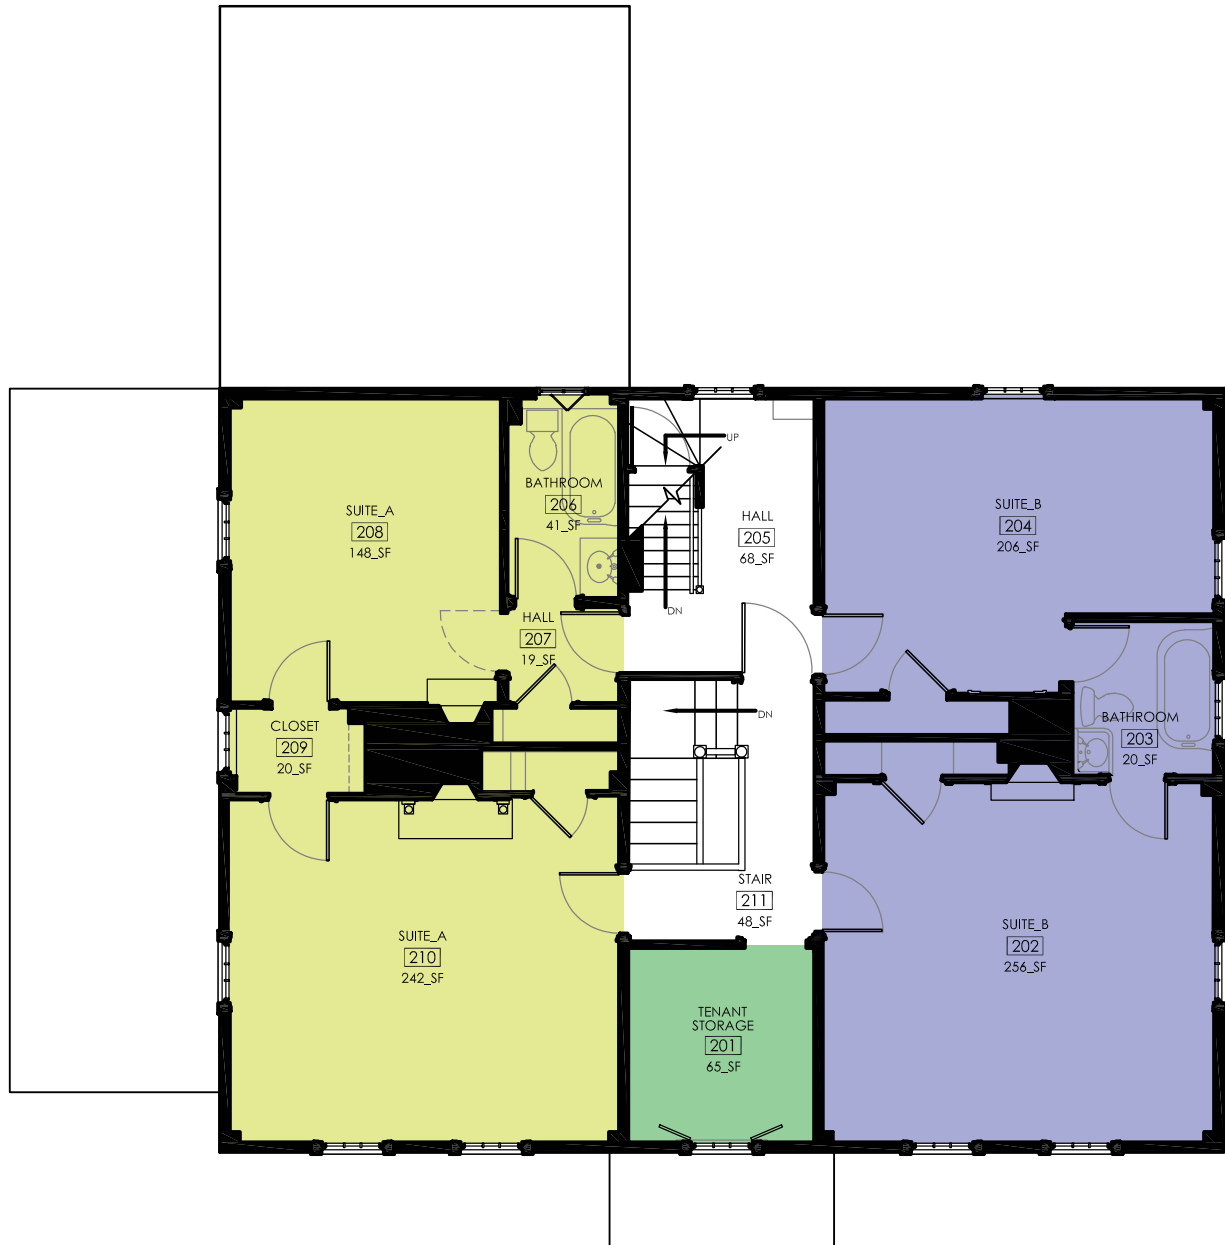
SECOND FLOOR

## SCHEME 2 - SCHOLAR IN RESIDENCE SUITES WITH PUBLIC SPACE
