# Historic Structures Report

## Nathaniel Parsons House

58 Bridge St.  
Northampton, MA

Prepared by  
Myron O. Stachiw  
April 2026

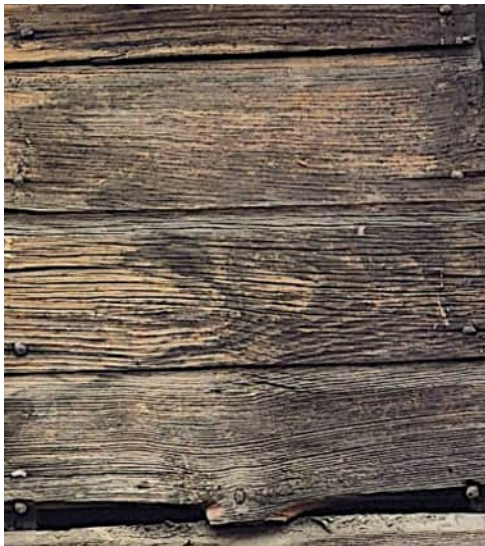
Figure 5.  
Detail of Phase 1 flush board siding on the south elevation. This one board was scored twice to make it appear like three overlapping weatherboards. (Photograph by Myron O. Stachiw.)

As described in the 1992 SPNEA study, the exterior of the building was finished with horizontal board siding, but of different quality on the various elevations.<sup>66</sup> On the front -or south elevation, the siding consisted of planed flush boarding, with horizontal scoring to simulate overlapping weatherboards. (Figure 5).

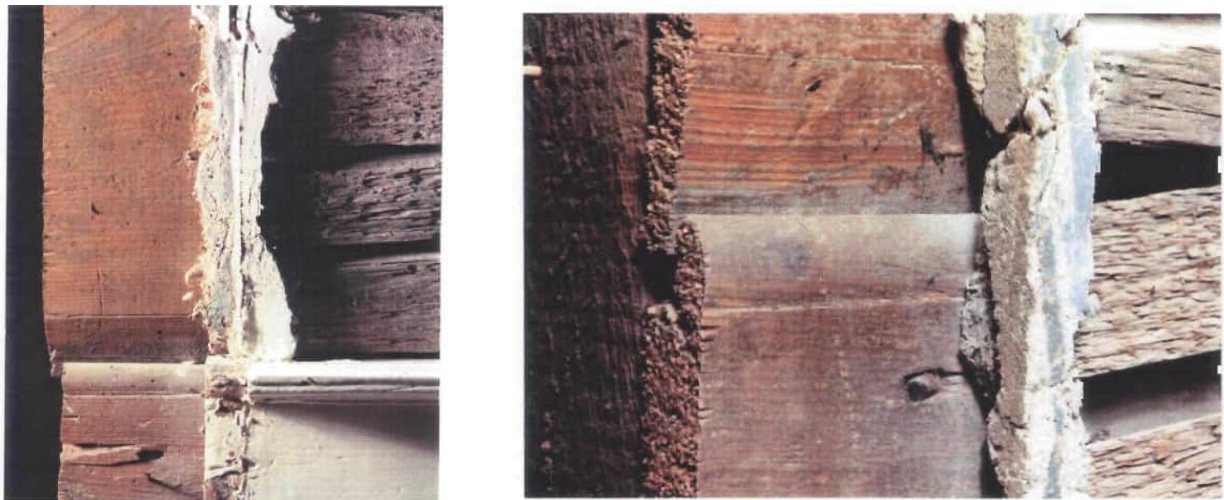
Figure 9. Detail views of the Phase 1 sheathing of the interior walls of the hall or kitchen (Rm 102). Phase 2 lath and plaster and wainscot were applied in the early 19<sup>th</sup> century over the Phase 1 sheathing. The Phase 1 sheathing exposed in these photographs was covered by an architrave surrounding a doorway to the rear lean-to. The mill-sawn boards, which measured between 8 and 12 inches in width, were planed smooth on one face and finished with a feathered lower edge and molded top edge. The feathered lower edge of the upper board fit behind the molded upper edge of the board beneath it. (Photographs 102-5 and 102-6 from Clancey and Leeke, 1992.)

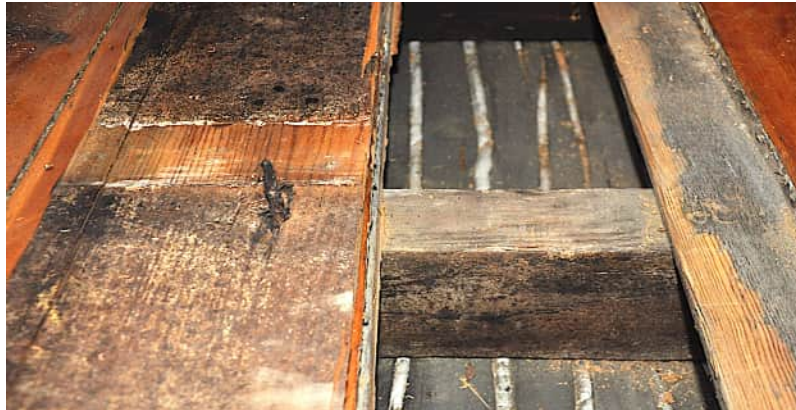
Figure 10.  
View of the floor joist and underside of a floorboard (on the left) in the ceiling of the hall (Rm 102). Note the dark soot/smoke/grease staining on the sides of the joist and on the floorboard, in contrast to the portion of the floorboard which lay over the joist. Note also the traces of whitewash. (Photograph by Myron O. Stachiw, 2024.)

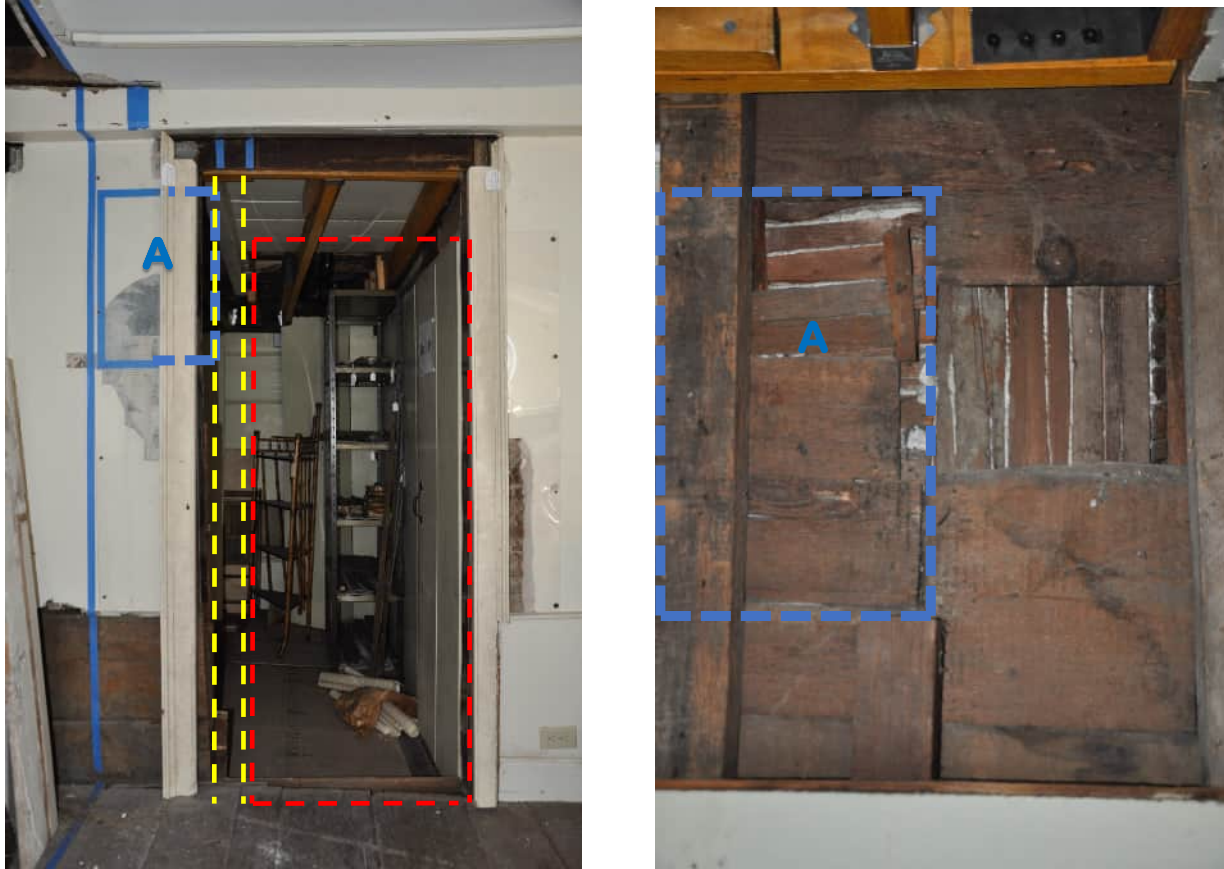
Figure 15. Left – View of the north wall of the hall (Rm 102), showing the current doorway to Rm 109 in the rear pile of the house. Throughout the 18<sup>th</sup> century a smaller doorway opening provided access to the rear lean-to in this same location. Its approximate dimensions and location are indicated by the dashed red lines. The area within the blue rectangle **A** indicates the location of the former opening for a small wall cupboard or window opening. This opening was originally bounded on its east side by a wall stud which was later relocated several inches to the west when the doorway was enlarged. The yellow dashed lines indicate the original location of a Phase 1 wall stud which was relocated several inches to the west when the door opening was enlarged during Phase 4.

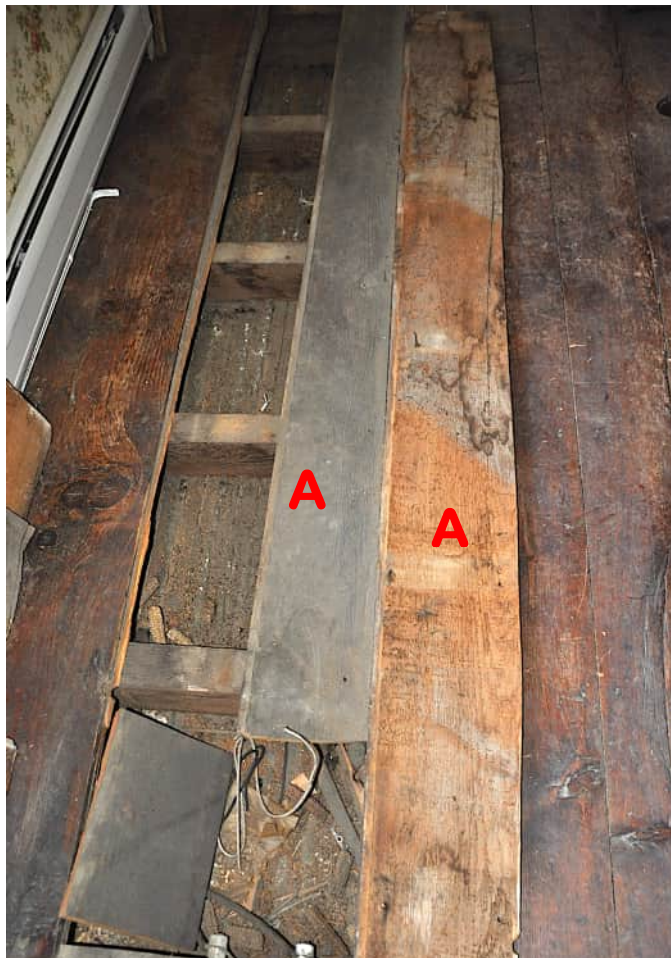
The removal of several floorboards in the chamber above the west parlor (Rm 210) revealed that the underside of the floorboards and framing members in the ceiling of the west parlor showed little or no smoke- or soot-staining. Although there was a fireplace in this room from the start, the absence of any significant accumulation of smoke residue on the surfaces of the framing members or on the underside of the overhead flooring indicates that the fireplace in this room was rarely used, if at all, until the ceiling of the room was lathed and plastered (Figure 16).

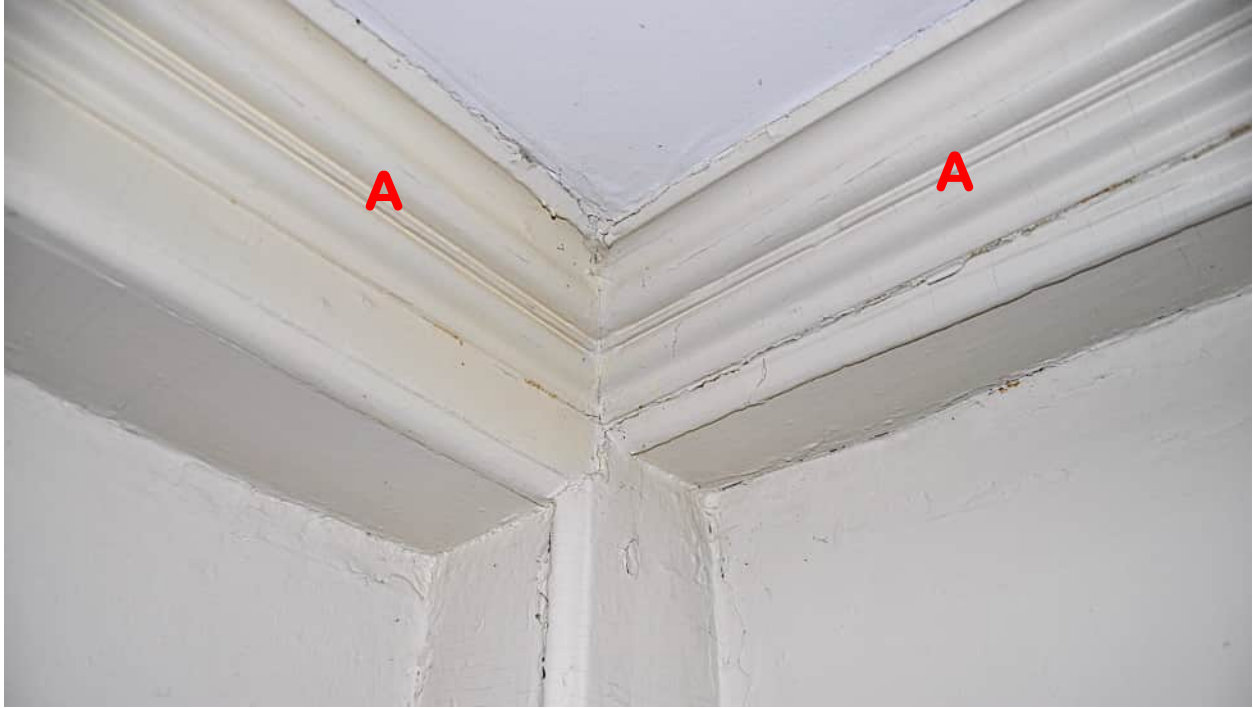
Figure 17. View of the casings applied to the posts and girts in the parlor (Rm 112) and the classically-inspired compound *cyma recta* and *cyma reversa* crown moldings applied over the girt- and summer beam casings. (Photograph by Myron O. Stachiw, 2024.)

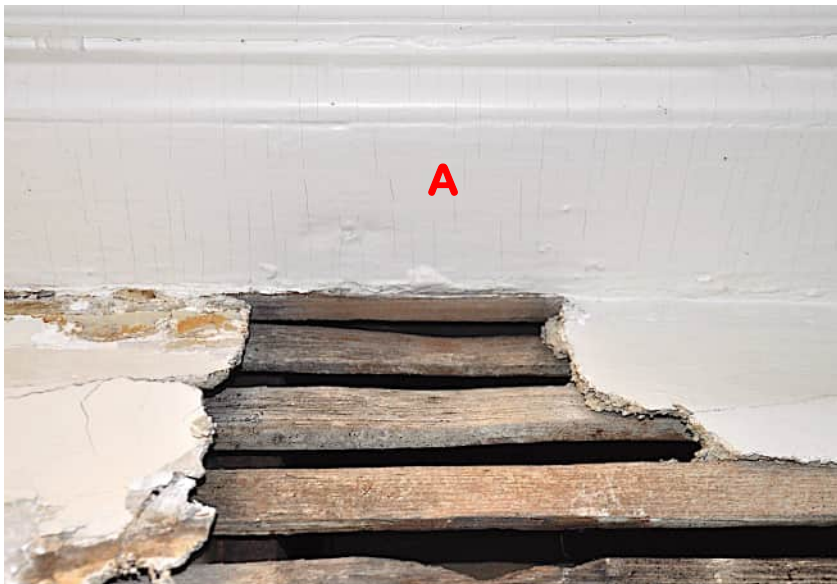
Figure 18. View of the underside of the beam casing **A** on the north wall of the parlor after removal of Phase 1 plaster applied over riven lath. Note that the plaster butts against the unpainted surface of the beam casing. The casings and crown molding in this room were painted after the plaster was applied with what appeared to be a dark brown faux graining. Traces of this paint were found on the plaster beneath later whitewash layers adjacent to the casing. (Photograph by Myron O. Stachiw, 2024.)

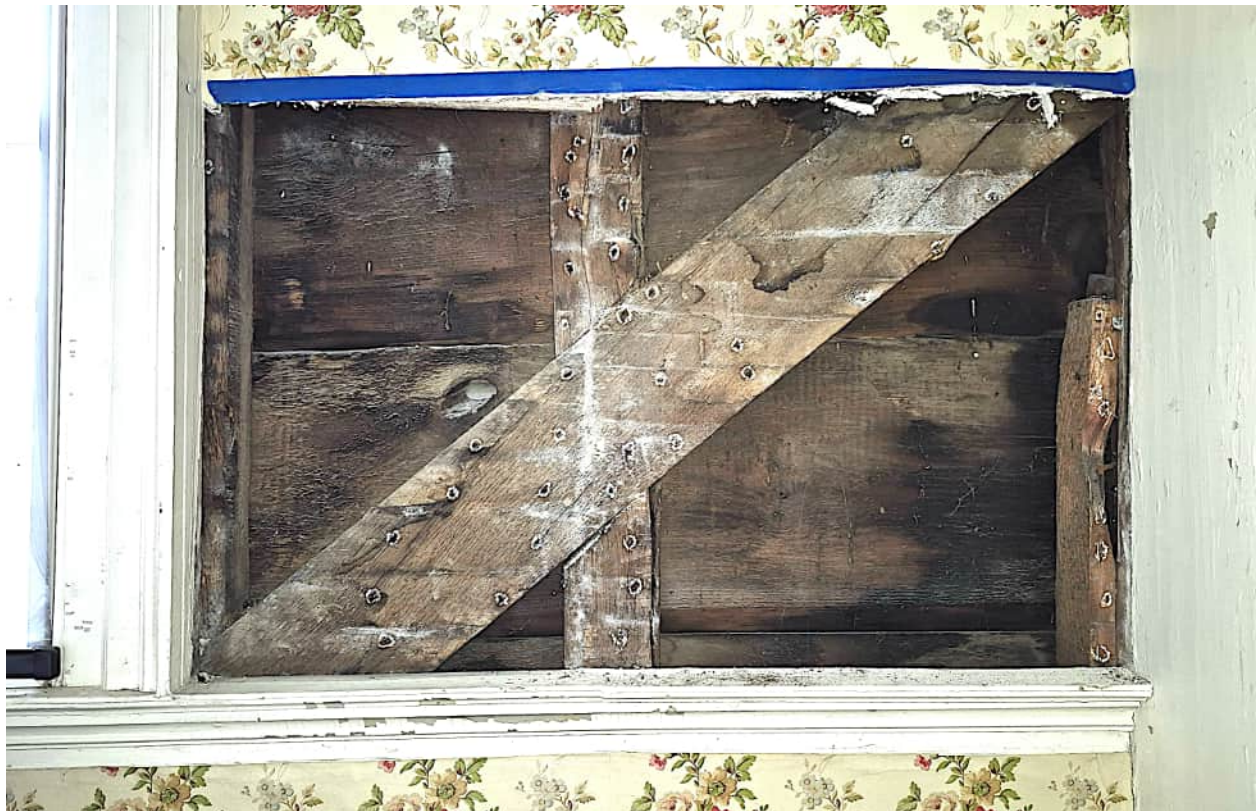
Figure 22. View of the 2025 excavation through the south wall of Rm 210. The early 19<sup>th</sup> century plaster and sawn- and split lath were removed, and the nail holes left by the early machine-cut nails which fastened the lath were marked. No extraneous nail holes from earlier finishes were discovered, supporting the conclusion reached by the investigators during the 1992 study that the walls of the second-floor rooms remained unfinished through the 18<sup>th</sup> century. Investigation of the ceiling in this room from the attic revealed that the sawn- and split lath applied to the ceiling in this room were not nailed to the underside of the attic floor joists, but to nailers suspended several inches below the joists. This allowed examination of the undersides of the attic floor joists; no nail holes from any earlier lath or board sheathing were discovered, confirming that the two second-floor rooms did not receive lath and plaster ceilings until the early 19<sup>th</sup> century, probably at the same time that the walls of these rooms were lathed and plastered. (Photograph by Myron O. Stachiw 2025.)

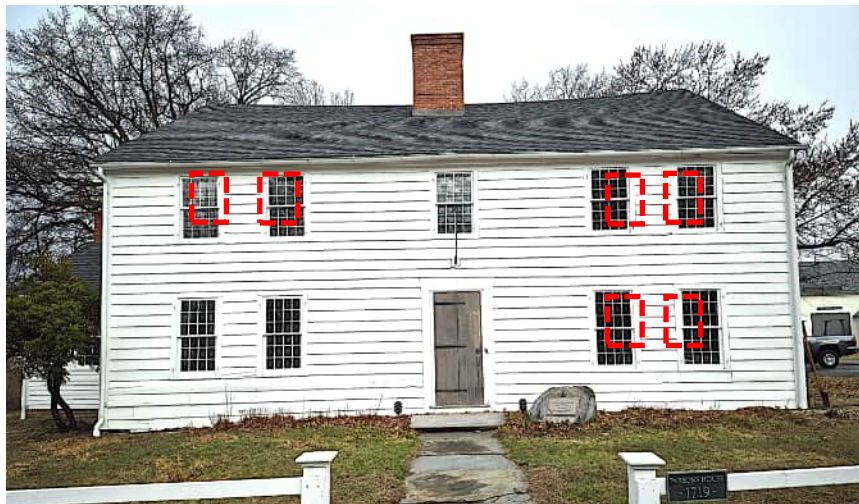
Figure 23.

Location of the evidence on the interior or exterior walls of the south elevation of the Parsons House for earlier paired sash windows. Although evidence for similar windows in the west ground-floor room (parlor - Rm 112) was obliterated by later improvements, it is very likely that identical windows existed there. (Photograph by Myron O. Stachiw, 2025).

Selective removal of existing weatherboards from the south elevation of the house in 2025, as well as removal of plaster and lath from the interior side of the south walls of the hall/kitchen and the parlor chamber revealed more evidence of the existence of these earlier paired windows, confirming that they existed on both floors and in both the east- and west rooms (Figures 23, 24, 25).

- the position of the new windows on the wall and their relationship to the key elements of the series of improvements made during the first Federal Period remodeling. Figures 23, 24, and 25 clearly indicate that the window sills of the new windows were located several inches above the sills of the present larger windows which were installed together with the wainscot and chair rails.

- Removal of casement window(s) on the south elevation and installation of two sash windows (see Figures 23, 24, 25). This occurred sometime after 1798, but probably several years before the major Phase 2 improvements.

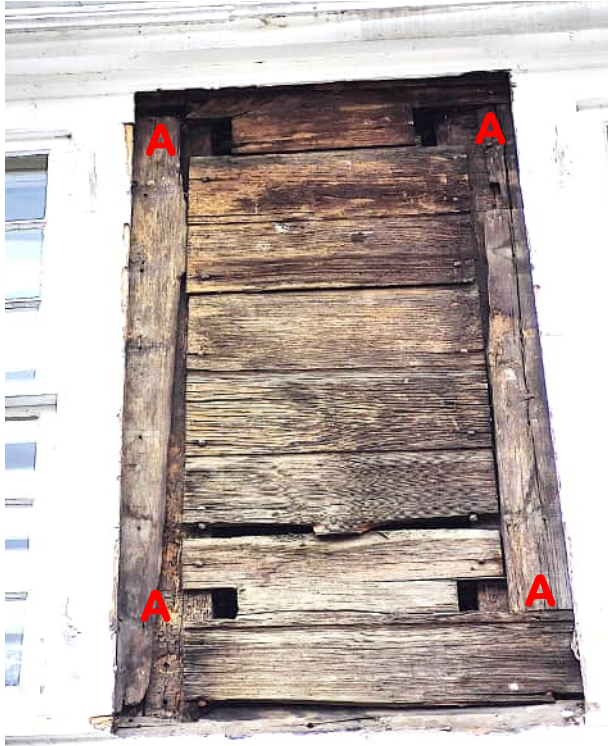
Figure 24.

View of the space between the two existing windows of the east chamber (Rm 202). Note the four notches (marked **A**) cut through the Phase I sheathing. (See also Figures 12 and 13). These notches accommodated the projecting ends of the top rails and sills of the joined window frames. On the exterior, these projecting ends of the rails and sills lapped over studs in the walls and allowed the window frames to be secured to the studs with nails. (Photograph by Myron O. Stachiw, 2025).

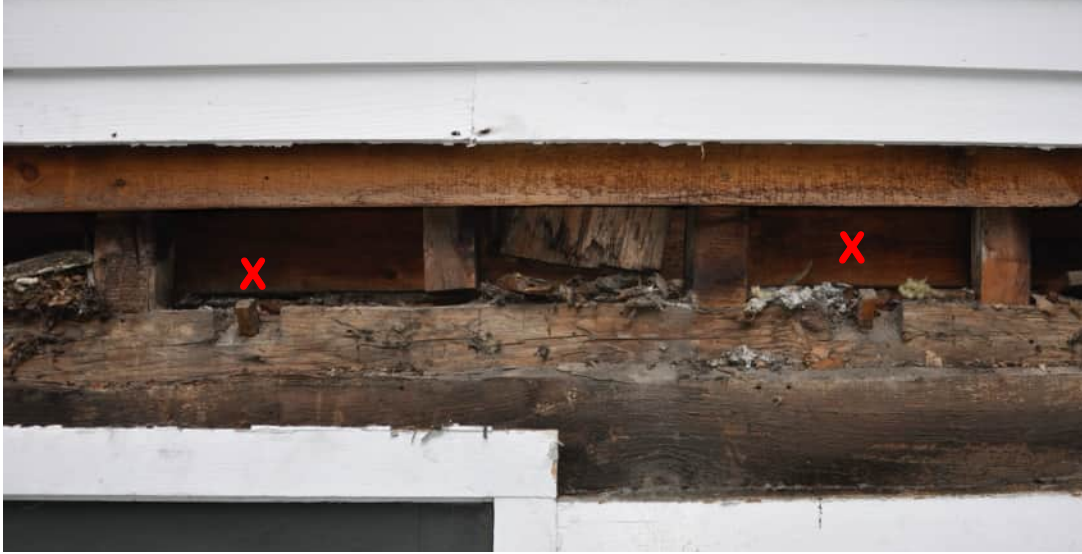
Figure 27. View of the north- or rear plate of the Phase 2 lean-to. Two step-mortises for the rafter feet of the Phase 2 lean-to roof rafters are indicated by X. Note the pegs which fastened the lower end of the rafters to the plate still in place in these mortises. The lower ends of a post and several studs are visible above the plate forming the south wall of the second-story rooms created when the Phase 2 rear lean-to was raised to two full stories in 1816 (Phase 3). (Photograph by Myron O. Stachiw, 2024.)

The rear plate of the lean-to is a single timber, extending 40 feet from one end to the other. The lean-to rafters were pegged into step mortises at their lower end into the rear plate of the lean-to (Figure 27). The upper ends of the lean-to rafters likely were lapped over the edge of the roof sheathing and nailed to the Phase 1 roof sheathing, as no additional mortises were cut into the Phase 1 house plate for the lean-to rafters.

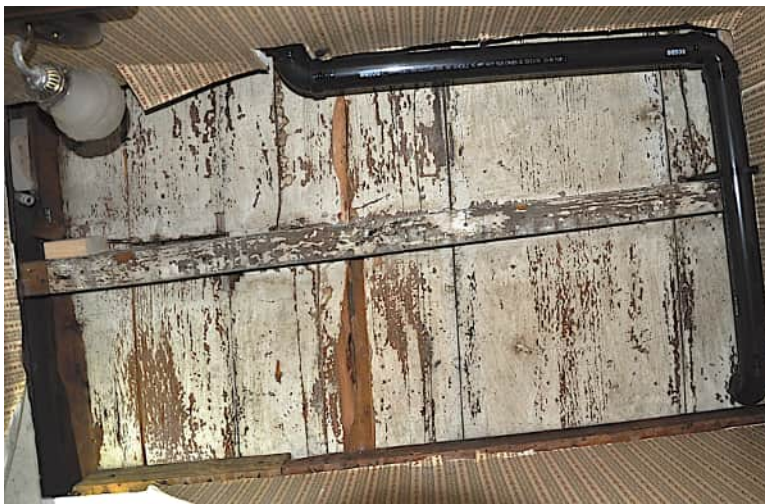
Figure 28.  
View of the Phase 2 ceiling in the rear lean-to over Rm 103. Looking up at the underside of the flooring above and a floor joist, The ceiling lath and plaster in this space was removed during the late 20<sup>th</sup> century improvements. (Photograph by Myron O. Stachiw, 2024.)

The rear lean-to was accessed from Phase 1 house through doorways in the north walls of the hall/kitchen and parlor. It was necessary to step down about 6 to 8 inches to the floor of the lean-to from the parlor and hall/kitchen. This was obviously an original configuration, and remains to this day, as the floor of the firebox and hearthstone of the fireplace, and the wooden floor throughout the rear pile of the house - the former Phase 2 lean-to - are still at this lower level. Most of the original ceiling framing of the lean-to survives, consisting of four hewn girts and hand-planed and beaded joists. The joists and the undersides of the floorboards above, where enclosed and protected from later alterations, reveal that they were originally whitewashed (Figure 28).

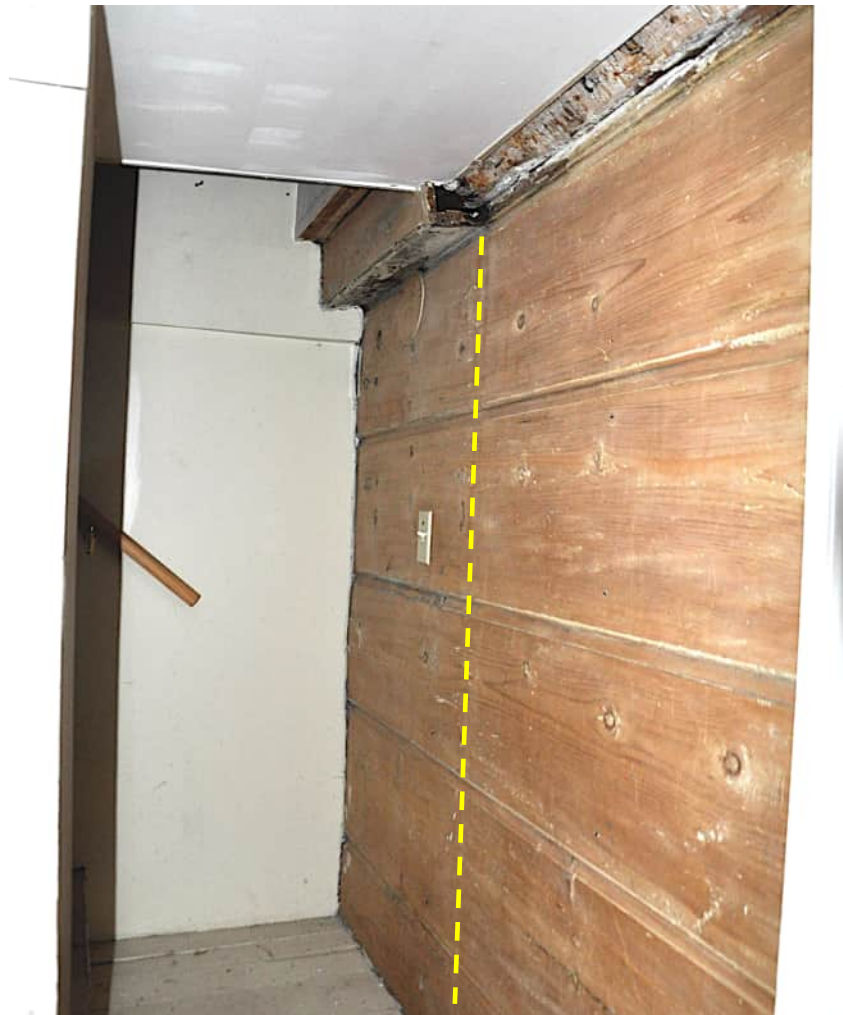
Figure 29. View of the horizontal, molded board sheathing on the north wall of Rm 104. These sheathing boards are continuous past the staircase and wall at left into Rm 109, suggesting that the rear staircase to the second floor and the room partitions across the rear lean-to were created after the walls were fully sheathed. The yellow dashed line indicates the location of a vertical scribe line on the surface of the sheathing boards which coincides with the location of the east wall of the original Phase 3- and present staircase. (Photograph by Myron O. Stachiw, 2024.)

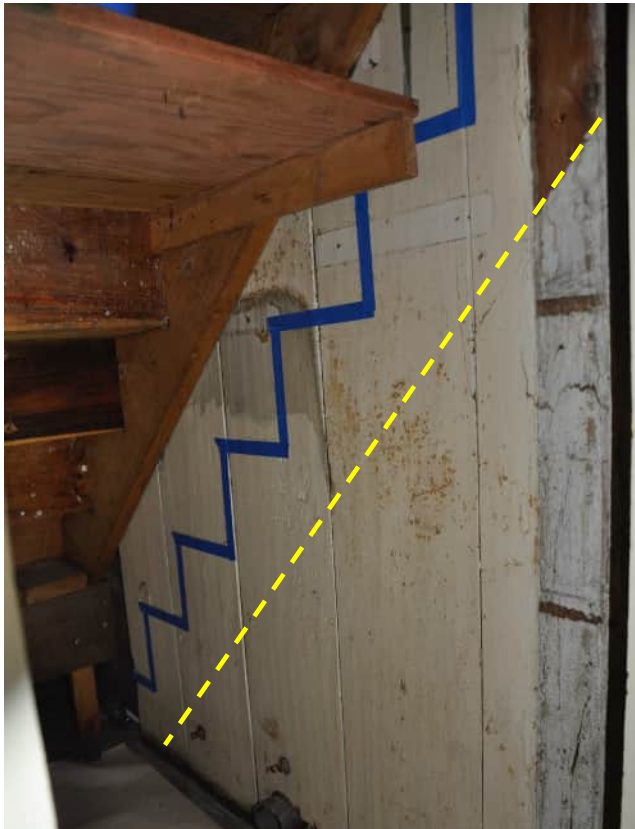
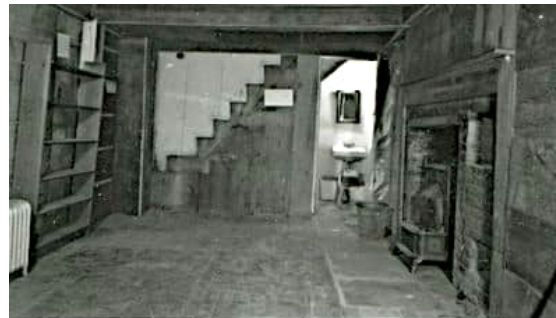
Figure 30.

Left - View of the east wall of the staircase from Rm 109 on the ground floor to the lean-to garret during Phase 2 and/or to the second floor of the rear pile during Phase 3. This wall is in its original location and reveals the location of the staircase before its removal in the early 20<sup>th</sup> century and re-erection about six feet to the west in Rm 109. The blue lines indicate the paint scars on the vertical-board east wall of the treads and risers of the staircase. The stairs on the left side of the image above the earlier stair scar were erected in 1981 during a major phase of

The original partitioning of the rear lean-to has not been conclusively determined, and no surviving traces of these Phase 2 partition walls have been identified; the existing partitions forming the small west room (Rm 110) and a small east room (now occupied by a staircase and parts of Rms 103 and 104) likely date to Phase 3 when the second-story rooms were added and finished. The existing rear staircase to the second floor, rising along the west wall of Rm 104, was created in the 1980s, but it was built in the same location as an early staircase, removed in the early 20<sup>th</sup> century, but created in Phase 3 when the rear lean-to was raised to two full stories (Figures 29, 30.)

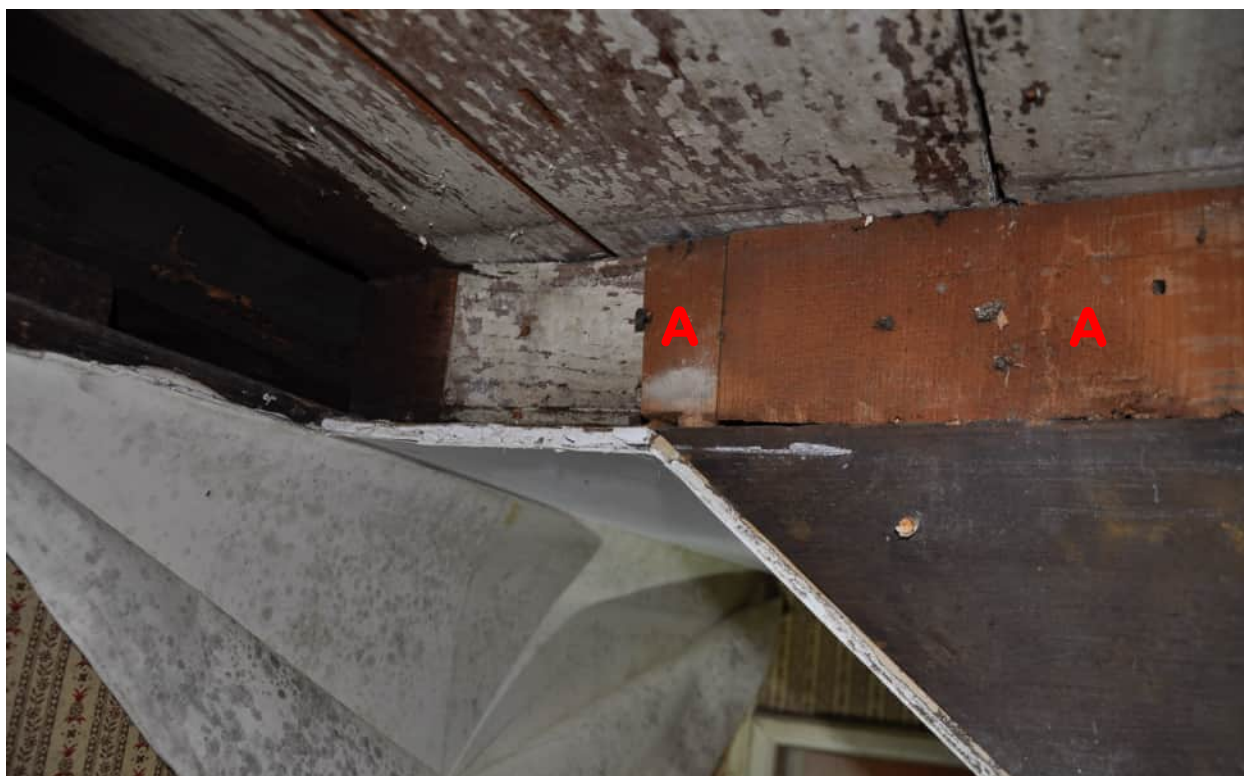
Figure 31. View of the east side of the remnants of vertical boards **A** which formed the east wall of the Phase 3 staircase. The vertical boards forming this wall were nailed to the east side of the joist with Type 2 machine-cut nails. Note that the unpainted vertical boards were applied over whitewash on the joists and ceiling boards. The lath and plaster ceiling were created after the staircase was in place, made evident by the unpainted section of the vertical boards above the level of the plaster ceiling. A nailer for the lath was applied over the vertical boards at joist level (removed at the time of this photograph). This nailer was a reused element. It was painted with a yellow/ochre distemper paint, the first-generation paint on the sheathing, providing further evidence that the staircase was likely erected during Phase 3 rather than Phase 2. The plaster ceiling in this space was removed in the late 20<sup>th</sup> century when a bathroom was created in this space, and several of the vertical boards were sawn off at the level of the joists to create a passageway into the new bathroom. (Photograph by Myron O. Stachiw, 2024.)

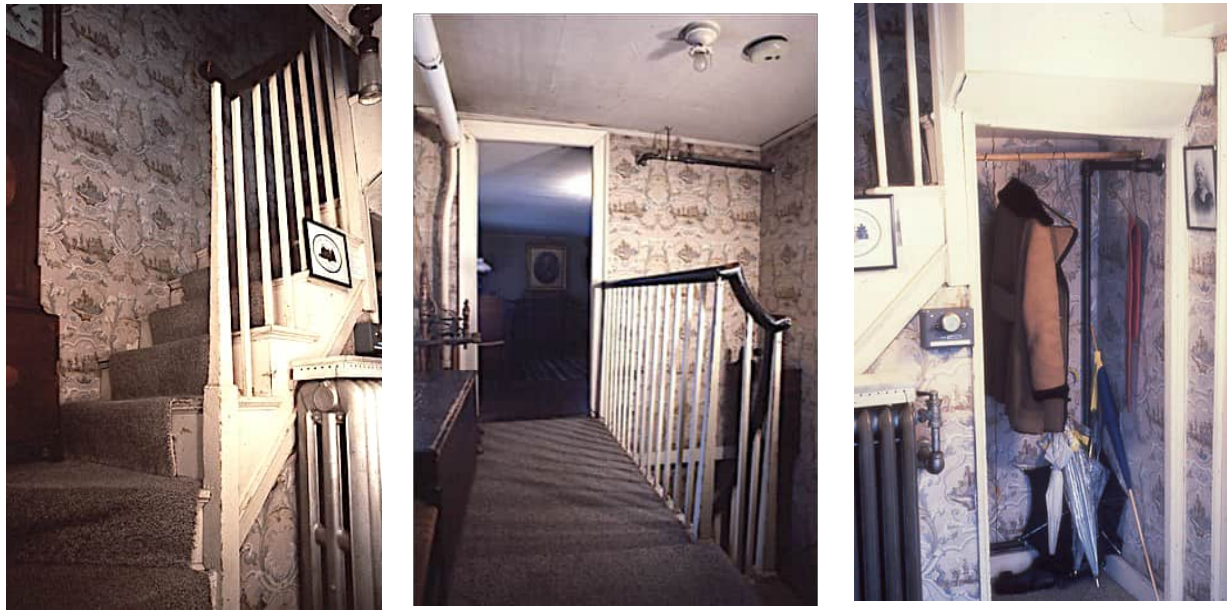
Figure 36. Views of the Phase 2 staircase rising from the ground-floor entry lobby (left) to the second-floor landing (center). A closet opening from the entry lobby was created in the 20<sup>th</sup> century in the former staircase to the cellar). (Courtesy of Historic Northampton, Archives.)

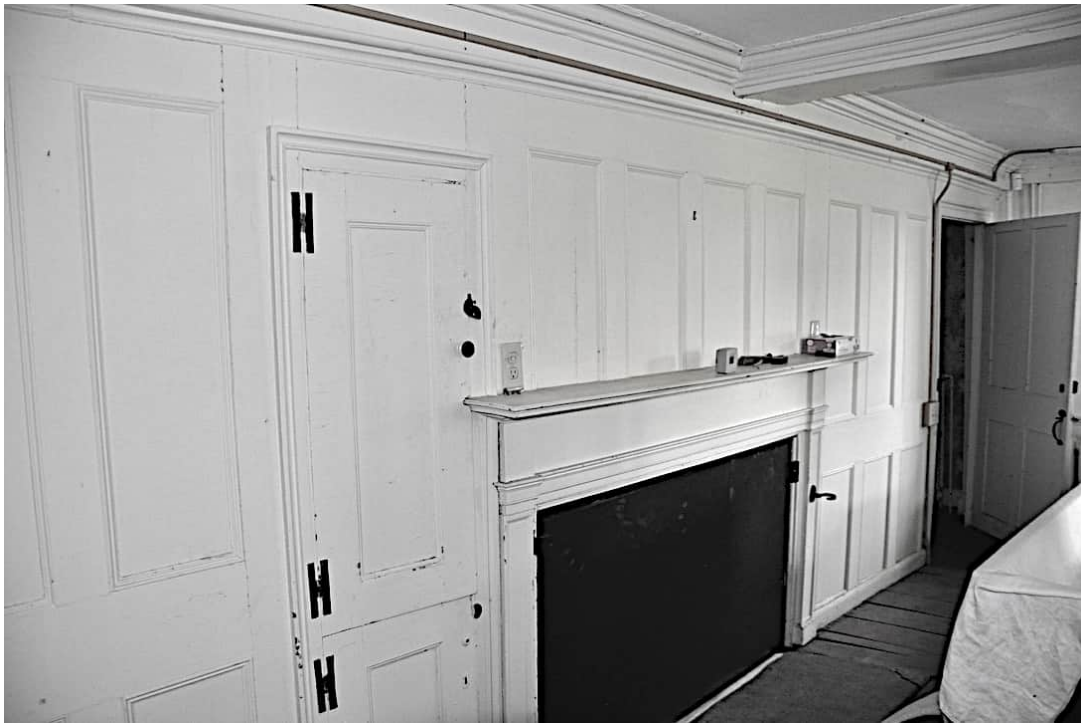
Figure 37. View of Phase 2 chimney breast wall paneling in the parlor (Rm 112). The flat panels and manner of construction of the paneled walls in both the hall/kitchen (Rm 102) and the parlor were identical. (Photograph by Myron O. Stachiw, 2025.)

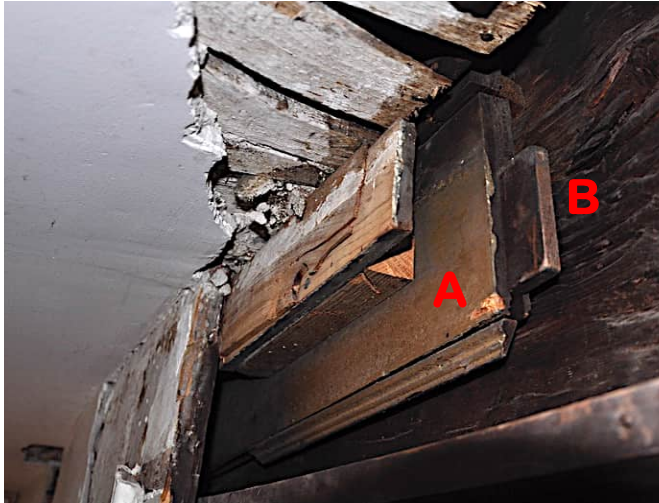
Figure 38.

Top –In the hall/kitchen the top rail **A** of the paneling was fastened to the east face of the uncased chimney girt **B**; in the parlor, the paneling was attached to planks or studs below the cased chimney girt. Note the tenon in the end of the rail. This tenon was mortised to a stile which formed the north edge of the paneled wall.

<sup>83</sup> There are no historic images or descriptions of the Phase 2 paneled chimney breast wall paneling in the hall/kitchen (Rm 102). The paneling was partially dismantled when the firebox was reduced in size during Phase 4 and the present wall was built out over the remains of the Phase 2 paneling. Remnants of the Phase 2 paneling were discovered *in situ* during the 2024-2025 investigation when some lath and plaster were removed from the wall above the current mantelpiece (Figures 38 - top and 38 - bottom).

The paneled chimney breast walls in both the hall/kitchen and parlor were built in the new Federal style with flat panels rather than raised- and fielded panels common in the 18<sup>th</sup> century Georgian style. Another difference was the use of applied moldings to secure the panels within the rabbets cut into the edges of the stiles and rails surrounding each panel, rather than the earlier tradition of these moldings being integral to the stiles and rails. Note the clear evidence of the molding separating from the rail in Figure 38 - top.

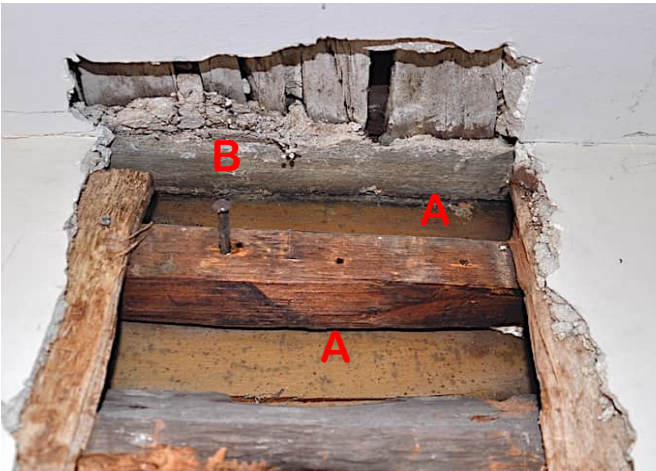
Bottom – Excavation through the built-out Phase 4 chimney breast wall to reveal the yellow-tan top rail **A** of the Phase 2 paneled chimney breast wall in the hall/kitchen (Rm 102). A fragment of the Phase 2 ceiling plaster **B** survived, captured by the Phase 3 build-out of the chimney breast wall when the kitchen function of the room ended, the present mantelpiece was added, and the room was improved for use as a formal dining room. Note that the ceiling plaster butted directly against the paneling rail. (Photographs by Myron O. Stachiw, 2024.)

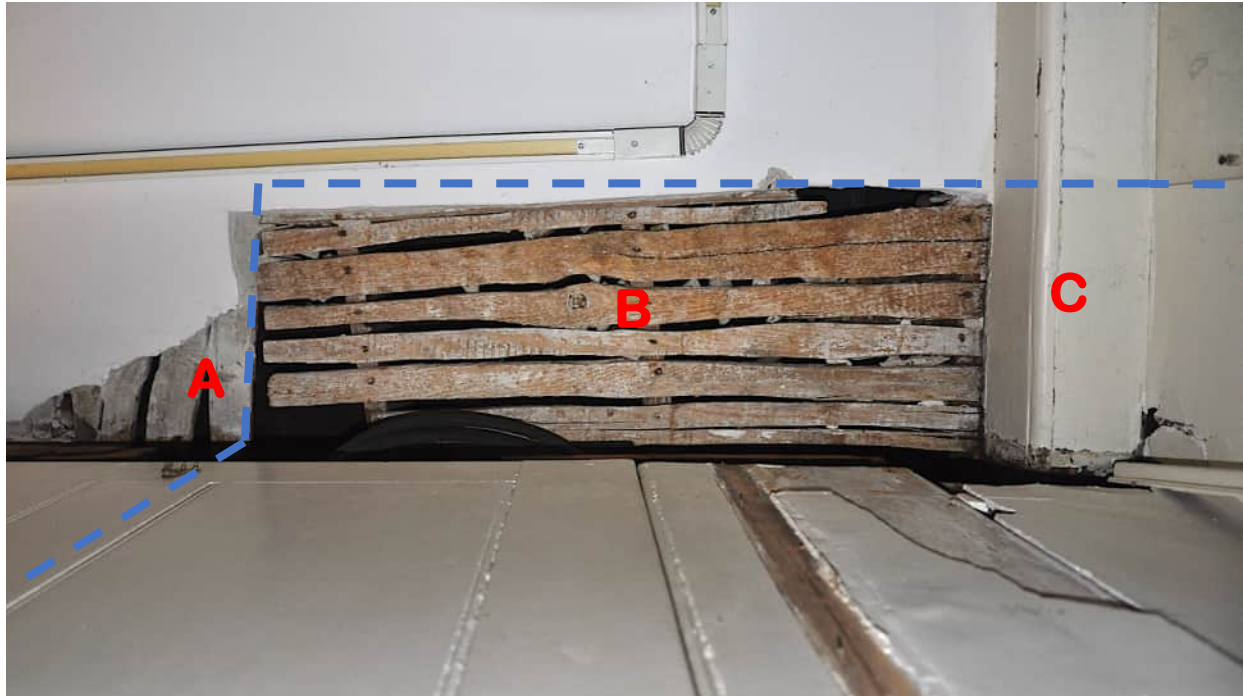
Figure 39. View of the hall/kitchen ceiling in the northwest corner of the room against the west (bottom) and north (right) walls of the room. Plaster has been removed to reveal a patch **B** in the original ceiling lath **A**. Note the original Phase 2 ceiling lath **A** was applied to joists in the ceiling in an east-west orientation, as the joists are oriented north-south. Lath **B** was applied in a north-south orientation to nailers introduced between the existing joists. The lath **A** was applied against the east and south sides of the cupboard (blue dashed lines indicates the outline of the cupboard). **C** is the cased girt on the north wall of the room. The cupboard was removed during the second Federal Period remodeling during Phase 4, which involved a major reconfiguration of the chimney breast wall of this room. This included a partial dismantling and blocking of the bake oven; reduction of the size of the firebox; partial dismantling of the Phase 2 paneled chimney breast wall; erection of a new wall several inches in front of the former paneled wall; construction of a new wall cupboard in front of the former bake oven; and installation of a new mantelpiece. (Photograph by Myron O. Stachiw, 2024.)

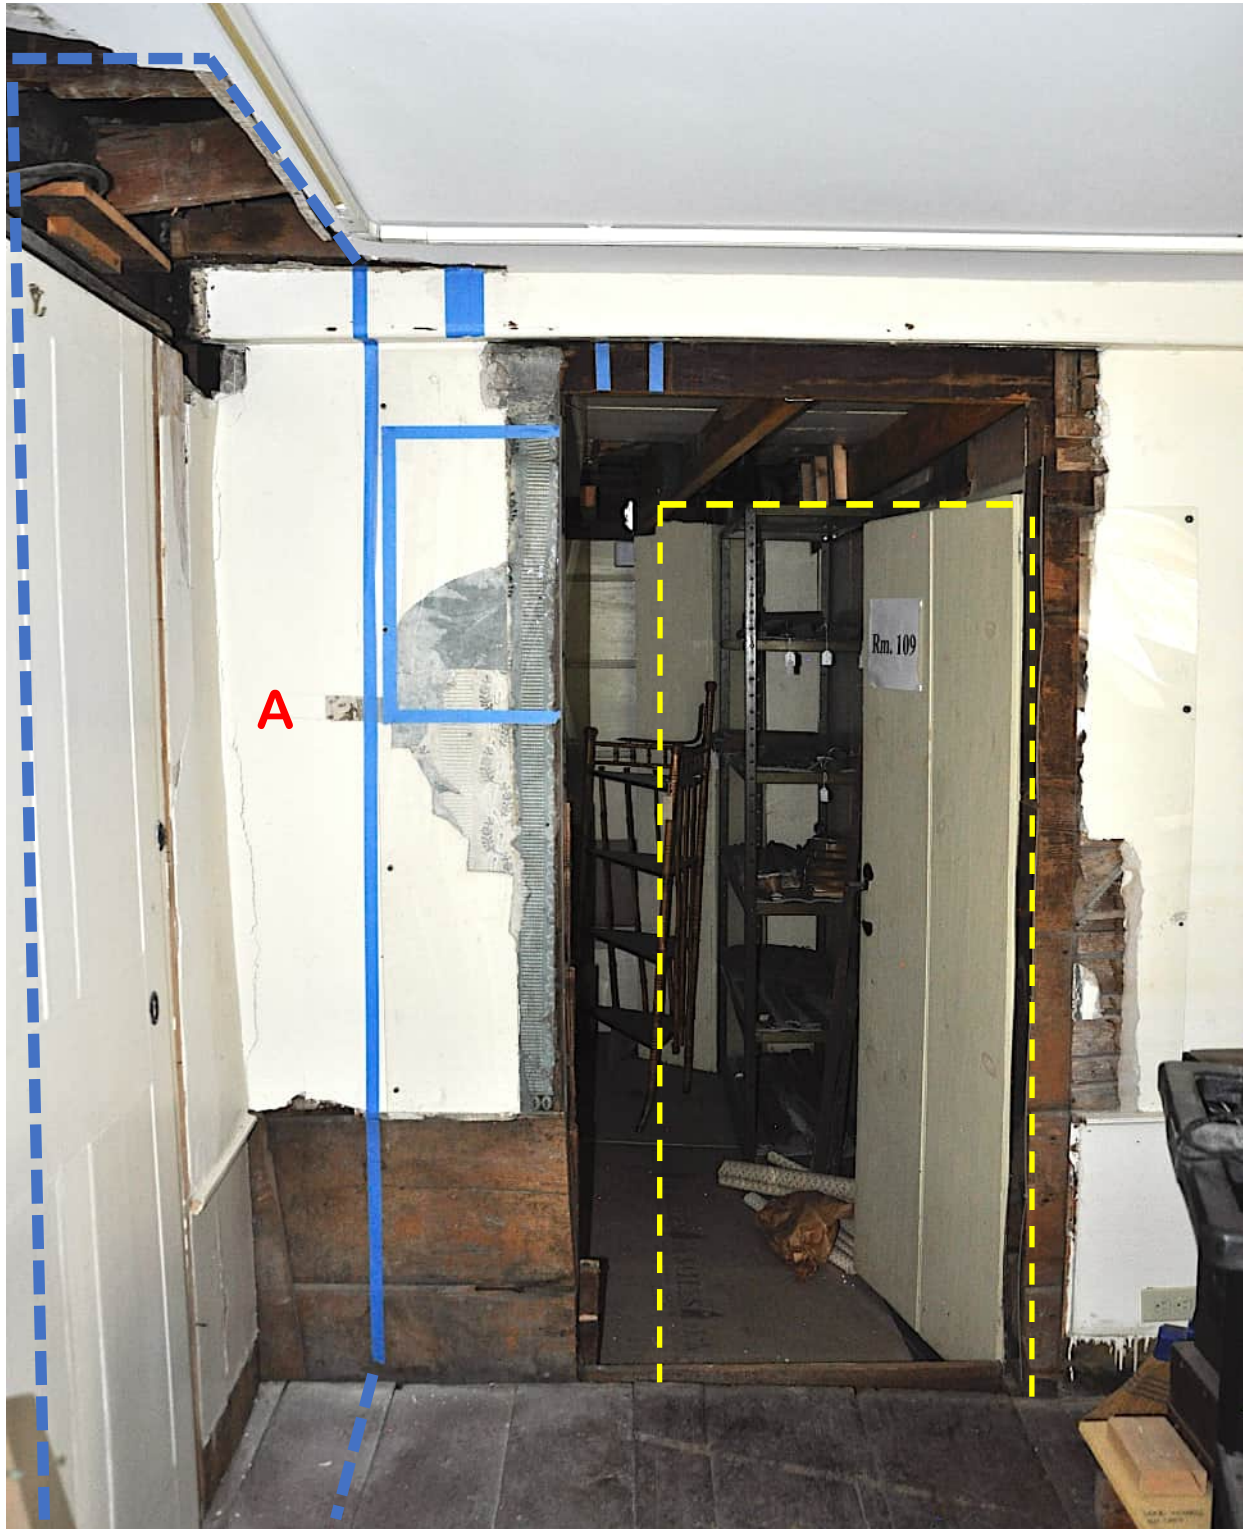
Figure 40. The dashed blue lines and the vertical blue line on the north wall of the hall/kitchen define the space occupied by the former Phase 2 cupboard. See Figure 41 for a detail view of the north wall at **A**. During Phases 1 and 2 the doorway from the hall/kitchen to the Phase 1- and Phase 2 rear lean-tos was smaller, as indicated by the yellow dashed lines. Enlargement of the doorway to its present size occurred during Phase 4. (Photograph by Myron O. Stachiw, 2024.)

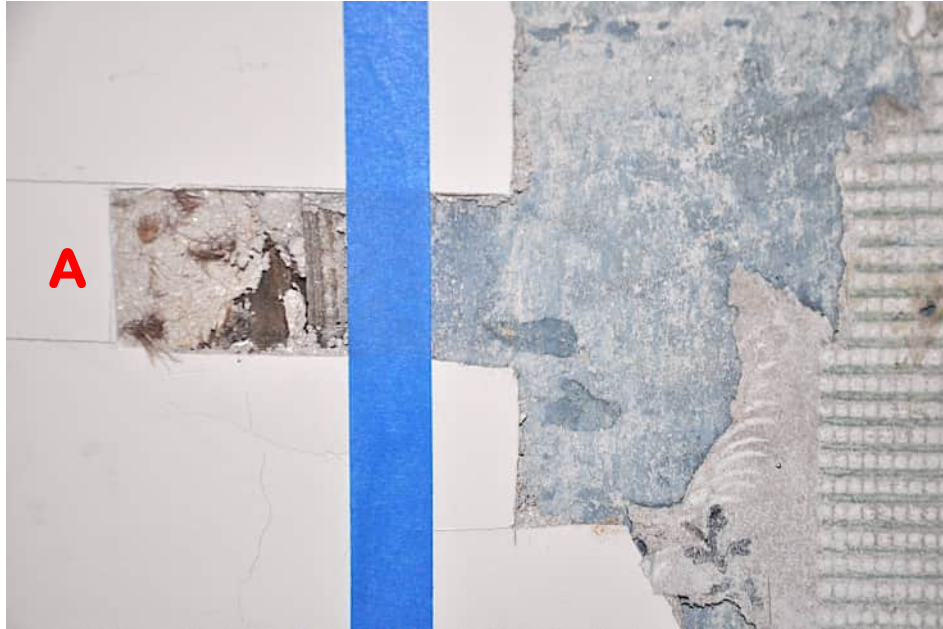
Figure 41. Detail view of the evidence of the former Phase 2 cupboard in Figure Y. The blue vertical line indicates the location of the east (front) face of the cupboard. **A** indicates an area where the Phase 4 plaster was applied to the north wall *after* the cupboard was removed. This plaster was applied over sawn- and split lath applied vertically, whereas the Phase 2 plaster (to the right of the blue line) was applied over horizontally-nailed lath. Note the blue paint and wallpaper to the right on the original Phase 2 wall finish, and the absence of blue paint on the plaster to the left of the blue vertical line. (Photograph by Myron O. Stachiw, 2024.)

A cupboard was built along the north end of the west wall, just beyond the north end of the paneled chimney breast wall and mouth of the bake oven. No physical parts of the cupboard survive, but very clear evidence of its configuration remains on the walls and ceiling of the hall/kitchen (Figures 39, 40, 41).

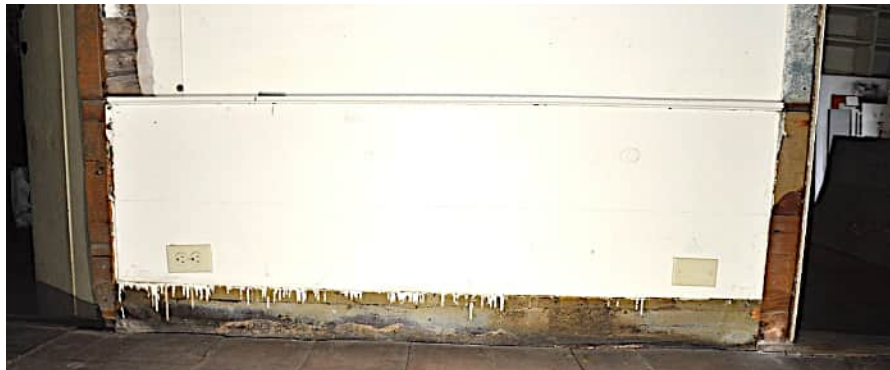
Figure 42. View of the Phase 2 wainscot on the north wall of the hall/kitchen (Rm 102). When first applied the wainscot was decorated with a red-painted mopboard (See Figure 45.) During Phase 3 or 4 a molded baseboard was applied over the painted mopboard. The doorway at left opens onto Rm 109 of the Phase 2 rear lean-to in the same location as the doorway into the Phase 1 lean-to. The Phase 1 horizontal boards on the interior walls of the hall/kitchen are visible after removal of the Phase 4 door architrave on the left doorway to Rm 109. The existing architrave on this doorway was installed during Phase 4 to match the architrave on the new doorway on the right created during Phase 4 after the east addition was constructed. Note that the architrave on the right-hand doorway was applied over the painted Phase 2 wainscoting. (Photograph by Myron O. Stachiw, 2024.)

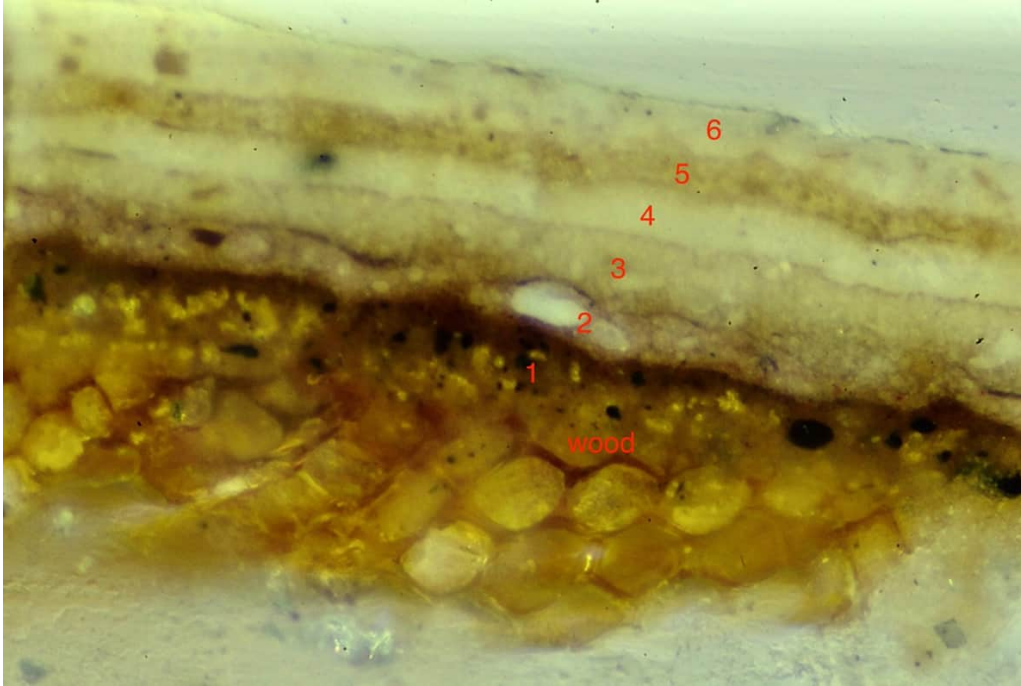
Figure 44. Photomicrograph of paint sample NPH 006 taken from the wainscot on the north wall which was not covered by the door architrave during Phase 3 or early Phase 4. This sample shows 4 layers of the tan yellow, but without any significant dirt line between layers, suggesting that the interval of time between applications was not particularly long. Numerous paint layers were applied after layer 6, but these were stripped in the 3<sup>rd</sup> quarter of the 20<sup>th</sup> century. (Photograph by Christine Thomson.)

Painted woodwork in the hall/kitchen underwent two major phases of paint stripping in the 1950s and 1980s. However, careful examination of the paint layers on the Phase 2 woodwork revealed during building archaeology revealed several painting campaigns undertaken during Phase 2. Figures 43, 44, and 45 show the paint layers applied to the board wainscot on the north wall during the three painting campaigns undertaken during Phase 2. Figure 43 shows the portion of the wainscot covered by the architrave of a doorway created during Phase 3 or early Phase 4. Figure 44 shows the paint layers on the portion of the north wall wainscot not covered by the door architrave. Both show the same first three layers: 1- yellow ochre applied to the bare wood; 2 – lavender brown (Figure 43 shows 2 layers of the lavender brown paint, Figure 44 only one – perhaps the painter missed this spot when applying the second coat– but the two layers represent a single painting campaign, as no dirt line is seen between the layers); 3 –yellow tan, a single painting campaign in two layers of the same paint. Figure 44 shows four layers of the yellow tan (3-6), none of which show a clear dirt line between the layers. The layers above these six were stripped from the wainscot during the mid- 20<sup>th</sup> century.
