# Historic Structures Report

## Nathaniel Parsons House

58 Bridge St.  
Northampton, MA

Prepared by  
Myron O. Stachiw  
April 2026

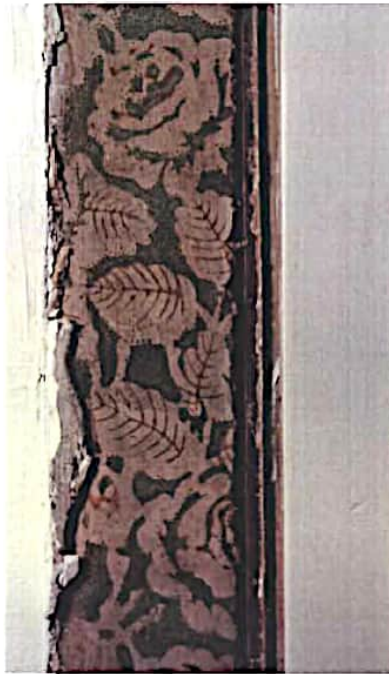
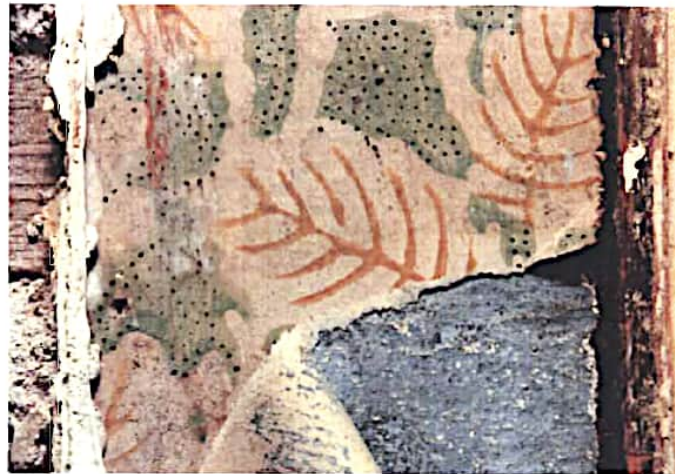
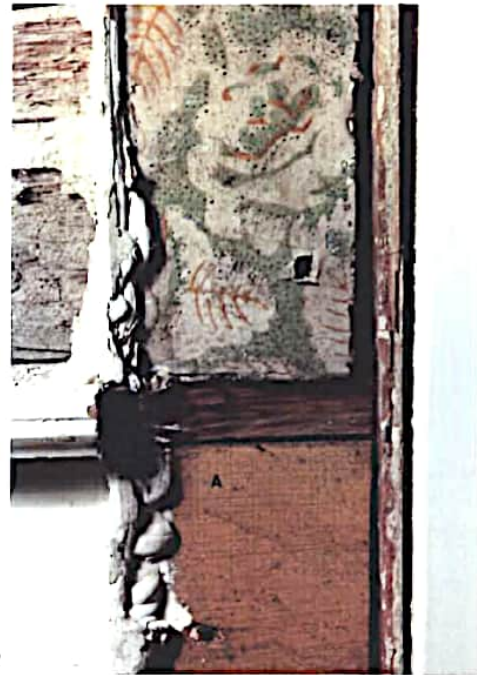
Figure 49. The second-generation wallpaper on the walls of the hall/kitchen was preserved only under the west architrave of the doorway to Rm 104. It is likely that this wallpaper was applied as a complement to the yellow tan paint visible on the wainscot in the above image 102-17, as both the wallpaper and the tan-colored wainscot were covered by the door architrave. This wallpaper was applied late in Phase 2 or during Phase 3, as some of the woodwork in this room has shown as much as four layers of the yellow tan paint. The color swatch provides a close approximation of the original color of the yellow tan paint on the wainscot and other woodwork in this room. This doorway to Room 104 was created during the Phase 4 improvements (Photograph from Clancey and Leeke, 1992.)

It should be noted that during the Federal Period construction- and remodeling campaigns during Phases 2, 3, and 4 these same colors were applied repeatedly in various shades to the plaster and woodwork throughout the house. Note the colors in the wallpaper and on the painted wainscot captured by the Phase 4 door architrave around the doorway between the hall/kitchen (Rm 102) and Rm 104 (Figure 49).

<sup>94</sup> In Figures 40, 41, and 48 only the first-generation blue wallpaper survived and was covered by the new architrave to the enlarged doorway. The second-generation wallpaper found under the architrave to the doorway from Rm 102 to Rm 104 (Figure 49) was apparently removed during the enlargement of the doorway to Rm 109.

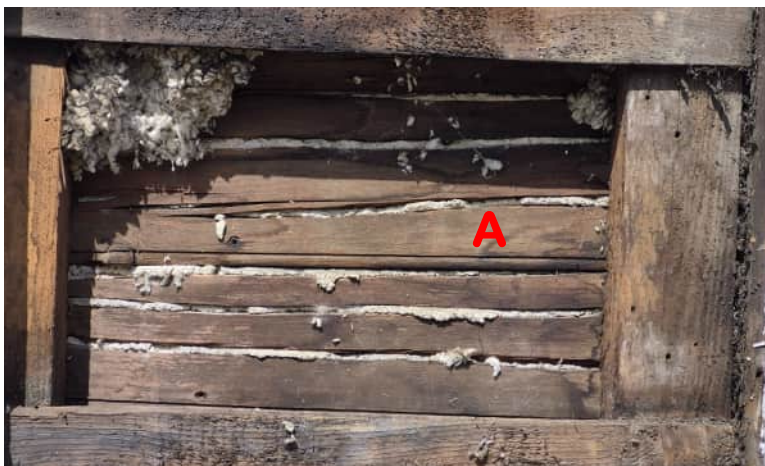
Figure 50.  
View of the exterior south wall of the west parlor between the two existing windows. Removal of an exterior siding board revealed former exterior door- or window trim (A) reused as split lath. Note that the board was planed smooth and a bead had been applied on one edge. (Photograph by Myron O. Stachiw, 2025)

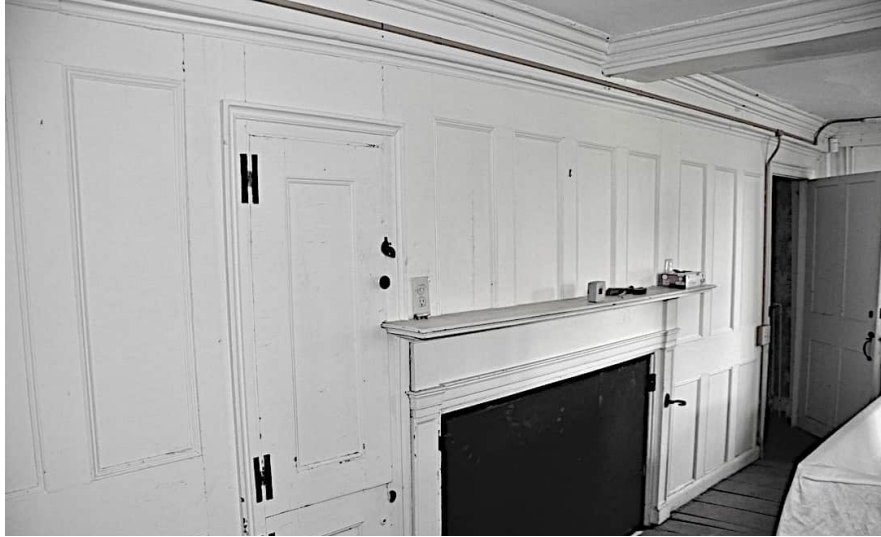
Figure 51. View of the new Phase 2 paneled chimney breast wall applied to the east wall of the parlor. The present mantelpiece was applied during Phase 4. During Phase 2 the firebox was surrounded by bolelection molding. (See Figures 52 and 53 below.) The cavetto with astragal molding (A) at the top of the paneled wall just below the cased girt was also applied at this time. (Photograph by Myron O. Stachiw 2024.)

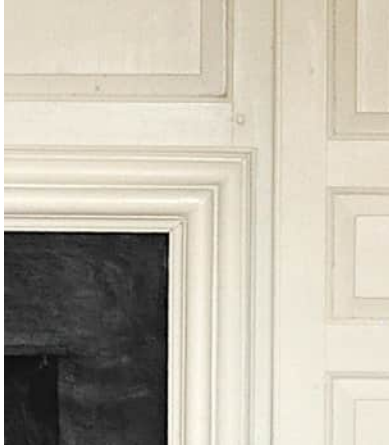
Figure 53.  
Example of a bolection molding fireplace surround. Babson-Alling House, Gloucester, MA. (Photograph by Myron O. Stachiw, 2025.)

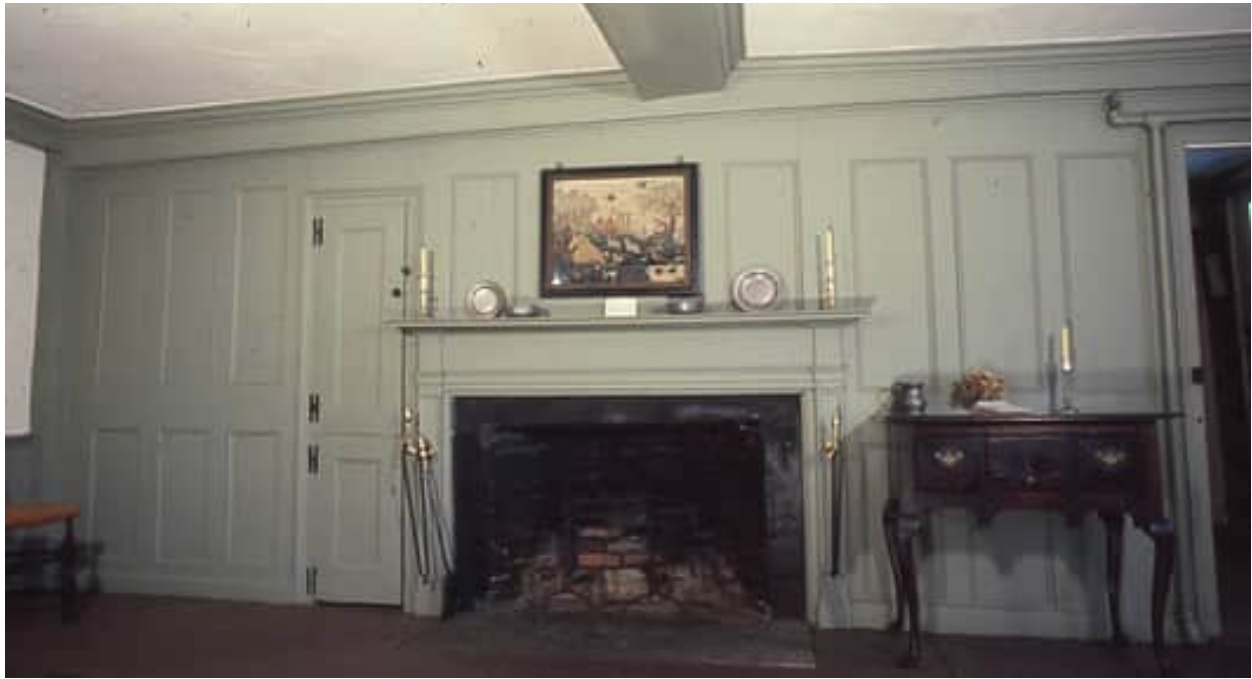
Figure 56. View of the east wall of the parlor, late 20<sup>th</sup> century. By the time the paneled chimney breast wall was constructed in the early 19<sup>th</sup> century the rear (north) sill had suffered significant deterioration as illustrated by the narrowing space between the top of the panels and the bottom of the girt. The paneled chimney breast wall was clearly built to the already settled north wall and cased chimney girt, but no effort was made at that time in the early 19<sup>th</sup> century to raise and level up the frame of the house. (Courtesy of Historic Northampton Archive.)

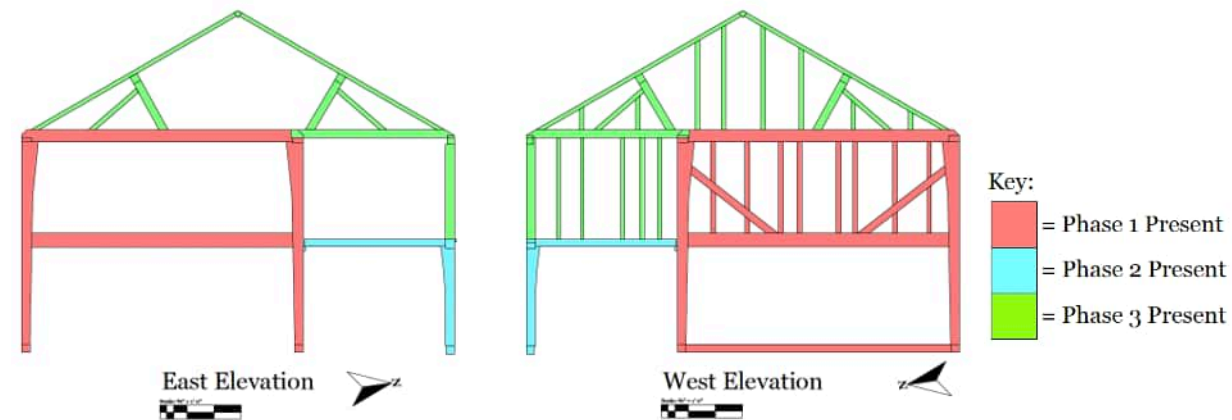
Figure 58. Phase 3, east and west elevations showing the principal framing elements by phase which exist in 2026. Where studs are not drawn indicates that the framing was not accessible in those areas. Where sills are not drawn indicates that they have been replaced since the Phase 3 construction. (Drawing by Nevan Carling.)

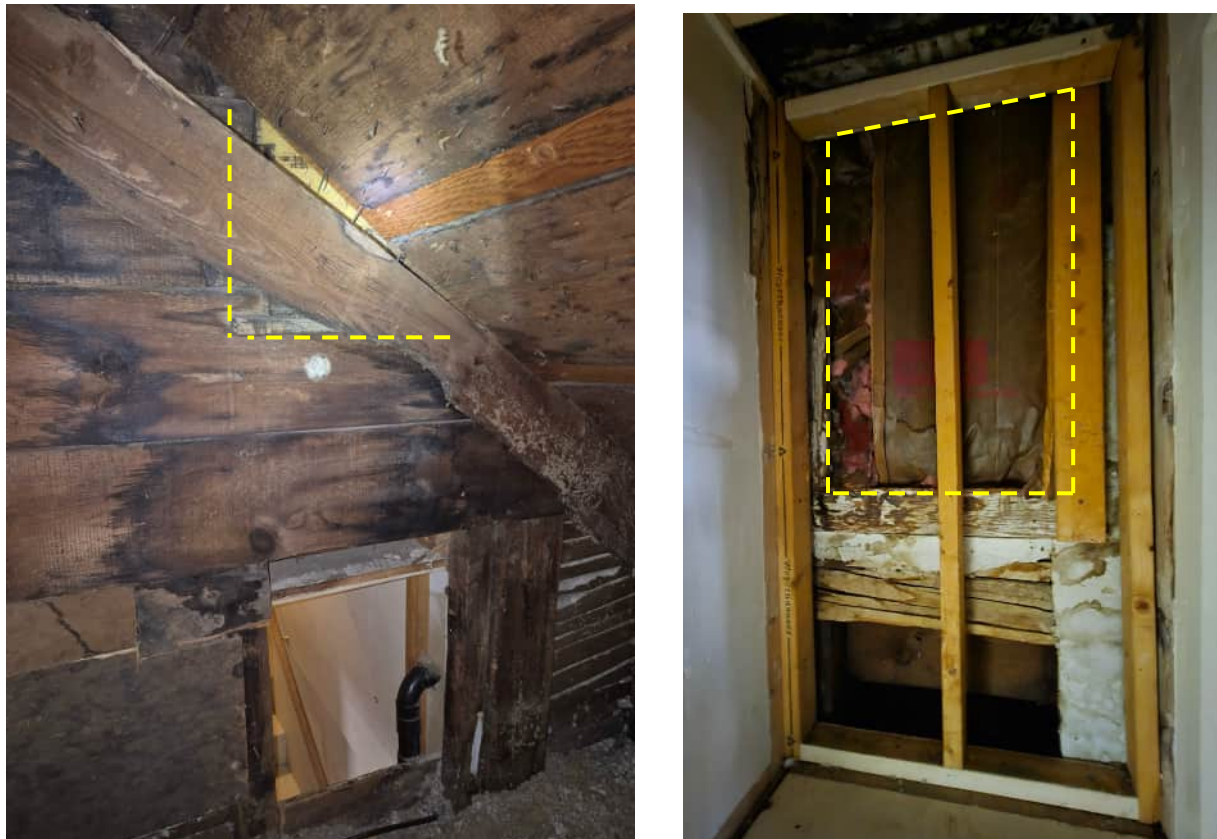
Figure 61. Left – View of the north wall of the Phase 3 raised second-story of the rear pile of the house from the garret of the Phase 5 one-story rear kitchen ell. They yellow dashed lines indicate the location and remains of the window opening and window trim. The opening below the former window is a modern access port to the rear ell garret.

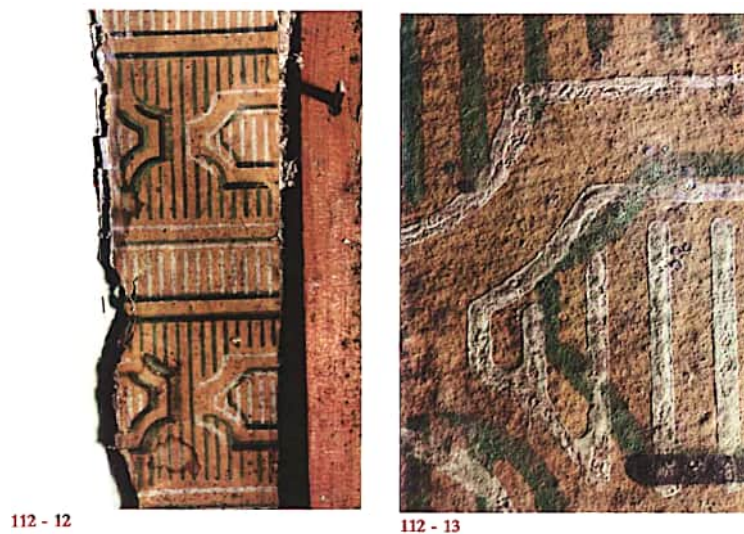
Figure 62.

Detail views of the Phase 3 wallpaper applied over the whitewashed plaster walls of the west parlor.

During the 1992 SPNEA investigation wallpaper was discovered *in situ* on the west wall of Rm 112 beneath the south architrave stile of the doorway to the new Phase 4 west wing. This doorway was created during the construction of the west wing, so it is clear that the wallpaper was applied to the wall prior to the commencement of the Phase 4 construction of the west wing in 1822 (Figure 62).

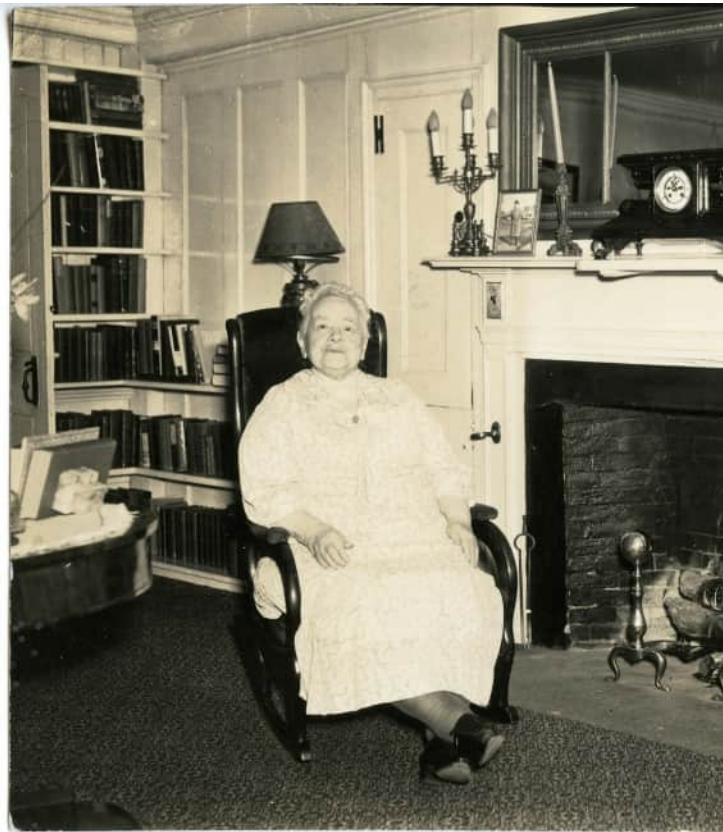
Figure 66.

View of the parlor (Rm 112) c.1940 with Anna Bliss. The bookcase in the corner behind Anna Bliss extending along the north and east walls occupies the same approximate space as the Phase 3-4 cupboard. The bookcase seen in the photograph was removed in the late 1980s. (Photograph courtesy of Historic Northampton.)

A photograph of the northeast corner of the parlor c.1940 shows a bookcase built against the north and east walls in the same location as the earlier cupboard (Figure 66).

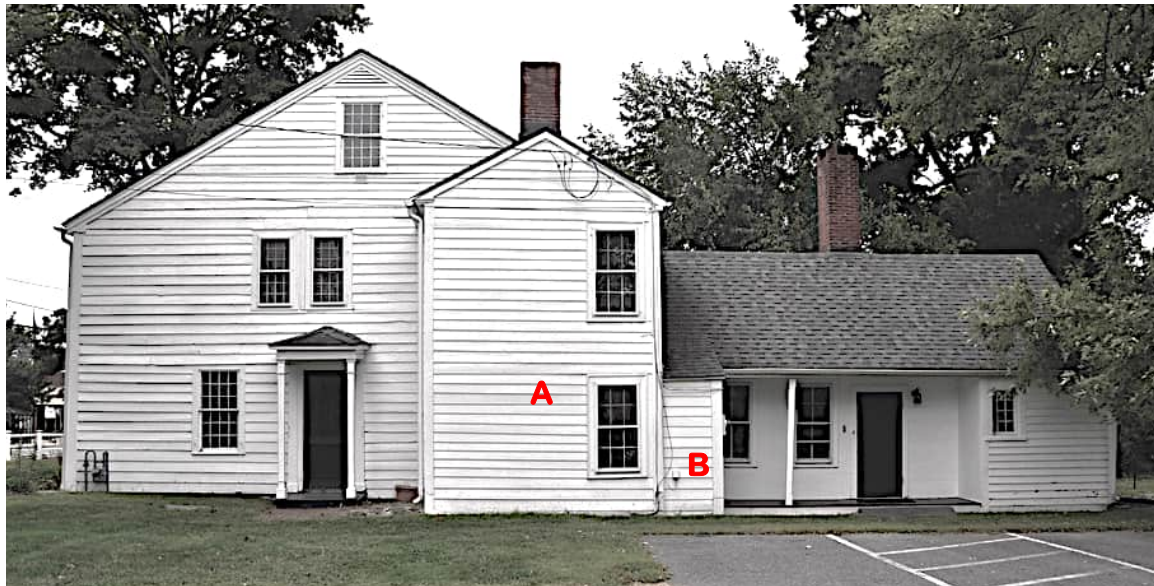
Figure 70.  
Above - View of the east elevation of the Parsons House, looking to the southwest. The Phase 4 two-story east wing is in the center (marked **A**), and the surviving section of the Phase 5 rear kitchen ell is at right. **B** represents an added cupboard on the north wall of Rm 104.

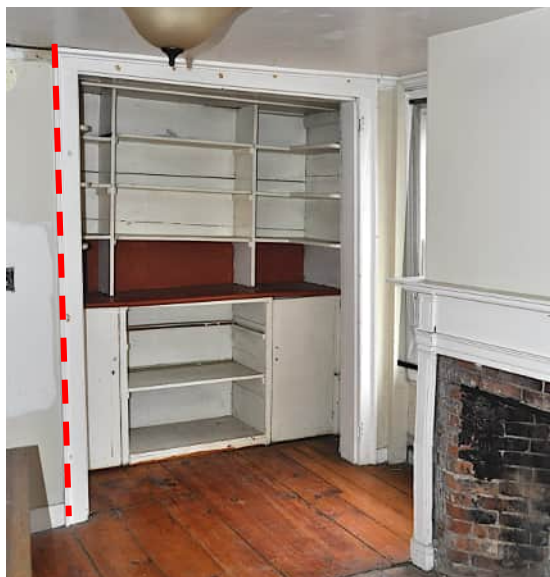
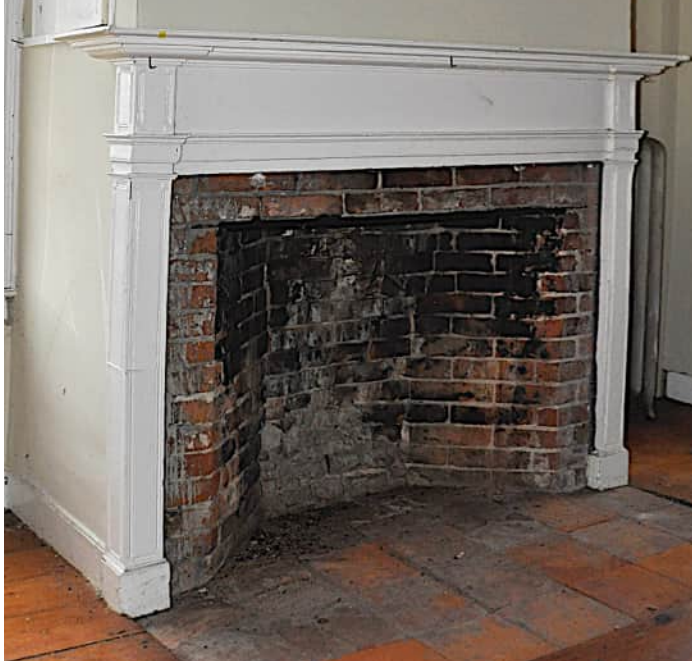
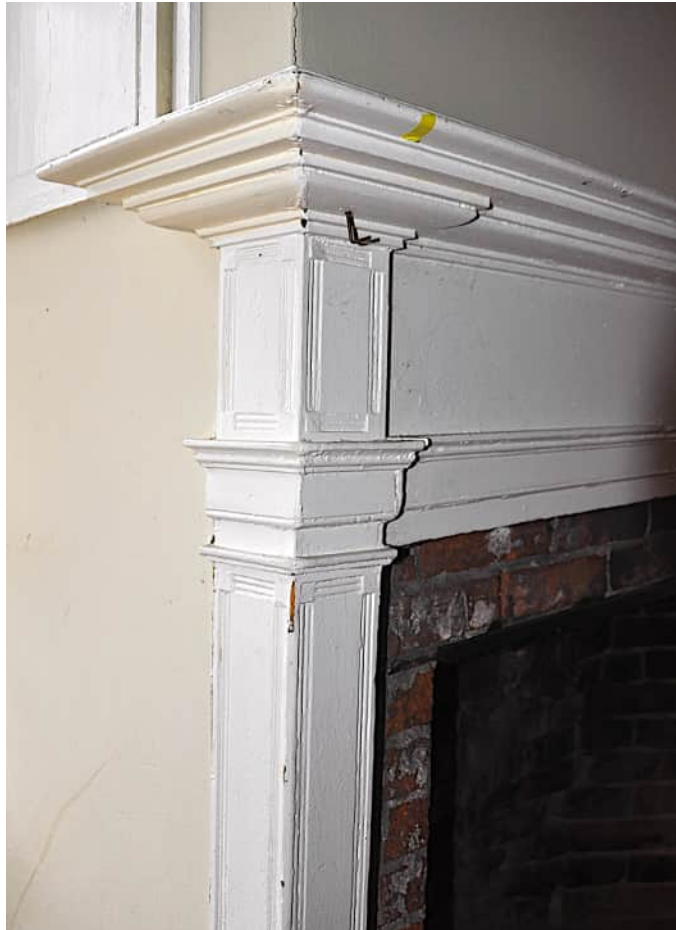
Figure 71.

Left - View of the cupboard on the north wall of Rm 104. The red dashed line indicates the location of the Phase 2 and 3 northeast corner post of the house and the location of the Phase 2 and 3 east wall. Originally double doors closed off the cupboard from Rm 104. Note the very clear settling of the cupboard shelves above the counter to the right or east, a result of settling due to deteriorated sills. The counter below the shelves was raised several inches at its east end, likely during the 20<sup>th</sup> century, to provide a level countertop. It has not been determined during this study whether the cupboard was erected during Phase 4 or during Phase 5 when the adjacent kitchen wing was constructed (Photographs by Myron O. Stachiw, 2024.)

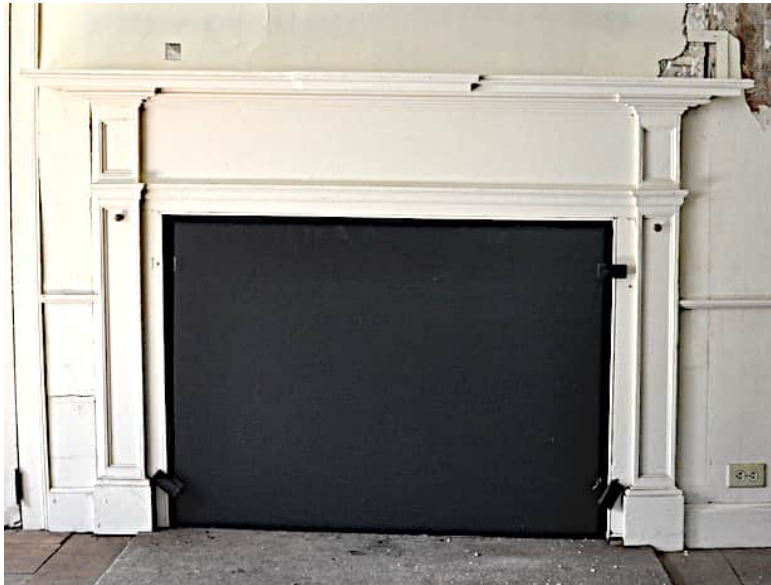
Figure 72.  
Left, above and below -  
Two views of the Phase 4  
mantelpiece applied in the  
former hall/kitchen Rm 102.  
Photographs by Myron O.  
Stachiw, 2024.)

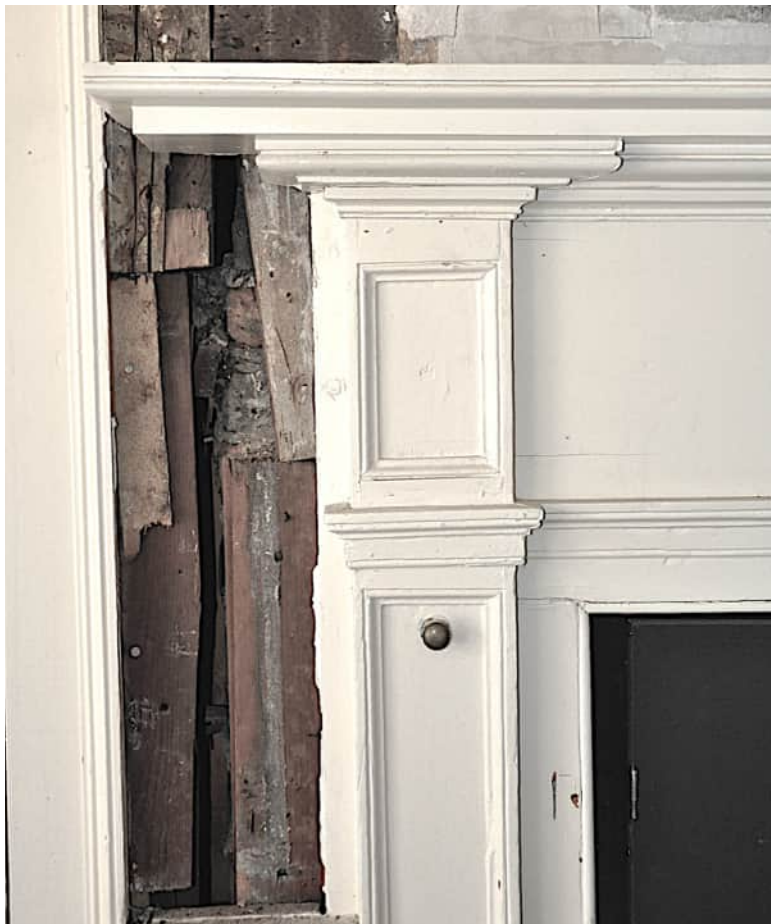
Figure 73  
View of the Phase 4  
mantelpiece applied to the east  
wall of the parlor (Rm 112).  
This mantelpiece replaced a  
Phase 3 fireplace surround  
composed of bold bolection  
molding (see Figures 48, 49).  
(Photograph by Myron O.  
Stachiw, 2024.)

Phase 4 alterations in the parlor were relatively minor cosmetic changes, triggered by the construction of the west wing in 1822. In terms of physical changes, the most noticeable was the replacement of the Phase 2 bolection molding fireplace surround with a stylish Federal Period mantelpiece (Figures 52, 53, 73). The new mantelpiece received as its first painted finish a tan orange paint which was also applied on the paneled chimney breast wall, wainscot, and most other woodwork in the room. This tan orange paint was the first layer applied to the door architrave in the west wall which was created to provide access to the new west wing (Rm 111), thus linking the construction of the west wing to the installation of the new mantelpiece in the parlor (Figures 73, 75).

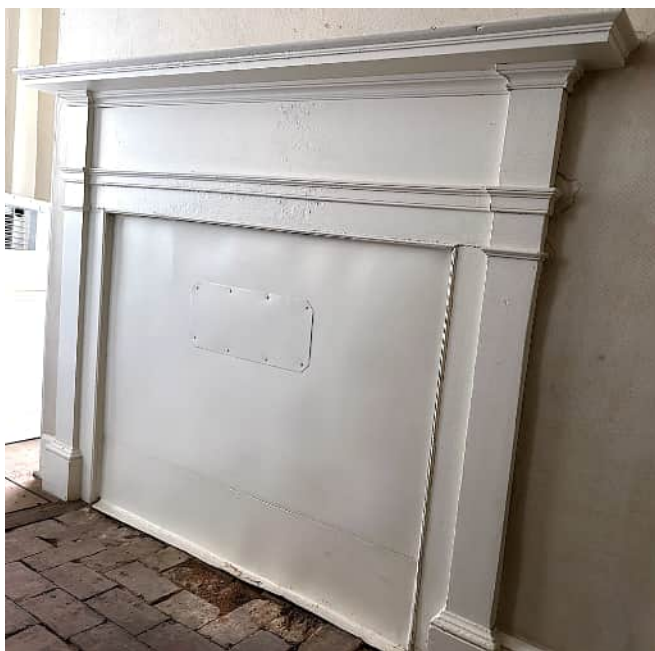
Figure 74.  
Mantelpiece installed in Rm 111 in the west  
wing during Phase 4. (Photograph by Laurie  
Sanders, 2026.)

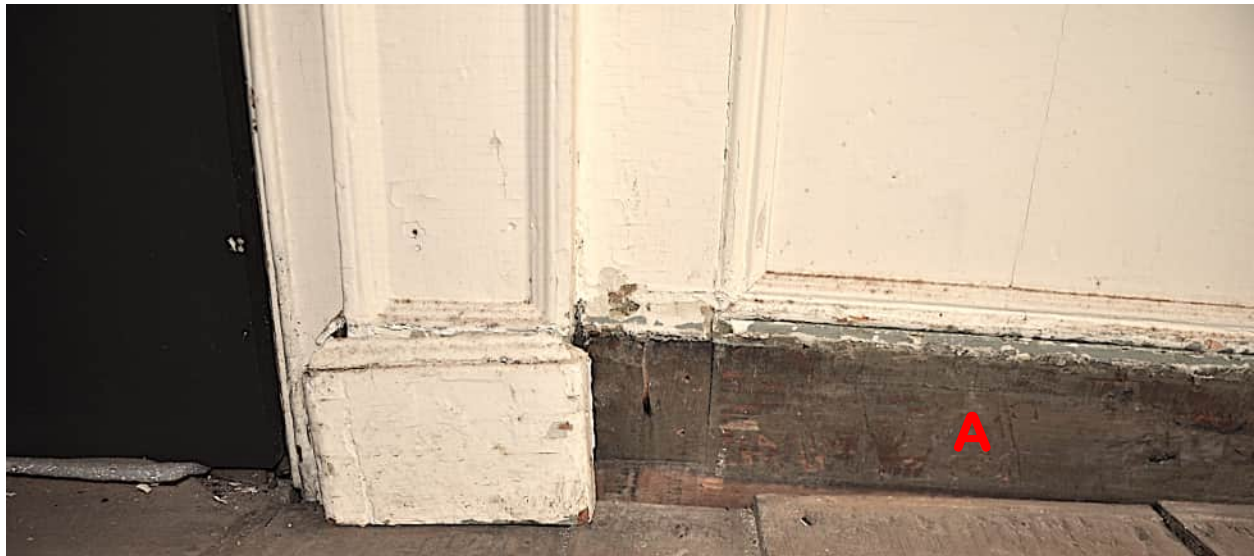
Figure 76. Detail view of the lower edge of the chimney breast paneling in Rm 112 after removal of the applied Phase 4 baseboard. **A** indicates the Phase 2 dark brown painted mopboard on the lower end of the rails and stiles of the paneled wall. The same painted mopboard was also found on the wainscot on the other walls in Rm 112. (Photograph by Myron O. Stachiw, 2024.)

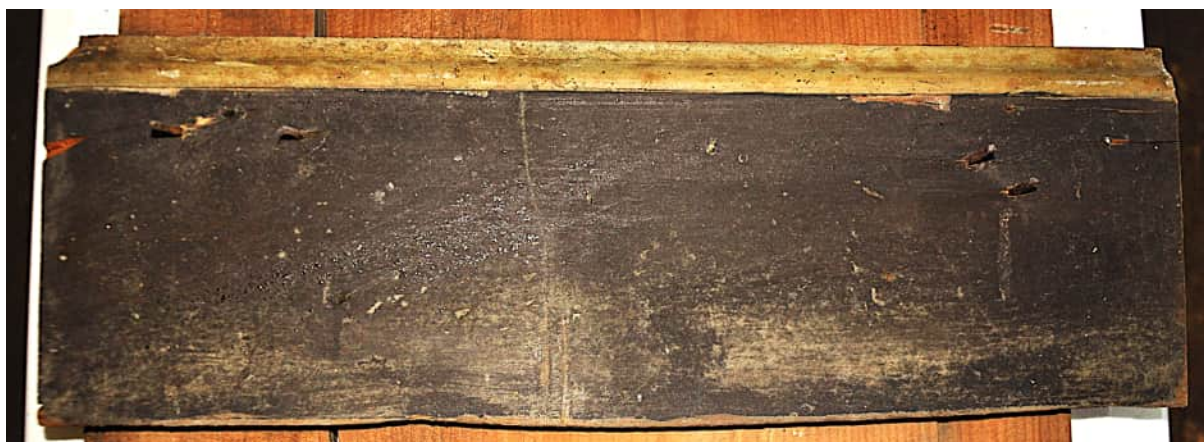
Figure 77. Reused polychrome baseboard fragment found in Rm 102. This same combination of light and dark paints on the baseboard was found in several rooms in the house applied over the earlier painted mopboards. (Photograph by Myron O. Stachiw, 2024.)

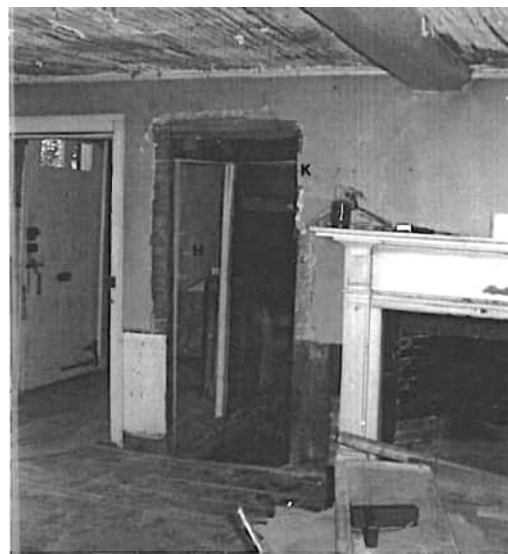
Figure 79. Left – Drawing of the Phase 4 chimney breast wall in Rm 102 after the cellar stairs were relocated to the southwest corner of Rm 110 during the Phase 4 remodeling. At that time the former door opening was lathed and plastered. Note the settling in the floor from left to right in both the drawing and photograph as indicated by the level of the ceiling and the fireplace mantelpiece. (Drawing from Clancey and Leeke, 1992.)

Right – view of the chimney breast wall of Rm 102 during the 1980s restoration. Cellar stairs to the new cellar under Rm 102 were built and the former doorway to the west cellar, closed-in and covered with lath and plaster during Phase 4, was reopened and reconstructed. During this project ceiling plaster was removed, but the lath was left in place and covered with sheetrock. (Photograph from Clancey and Leeke, 1992.)

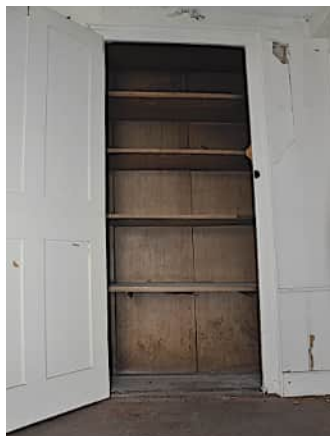
Figure 80.

Above - View of the west wall of the former hall/kitchen with Phase 4 changes (A, B, C, D) and the 1981 reconstruction of the Phases 1 – 3 doorway to the staircase to the west cellar E.<sup>93</sup> A is the new Federal Style mantelpiece applied during Phase 4; B is the doorway to the new Phase 4 cupboard; C and the red dashed lines) mark the location of the partially-dismantled Phase 2-3 bake oven, no longer needed when this room was repurposed as a formal dining room. D and blue dashed lines mark the location of the Phase 2-3 cupboard, dismantled during the Phase 4 remodeling. The area within the green dashed lines mark the new lathed and plastered wall which was built out during Phase 4 in front of the partially-dismantled Phase 2 paneled chimney breast wall. This new wall terminated at the north wall approximately three inches out from the original Phase 2 wall. (Photographs by Myron O. Stachiw, 2024.)

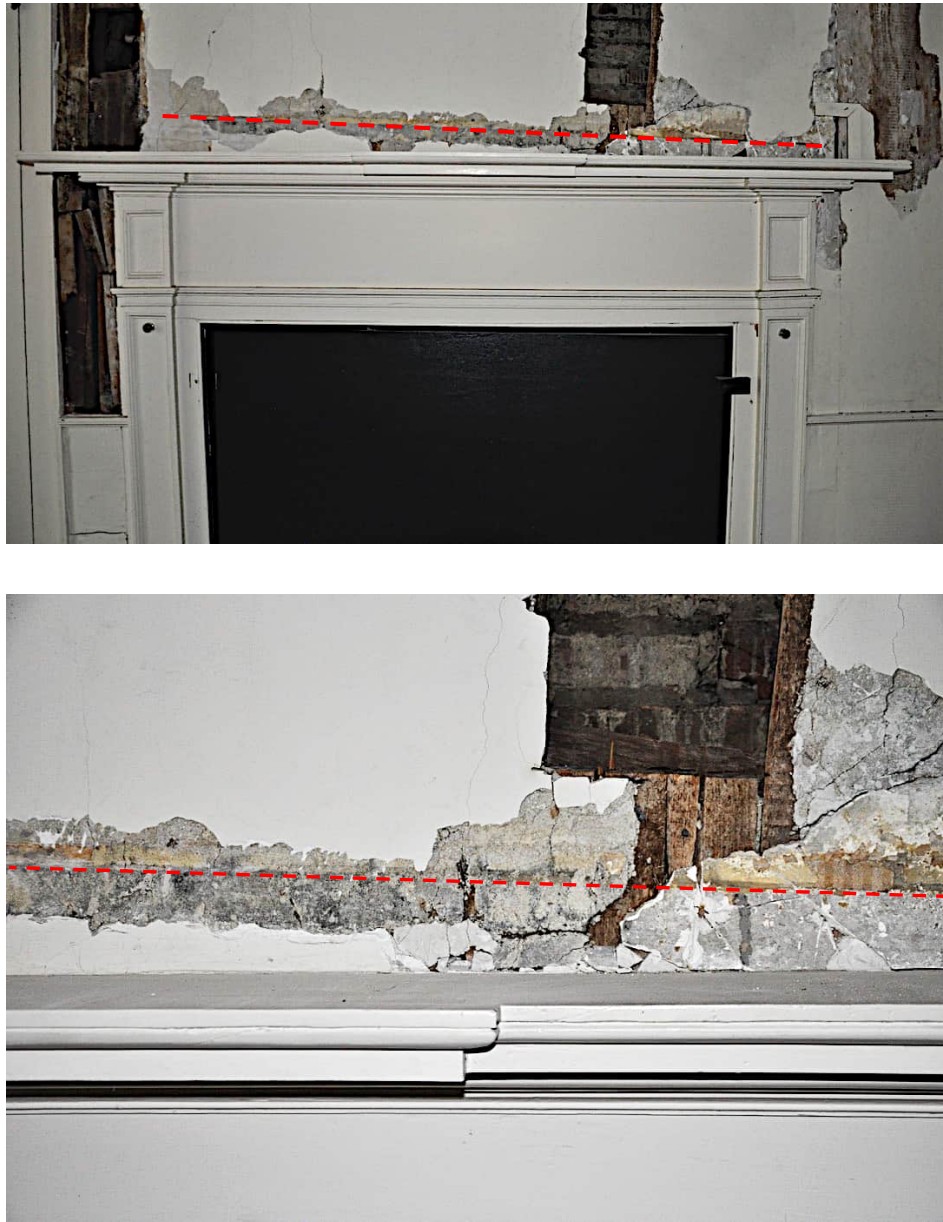
Figure 82. Top – View of the expanded excavation through the plaster above the mantelpiece in Rm 102 undertaken to reveal the full extent of the overmantel decorative painting. The red dashed line indicates the degree of settling which occurred since the early-mid 19<sup>th</sup> century due to the deterioration of the north sill of the house. The mantelpiece had settled with the walls and floor, but during the 1981 renovations, which included leveling the floor in this room, the mantelpiece was removed and reapplied over the newly-leveled floor and fireplace hearth.

Bottom – Detail of the painted overmantel decoration. The central portion of the plaster above the mantel shelf did not reveal any paint, suggesting that only a border was painted around a rectangular element – a mirror, a painting, or a wallpaper mural. Later in the 19<sup>th</sup>- and 20<sup>th</sup> centuries numerous layers of wallpaper were applied and removed, finally covering the old plaster in 1981 with a new plaster skim coat. (Photographs by Myron O. Stachiw, 2024.)

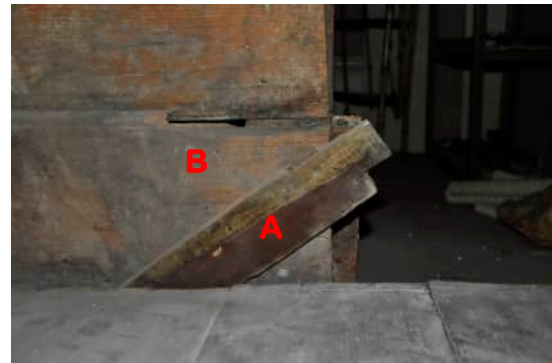
Figure 84.

Above left – view looking down at the floor at the west edge of the doorway from Rm 102 to Rm 109. **B** marks the lowest Phase 1 sheathing board which was cut when the doorway was enlarged during Phase 4 (**B** in Figure 83). **A** marks the Phase 2 wainscot which was left in place when the upper section was cut away at the time the doorway was enlarged. Note that the right edge of the cut-off wainscot board **A** stops about 2 inches short of the edge of **B** at the Phase 1 door opening. This indicates the width of the architrave which surrounded the door opening during Phases 1-3.

At the time of the Phase 4 remodeling and floor leveling, the lower portion of the Rm 102 walls was covered by board wainscoting applied during Phase 2. Building archaeology in 2024 revealed a surviving lower portion of the wainscoting below the present level of the floor, still attached to a stud at its west end. The Phase 2-3 wainscot on the west side of the smaller doorway, which extended from the west edge of the doorway to the Phase 2-3 cupboard on the west wall, was cut back after the floor was leveled and removed, leaving the section below floor level in place (Figure 84).

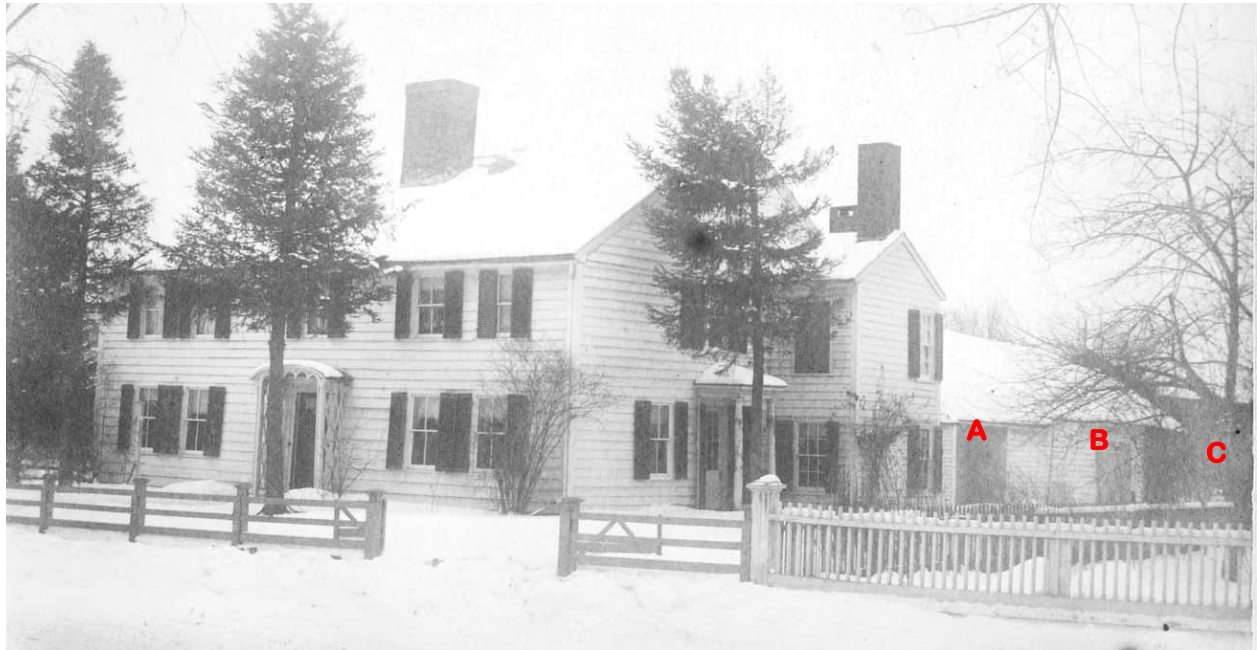
Figure 88. View of the house looking northwest from Bridge Street, c.1882. This is one of only two photographs which show the full extent of the buildings comprising the rear kitchen ell. **A** indicates the one-story two-room kitchen ell; **B** indicates the one-story woodshed; **C** indicates a slightly taller, unpainted structure attached to the north end of the woodshed, likely a barn/stable. (Historic Northampton Archives.)

The final major construction carried out on the Parsons House during the 19<sup>th</sup> century was the erection of the one-story rear kitchen ell and attached one-story woodshed and barn/stable (Figures 88, 89, 90).

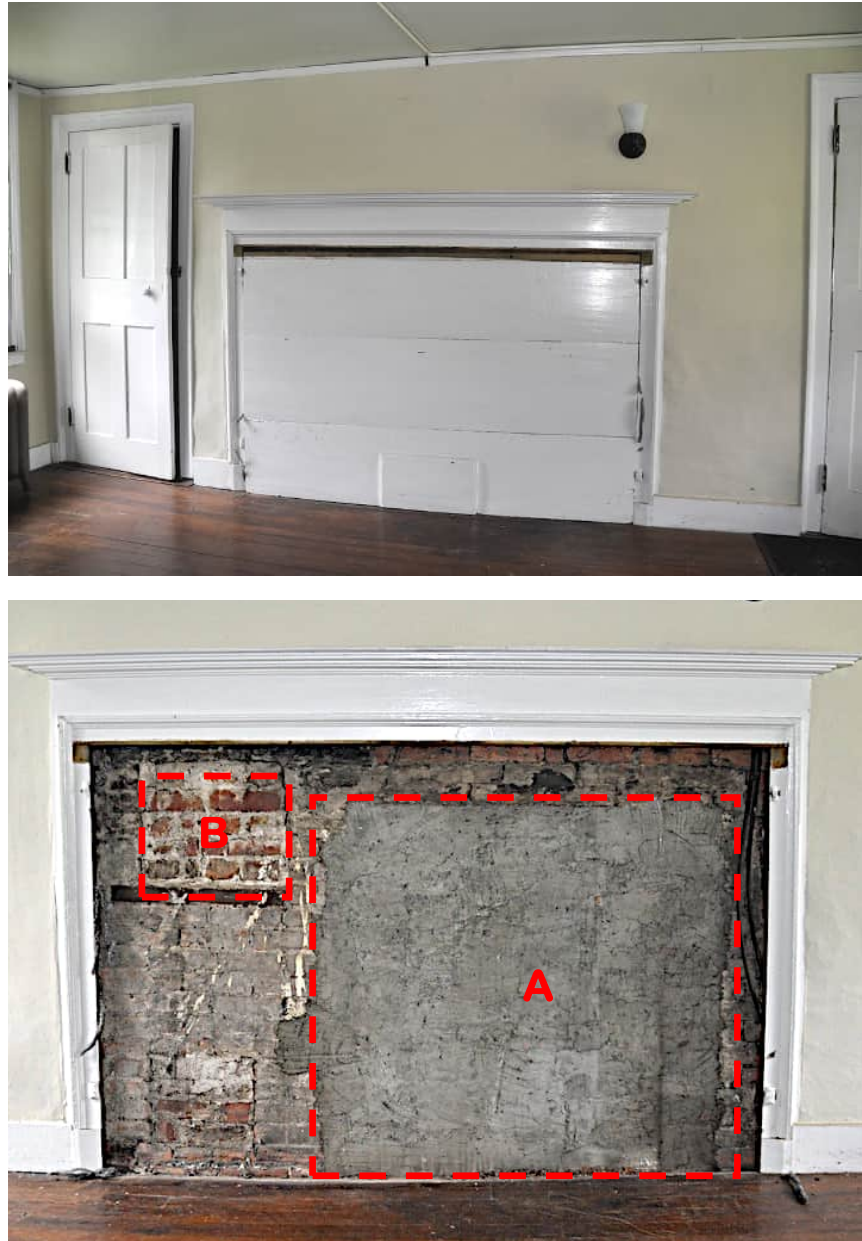
Figure 91. Two views of the rear ell kitchen fireplace in the north wall of Rm 107. The use of the fireplace **A** and bake oven **B** were discontinued during the second half of the 19<sup>th</sup> century when a cast iron cook stove was installed. The fireplace- and bake oven openings were likely sealed with bricks and mortar during the 20<sup>th</sup> century. Behind the doorway to the left of the fireplace is a small pantry with a pass-through opening in the north wall to Rm 107. (Photographs by Myron O. Stachiw, 2024.)

The construction of the rear kitchen wing was likely the last major remodeling project undertaken before the death of Ferdinand Hunt Wright in 1842. The primary kitchen activity was moved to Rm 105 in the rear ell, where a large cooking fireplace and bake oven were constructed opening into Rm 105 (Figure 91).

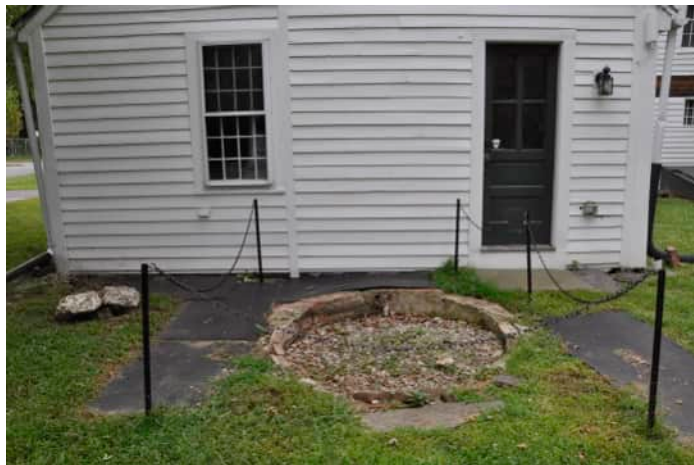
Figure 92.

View of the north wall of the rear kitchen ell, 2025. The one-story rear woodshed which was attached to the north end of the kitchen wing was removed in the late 19<sup>th</sup> or early 20<sup>th</sup> century. Later in the 20<sup>th</sup> century a small, one-room lean-to was built onto the north wall of the rear ell, covering the brick cistern. This lean-to, referred to as a “mud room”, was removed in 2016, and the existence of the former cistern was discovered. (Photograph by Myron O. Stachiw, 2024.)

Remains of a brick cistern just north of the existing kitchen wing structure suggests that there may have been a water pump in Rm 107 or in the woodshed connected to the cistern (Figure 92).

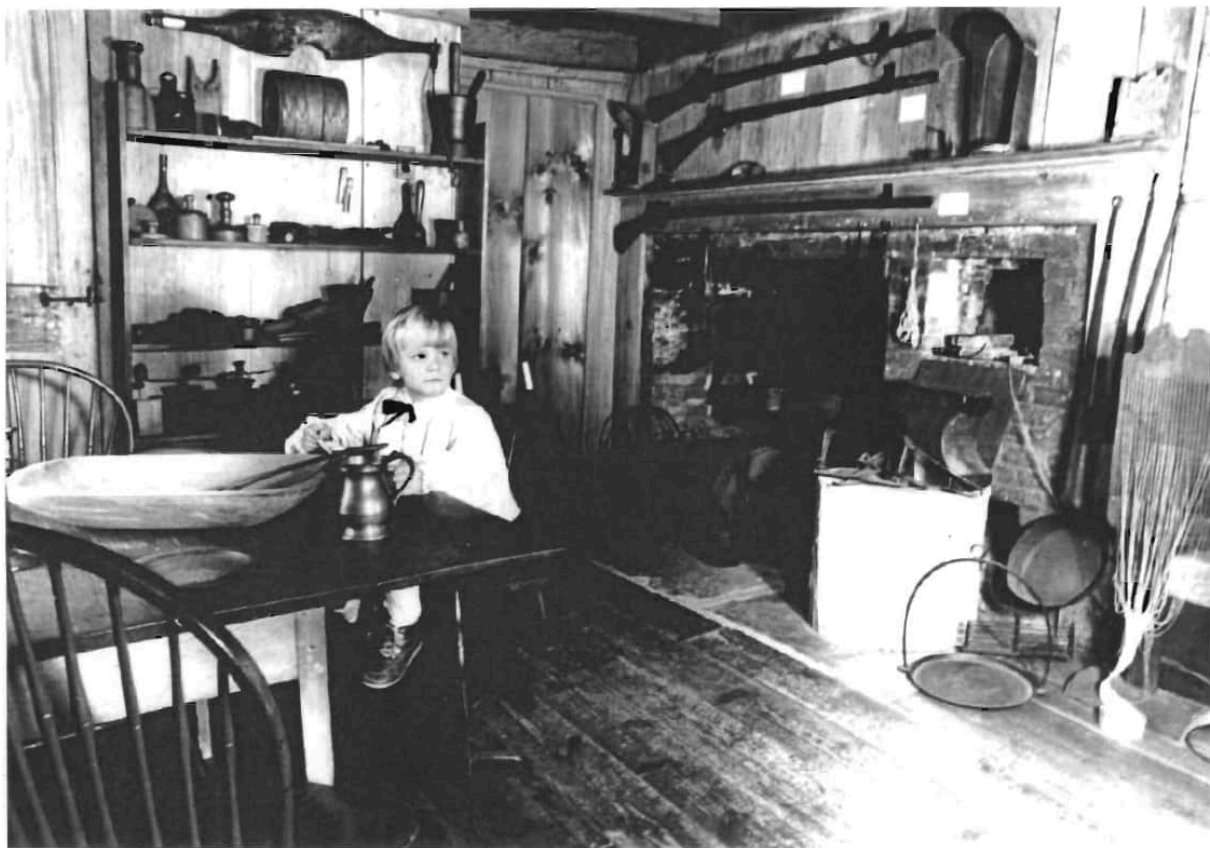
(Photographs from Clancey and Leeke, 1992.)

Bottom – View towards the southeast corner of Rm 109 showing the rear lean-to kitchen fireplace and bake oven. The mantelpiece and the boards above it were part of the 1953 "restoration".
