# ANNOTATED PHOTOTOGRAPHS & ILLUSTRATIVE SITE PLANS SHEPHERD HOUSE

66 BRIDGE STREET, NORTHAMPTON, MASS. 01060

NORTHAMPTON HISTORICAL SOCIETY

**Menke & Menke**

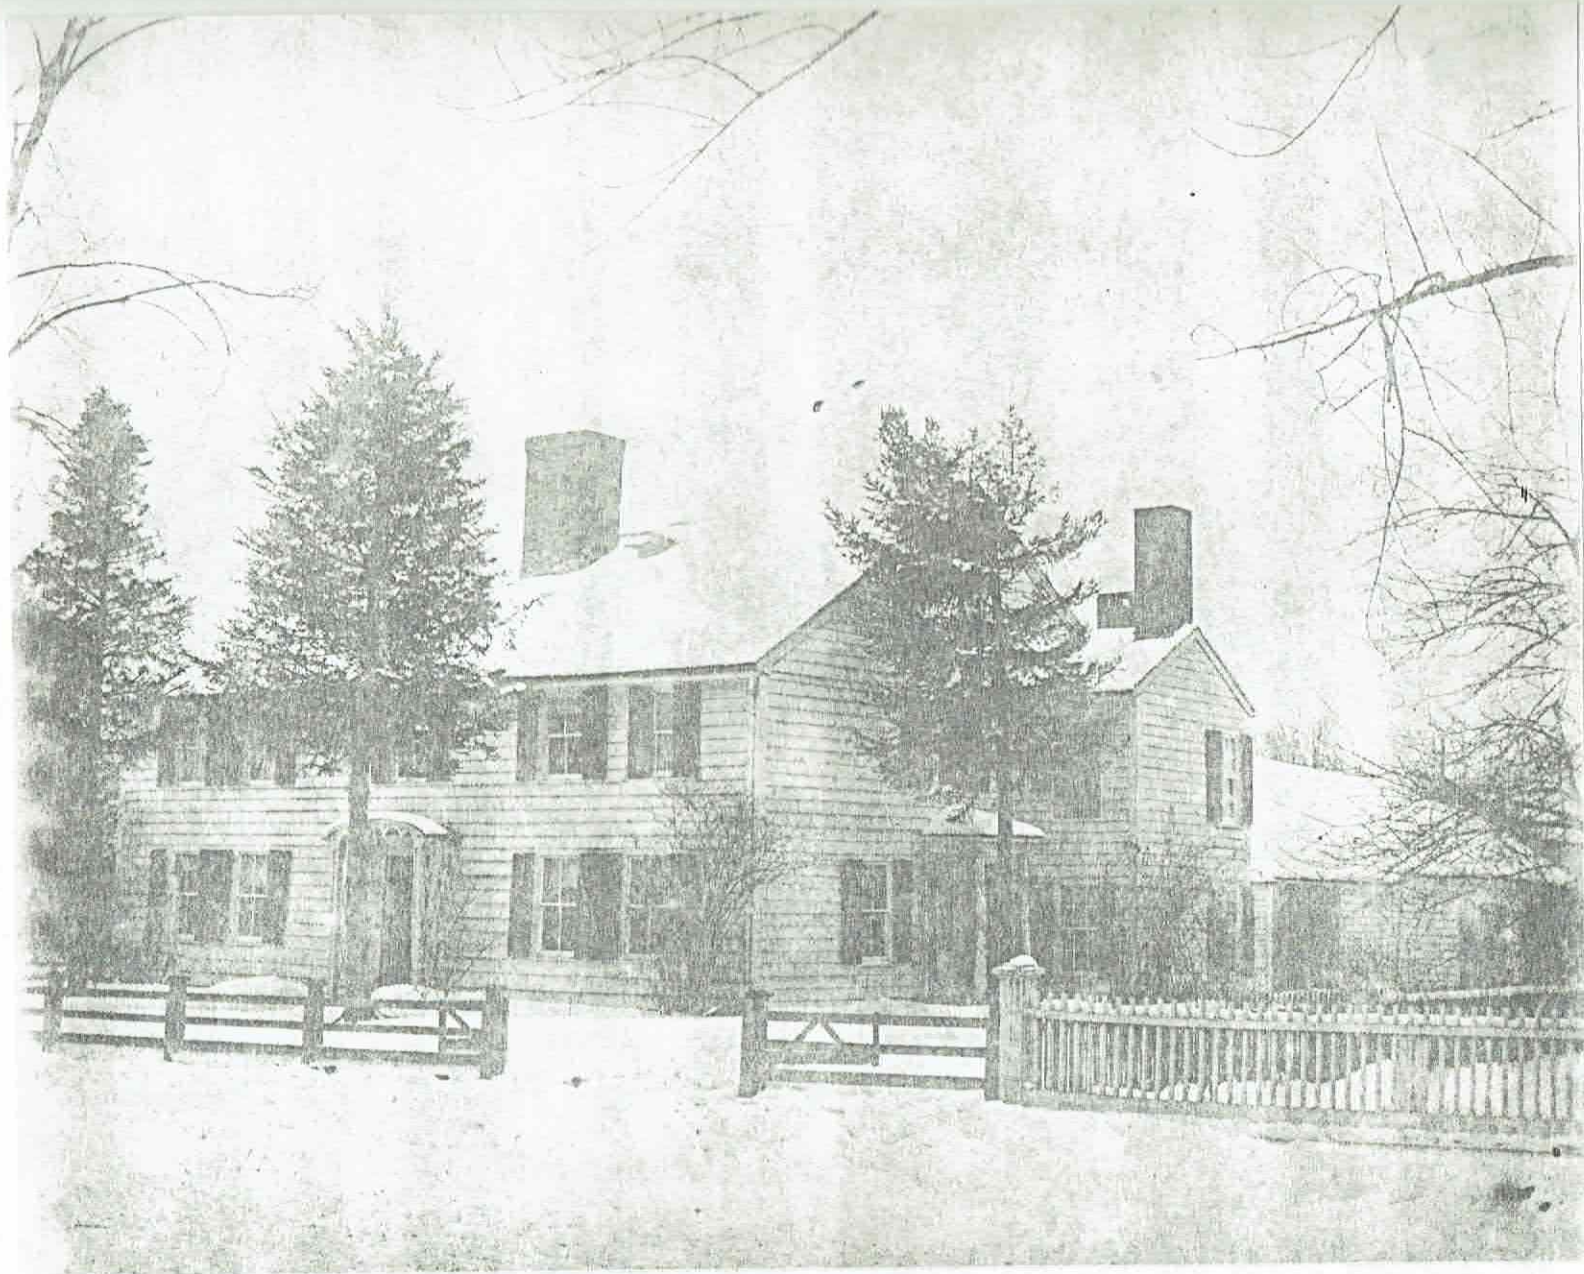
Photograph circa 1890-1900, Homestead View Company, 155 State Street, Springfield, Mass. Note end of Shepherd white picket fence at post, beginning of Parsons rail fence, while a third fence (low Stockade) separates the two properties. [Note also the 19th Century porch at the Parsons House].

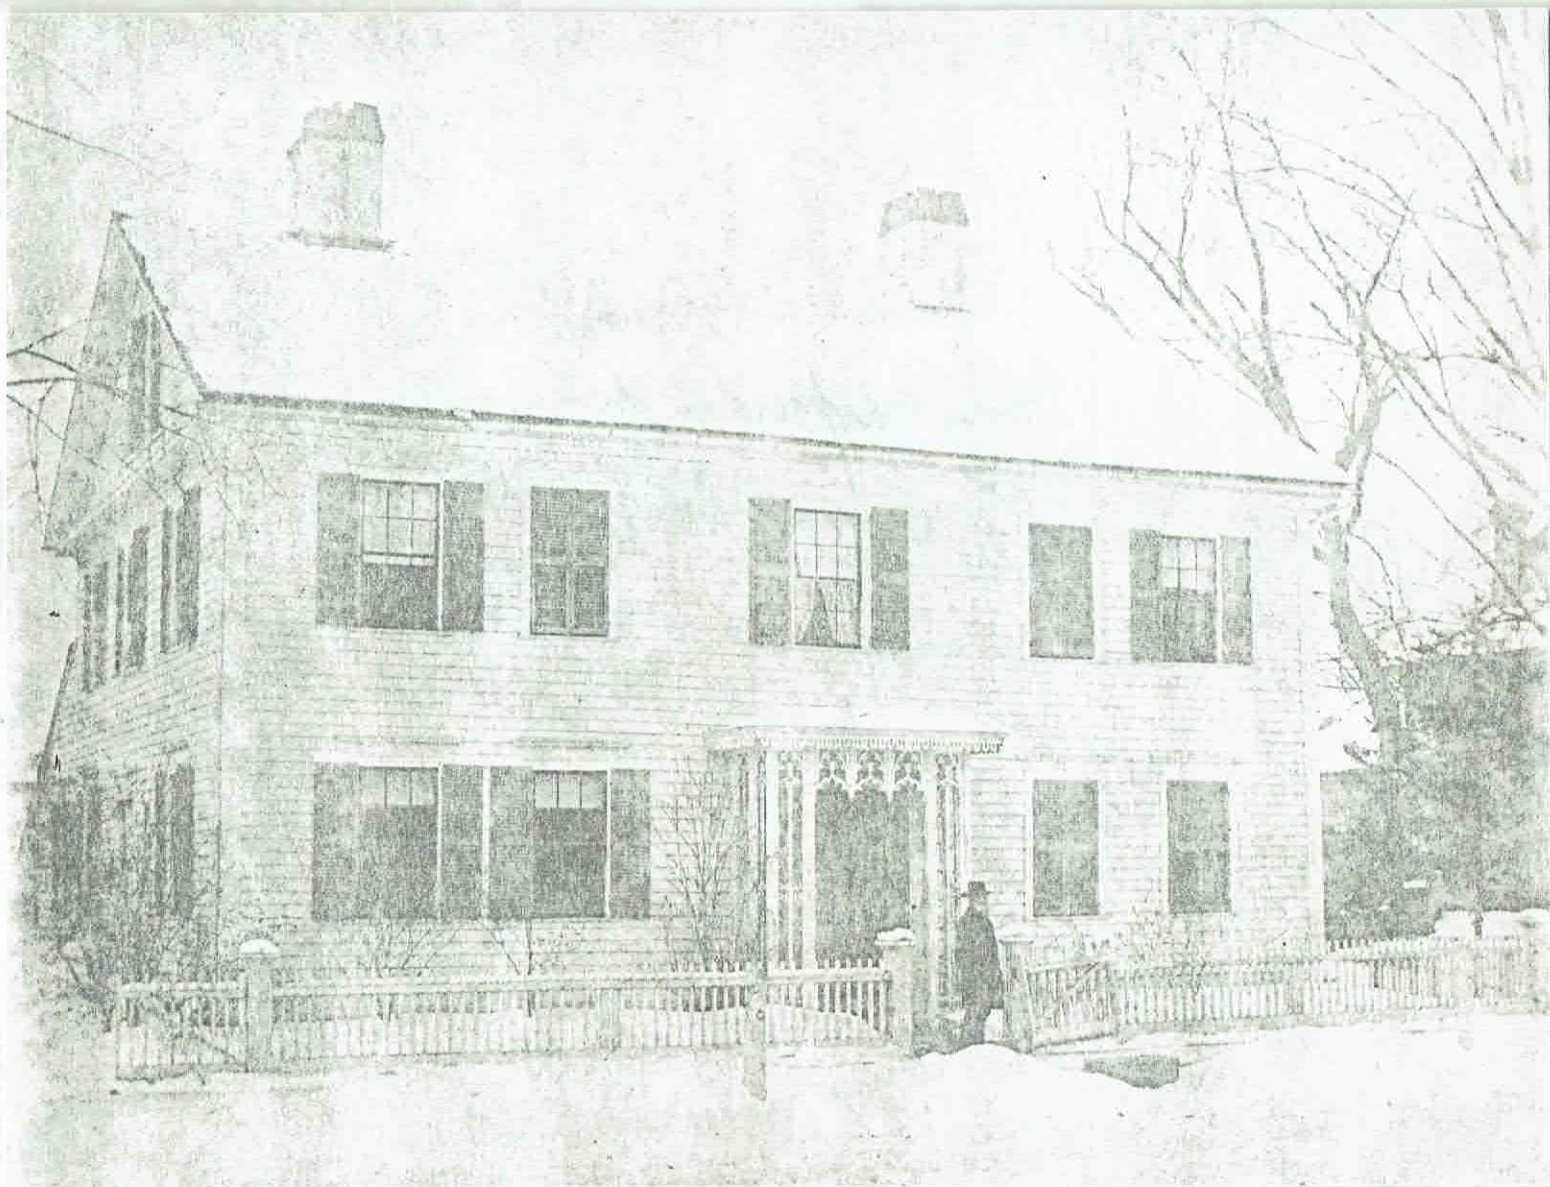
Photograph circa 1895 of Shepherd House. Picket fencing and gates enclose the property at the sidewalk line. Posts are at gates and ends, while intermediate support is provided by stone supports behind the fence line. Note also the lack of the side porch, deciduous plantings at the front and side, stone hitching posts and stairs at the street edge. [Henry Shepherd in doorway].

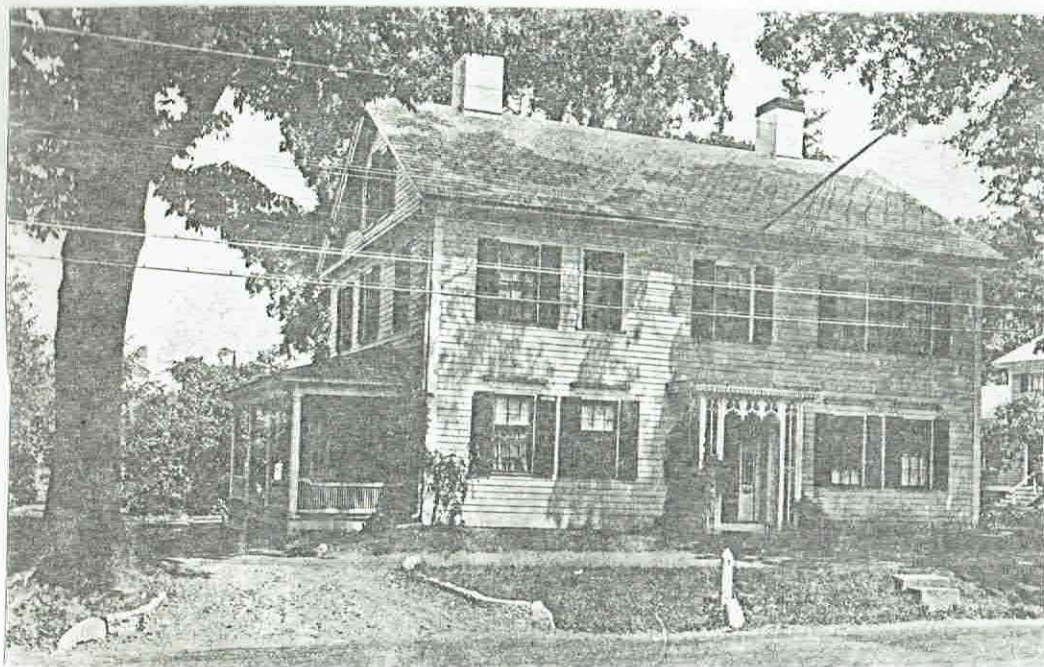
All Shepherd House: Upper Left circa 1905 showing large flagpole, hitching posts, porch without planter boxes, lack of foundation plantings. Upper Right, post card circa 1935-40 with evergreen foundation plants, Elm as street tree. Shows mostly deciduous plantings between building and neighbors' drive. Bottom; two sides of photograph and plan circa 1905, "Mrs. Burnett at 66 Bridge Street." Plan shows floor plan of Shepherd house, porches, drive turnaround with oval in center, hitching post nearby, planted strips, trees (small circles), barn with carriage ell, small shed and fenced yard. Freestanding structures include one behind barn (corn crib?), one to left of barn, and large structure behind property (shown on the Sanborn Insurance maps). Note also property line is approximately same as existing.

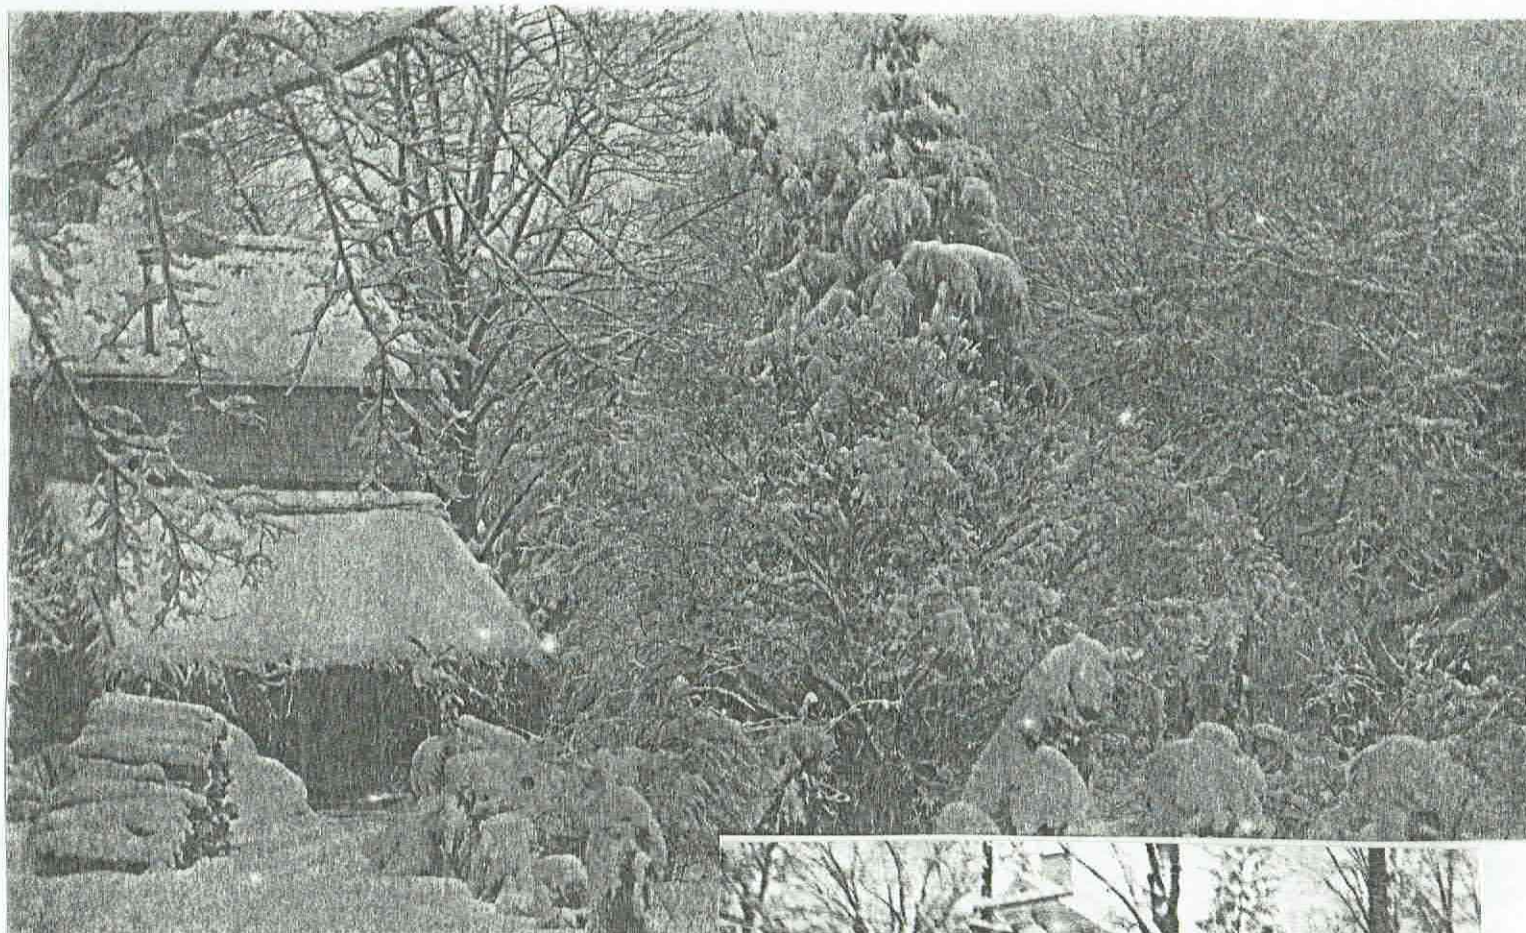
Winter scenes at the Shepherd House. *Image*  
Upper: a heavy turn-of-the-century snowstorm has blanketed the landscape, causing especially the evergreens to bend. Note the wood piled near the rear door for ready access.  
Inset: photograph of Shepherd House from across the street, not dated, prob. circa 1905. Note shuttered windows, lack of evergreen planting; telephone pole in foreground at left. Large Ash in rear yard and mature Maple by driveway entrance are clearly visible.

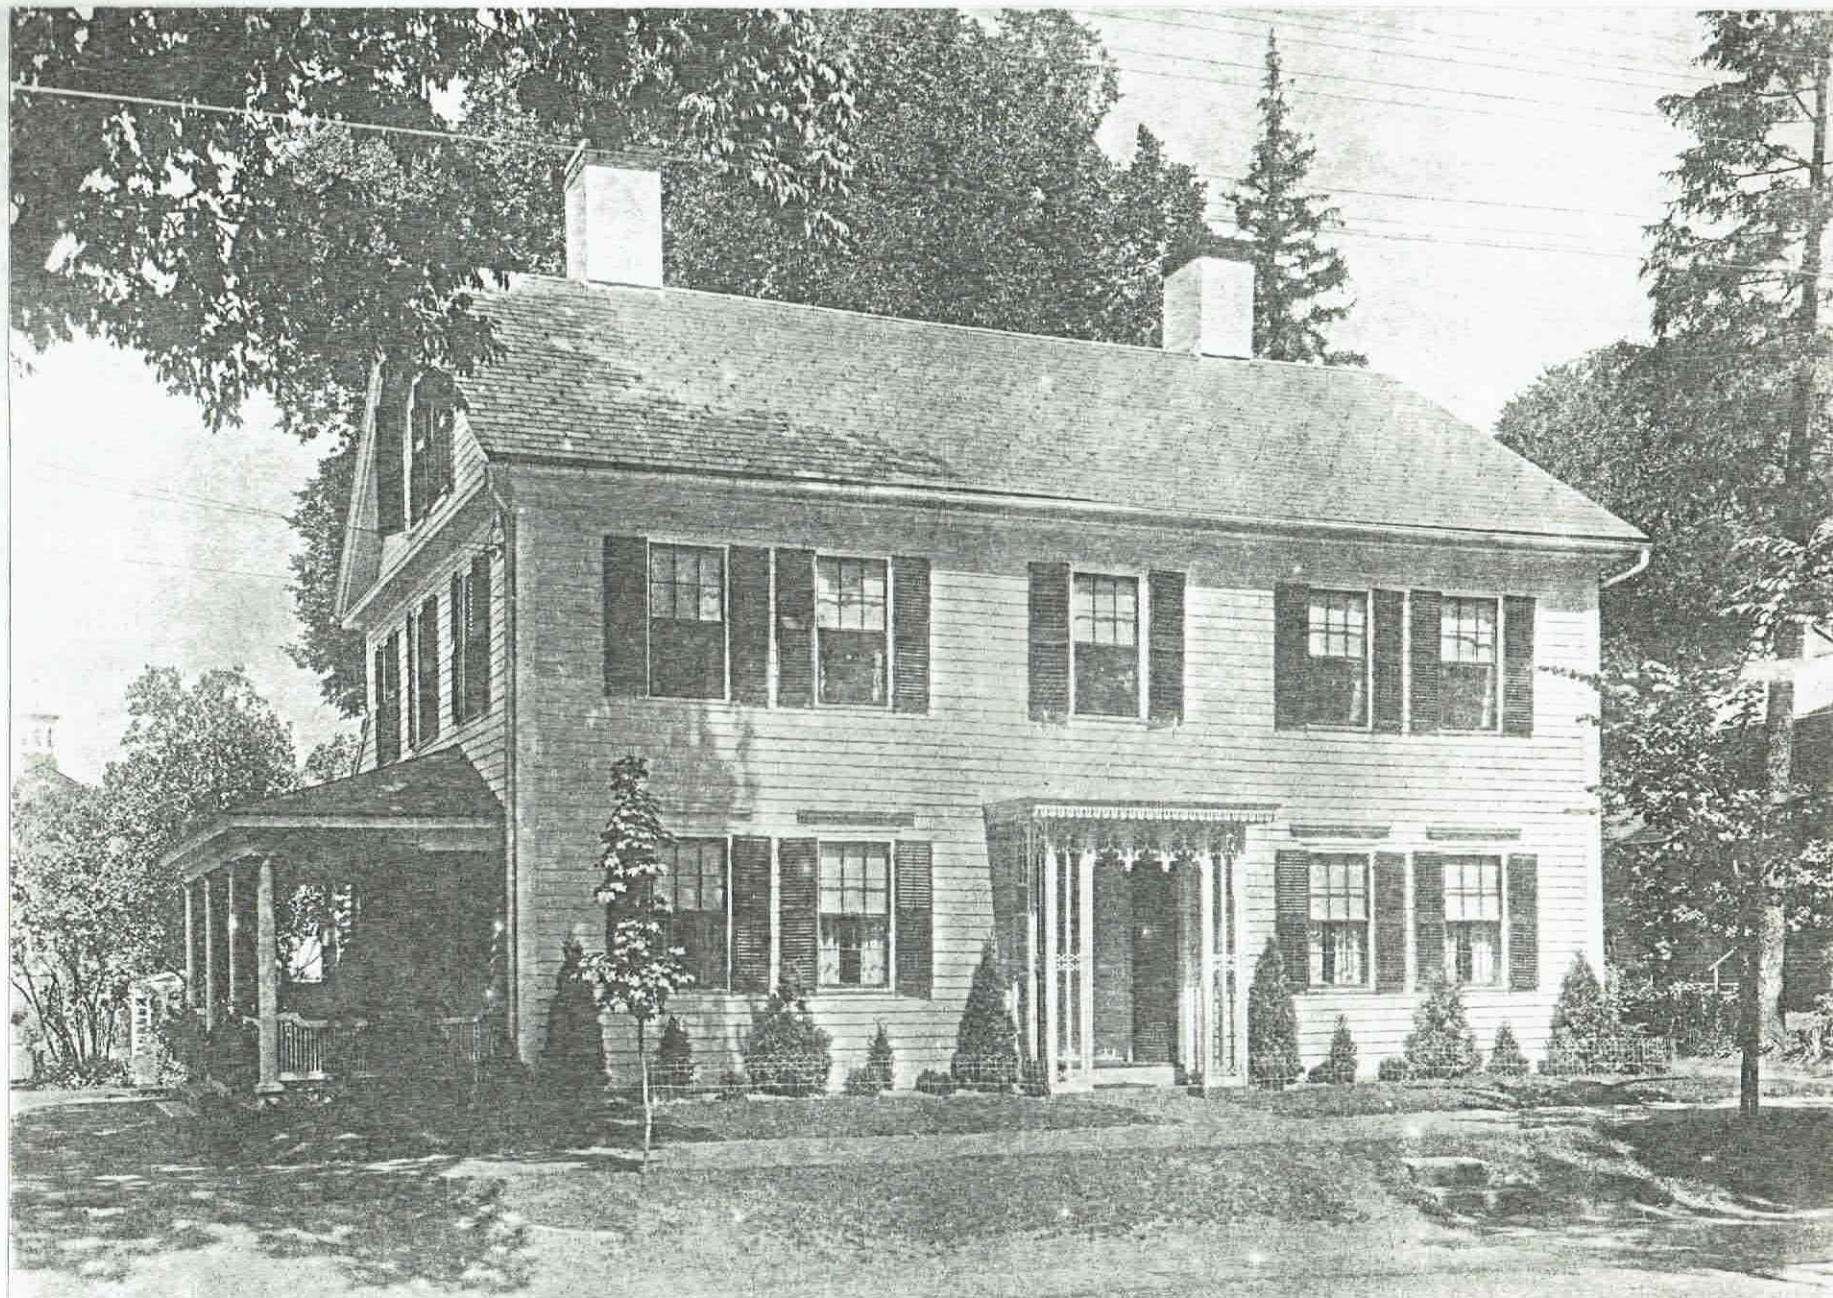
Shepherd House photograph 1932. Note crisp planting of evergreens at the foundation line behind a low wire fence, young maple and elm street trees, side porch planter boxes, lilacs and perennials in strips with trellis structures lined up with the cupola of the County Jail (beyond on Union Street).

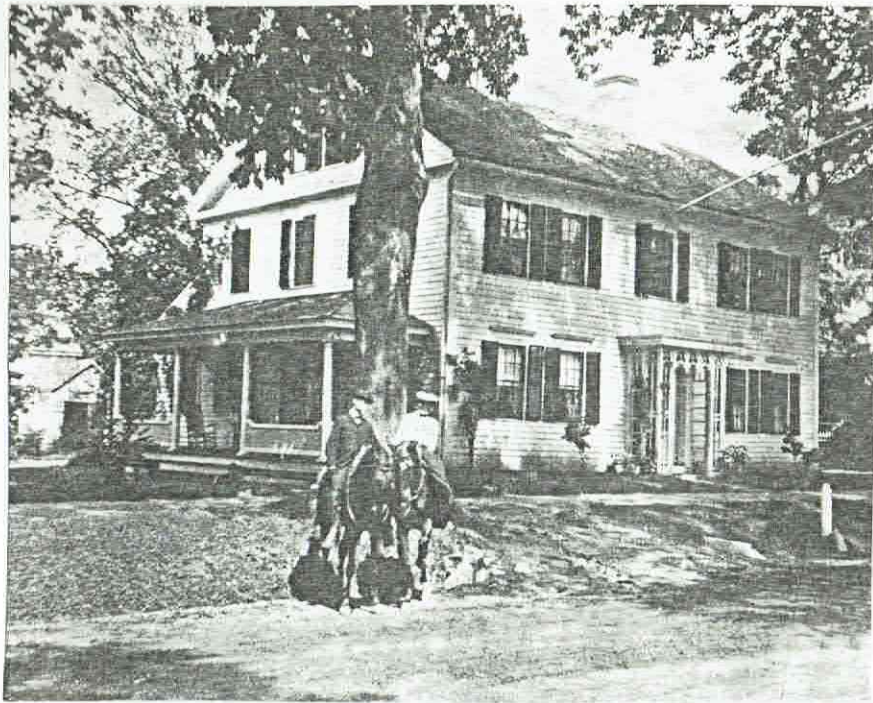
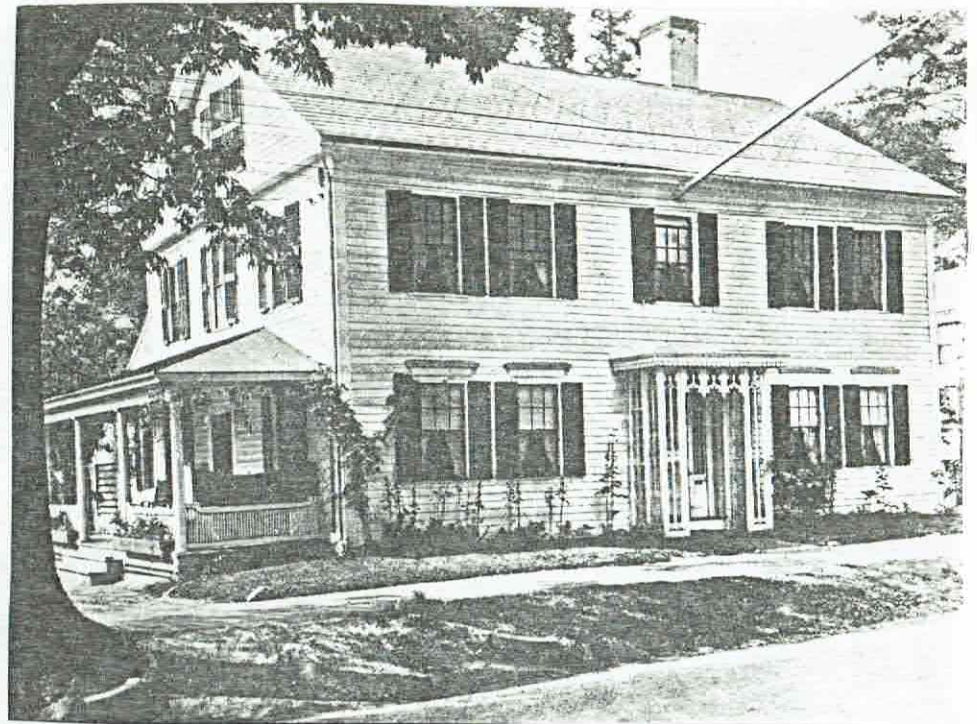
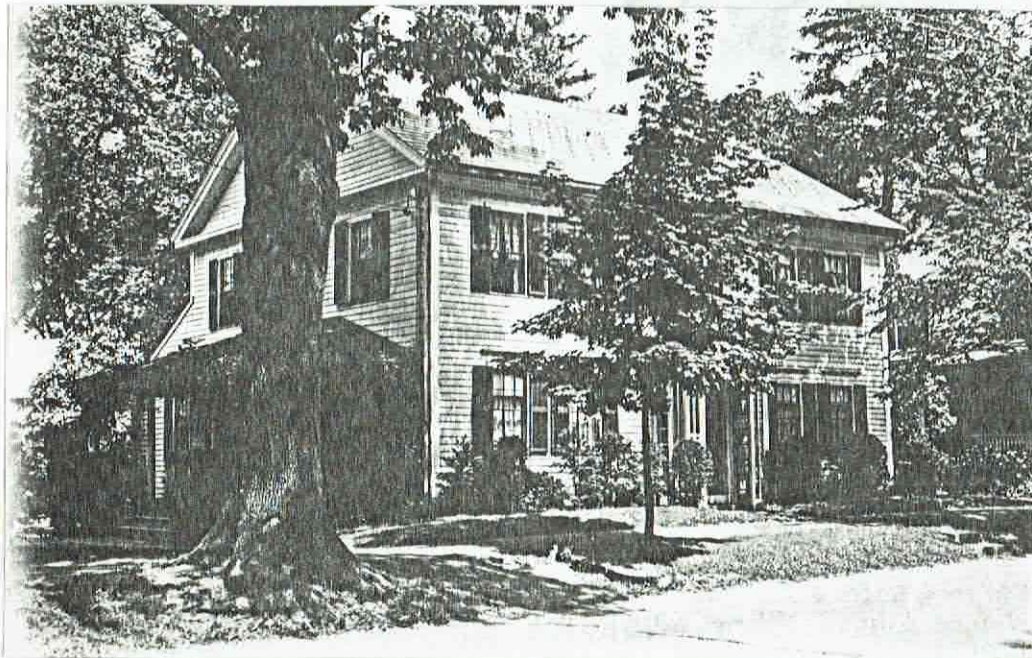
All Shepherd House. Top left: circa 1905, note hitching post (for horsemen), lack of planters on porch, large Maple is only street tree. Top right: c. 1905, hitching post is gone, flowers at the foundation, planters added to the porch. Bottom left: circa 1935-40. Note evergreens at the foundation line, new Maple at center of photograph, large flag-pole gone.

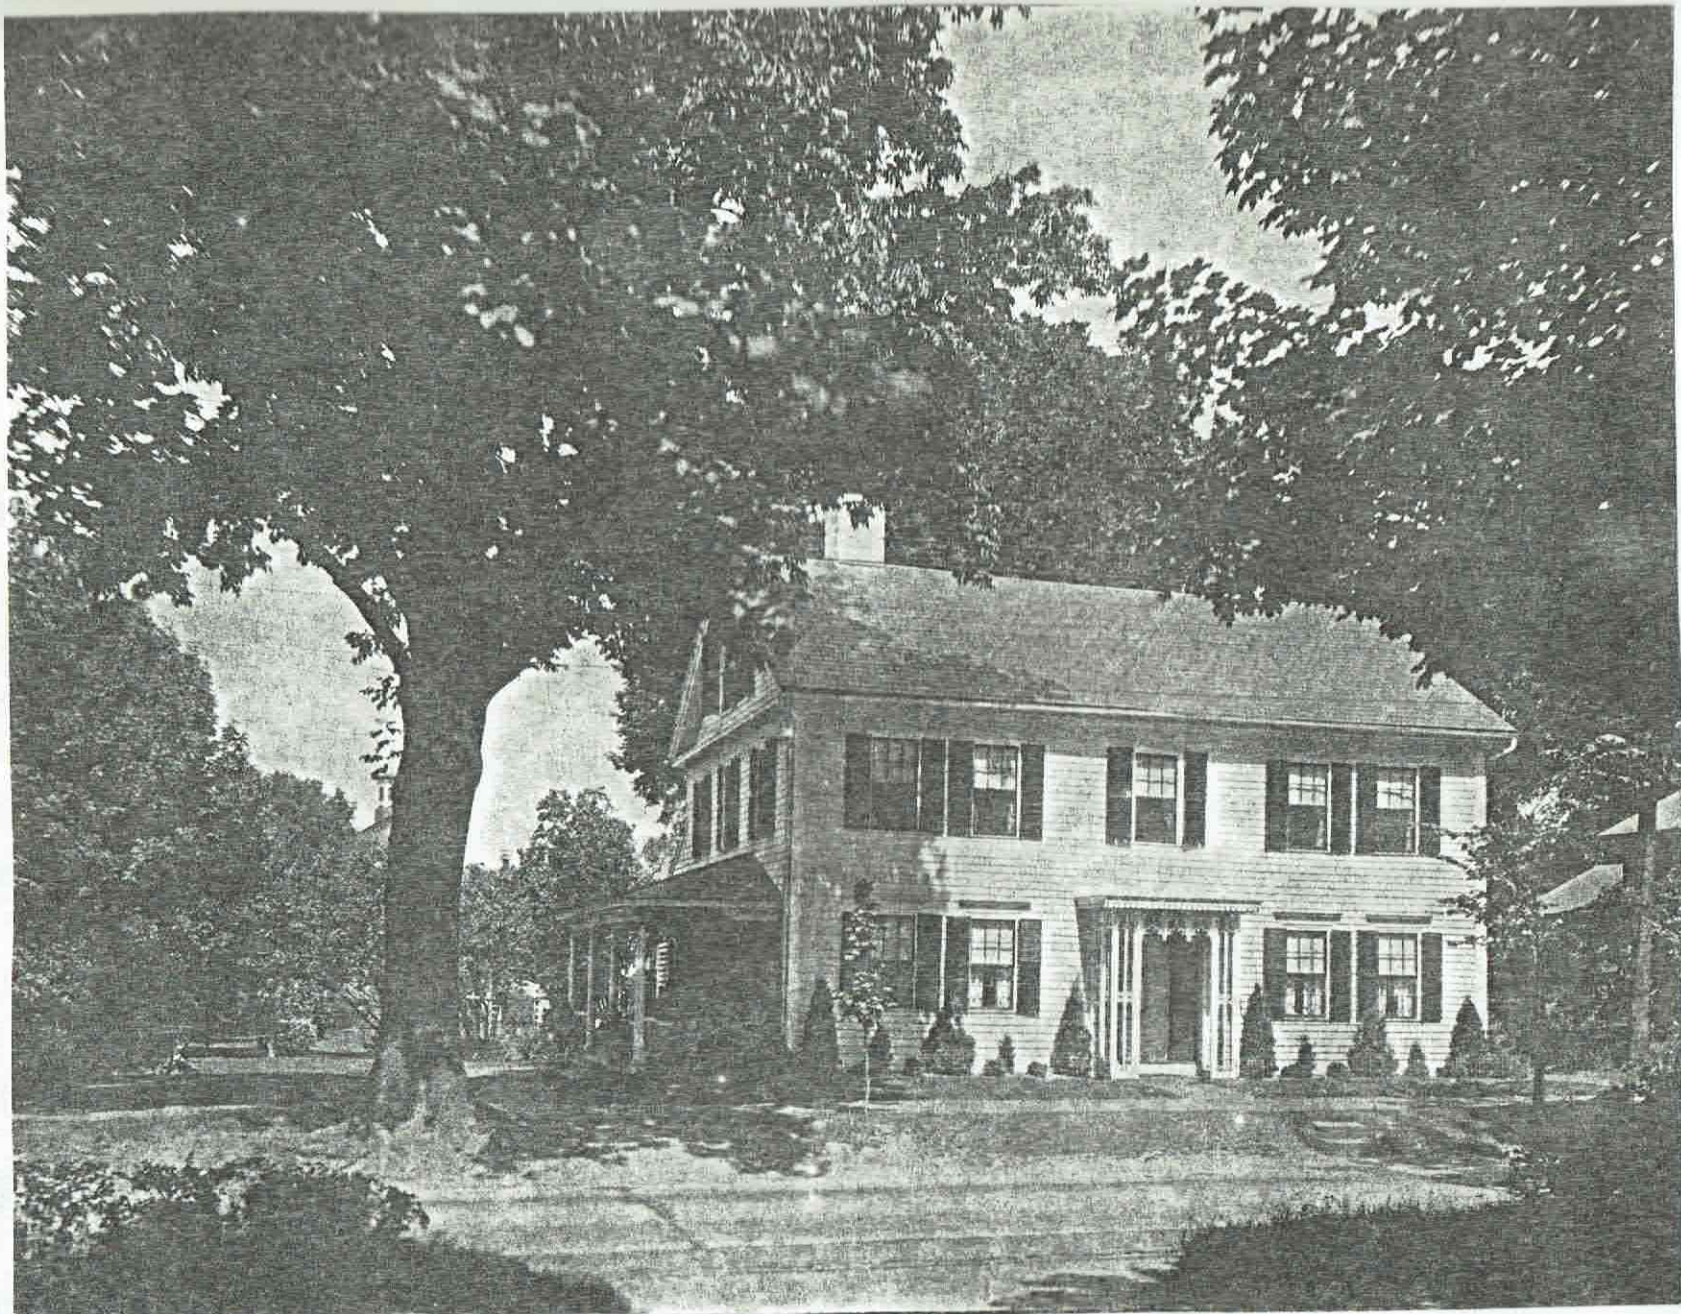
Photograph taken in 1932 of the Shepherd House from across Bridge Street. Note the evergreen foundation plantings, newly planted Maple street tree, openness of the yard. One can see the trellis structure at the end of the perennial beds, and beyond the cupola of the County Jail which provided the termination to the vista.

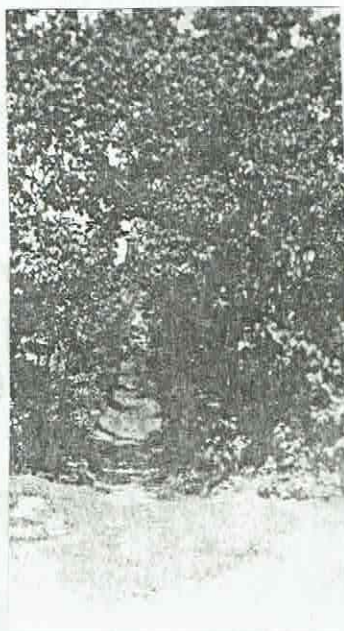
Upper left: the strips focusing upon the cupola of the County Jail on Union Street, circa 1920.

Upper right: view toward the carriage shed circa 1920 showing the "lattice tree" central feature.

Left: hitching post at center, "lattice tree" at right in rear yard, circa 1920.

Below left: "lattice tree" as central feature in flower bed at center of carriage turnaround, circa 1920.

Below right: October 1932 photograph of Shepherd rear property from behind Shepherd Barn. Horse yard and small building have been demolished and a second trellis structure has appeared. In immediate foreground is the edge of the vegetable garden. Between the two trellisses is probably a row of Red Currants.

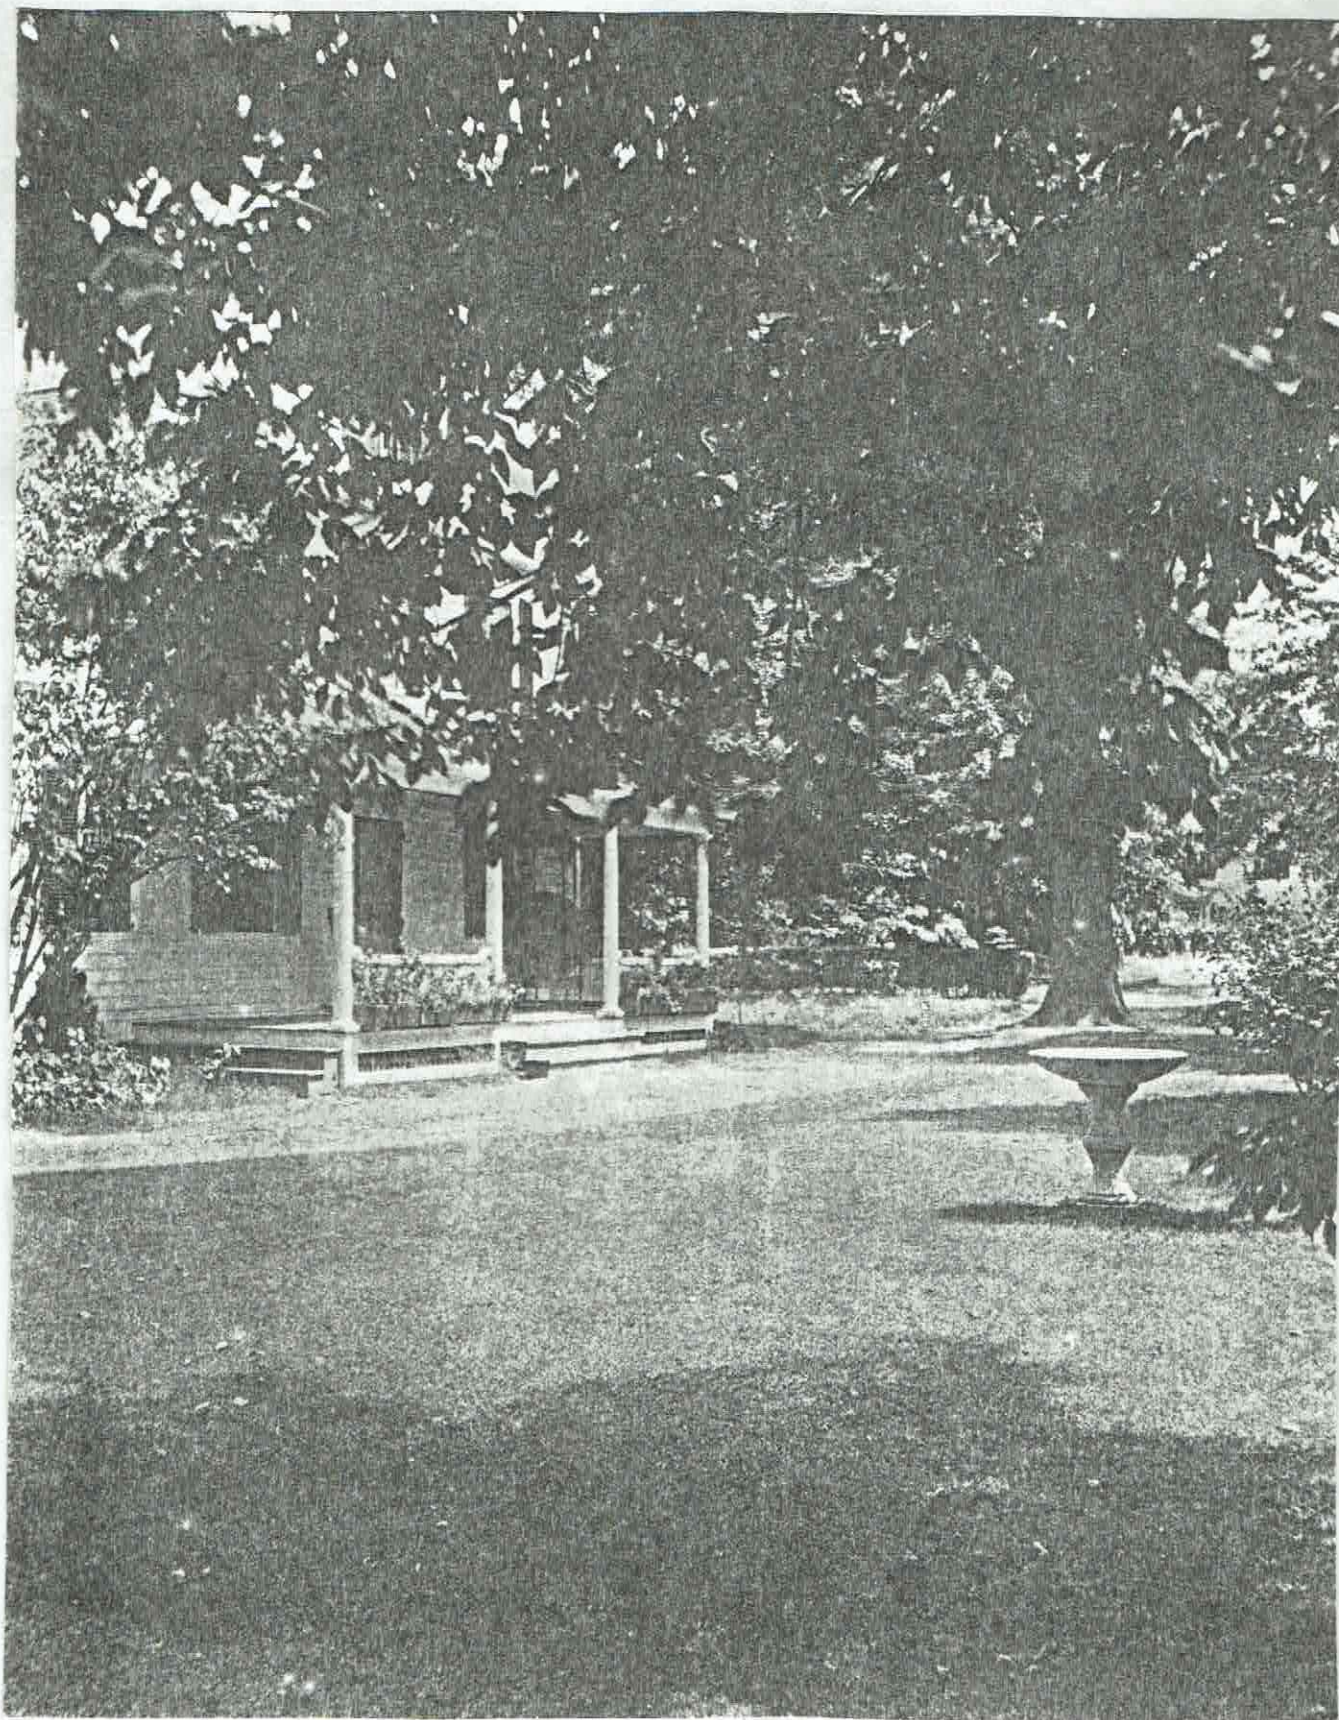
Photograph taken in 1932 of the side yard of the Shepherd property. Note the flower planters on the porch, the neat lawn and the bird bath. Lilacs appear to be growing next to the kitchen at the left.

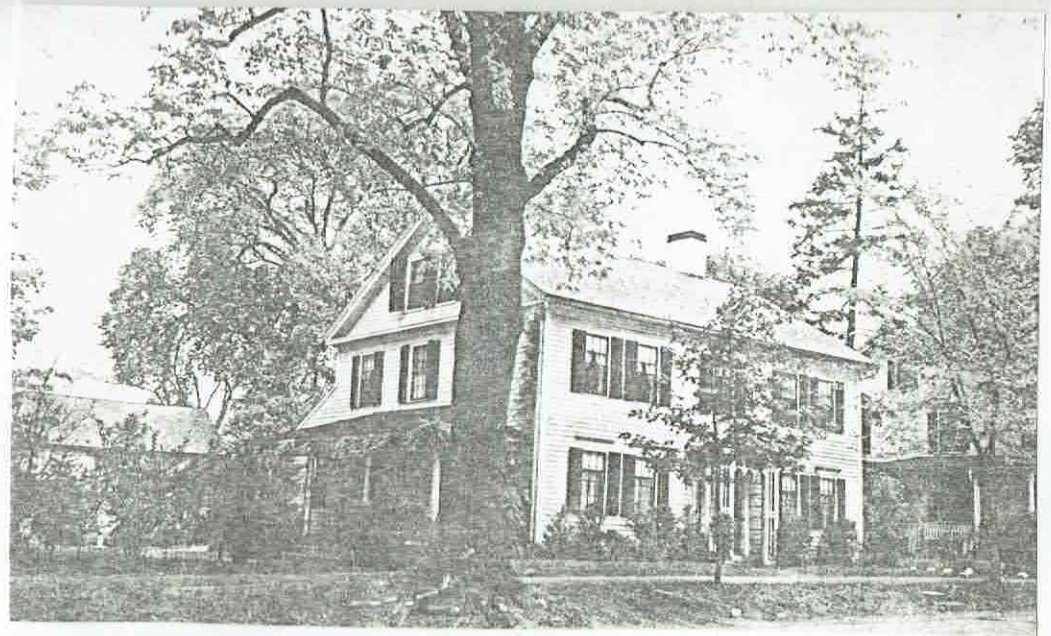
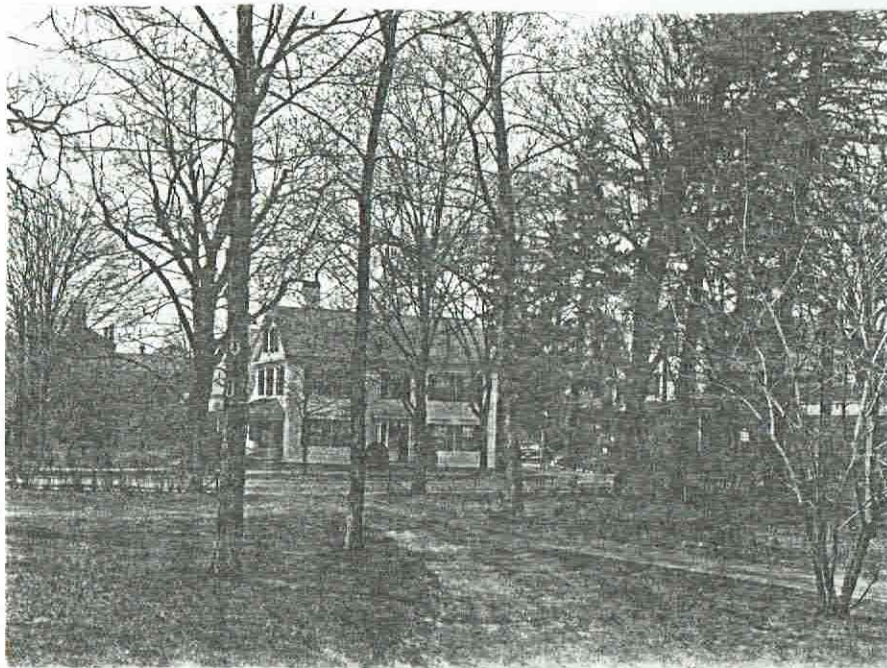
Upper left: large Elm across street from Shepherd House, not dated.

Upper right: May 11, 1941 photograph of the Shepherd House. Note recently planted street trees beginning to mature, taller evergreens @ foundation line, vines climbing the house and across porch roof, bird bath as central feature in turnaround planting area in rear yard.

Left: Winter scene in the 1950's. Note disappearance of foundation plants of the 1940's, appearance of 'gum-ball' evergreens flanking the front walk. Street trees have reached good canopy size. Note County Jail cupola to the left.

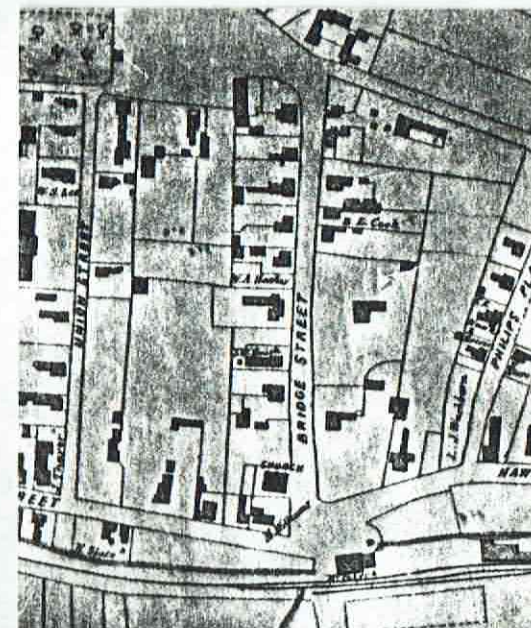
Top: 1853 map portion from "1853 Map of Northampton, Mass. Published by Presdee and Edwards, Civil Engineers and Surveyors, New York & Jersey City, Lithography of Sarony and Major, New York." Note that the Shepherd property has not been consolidated. Several outbuildings are shown including the Shepherd Barn. The Carriage Ell is not shown; the lean-to structure shown in photographs may be between the house and barn. Graves Ave. has not yet been constructed.

Left: 1895 map from "Atlas of the City of Northampton...D.L. Miller, Phila." Note that a drive to the barn and carriage ell is shown, as is an attached smaller structure at the other corner. The property behind the barn is still separate. Graves Avenue is finished. (Source for both maps: Forbes Library).

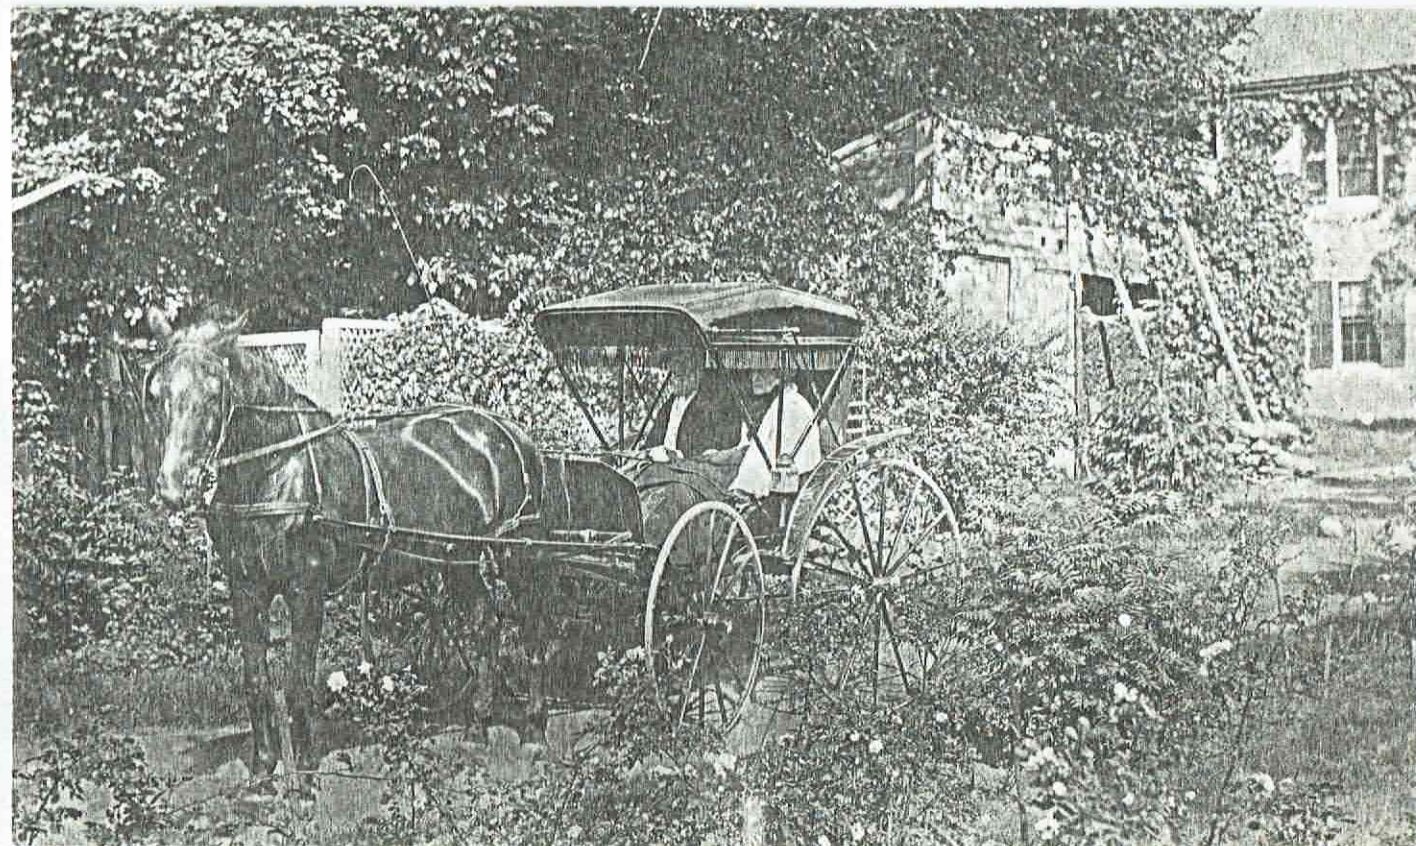
Top: June 1890 photograph of Shepherd rear yard looking toward the house. Mr. and Mrs Henry Shepherd are in the carriage on a gravel drive which turned around in front of the barn and carriage ell. Note the roses planted on the oval area created by the turnaround. The lean-to structure may be the structure indicated on the map to the left. Note also the trellis fencing, and to the left may be the tip of the wheeled structure shown in the 1883 "Robinette" photograph.

Left: Portion of 1884 "Atlas of Northampton City, Massachusetts, compiled from recent and actual surveys and records under the direction of the publishers, pub. by Geo. H. Walker and Co., 160 Tremont St., Boston, Mass, 1884." Note carriage ell and structure between house and barn (see photograph above as to probable form). Note that rear property has not yet been acquired, belongs to F. Edwards. [Source: Forbes Library].

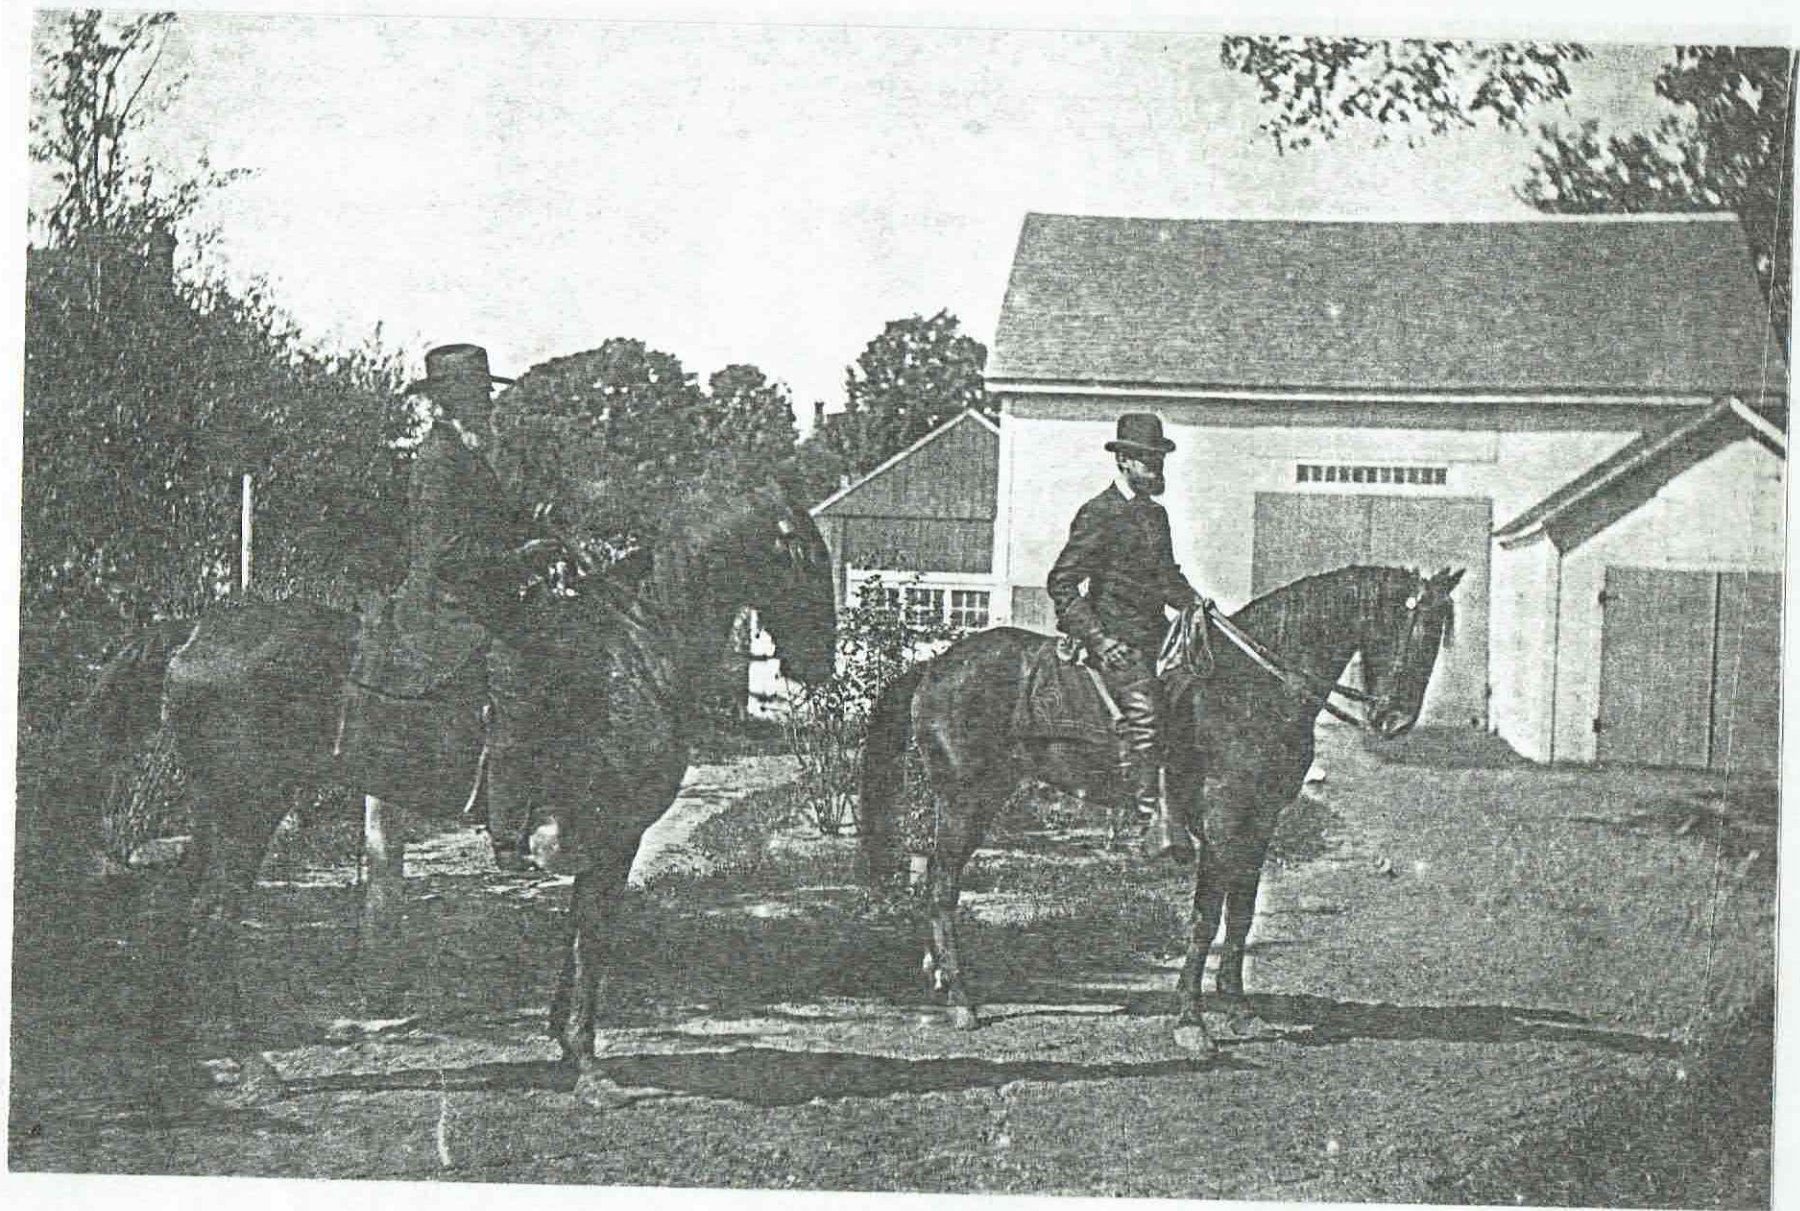
"Henry Shepherd on 'Mr. Fox' and Thomas Munroe on 'Brer' Rabbit' in homestead yard (66 Bridge Street) Return from Hatfield trip-September 26, 1898." Note rose garden at center of turn-around, vanished outbuildings at side of barn, vanished hitching post behind Mr. Fox.
