# ANNOTATED PHOTOTOGRAPHS & ILLUSTRATIVE SITE PLANS SHEPHERD HOUSE

66 BRIDGE STREET, NORTHAMPTON, MASS. 01060

NORTHAMPTON HISTORICAL SOCIETY

**Menke & Menke**

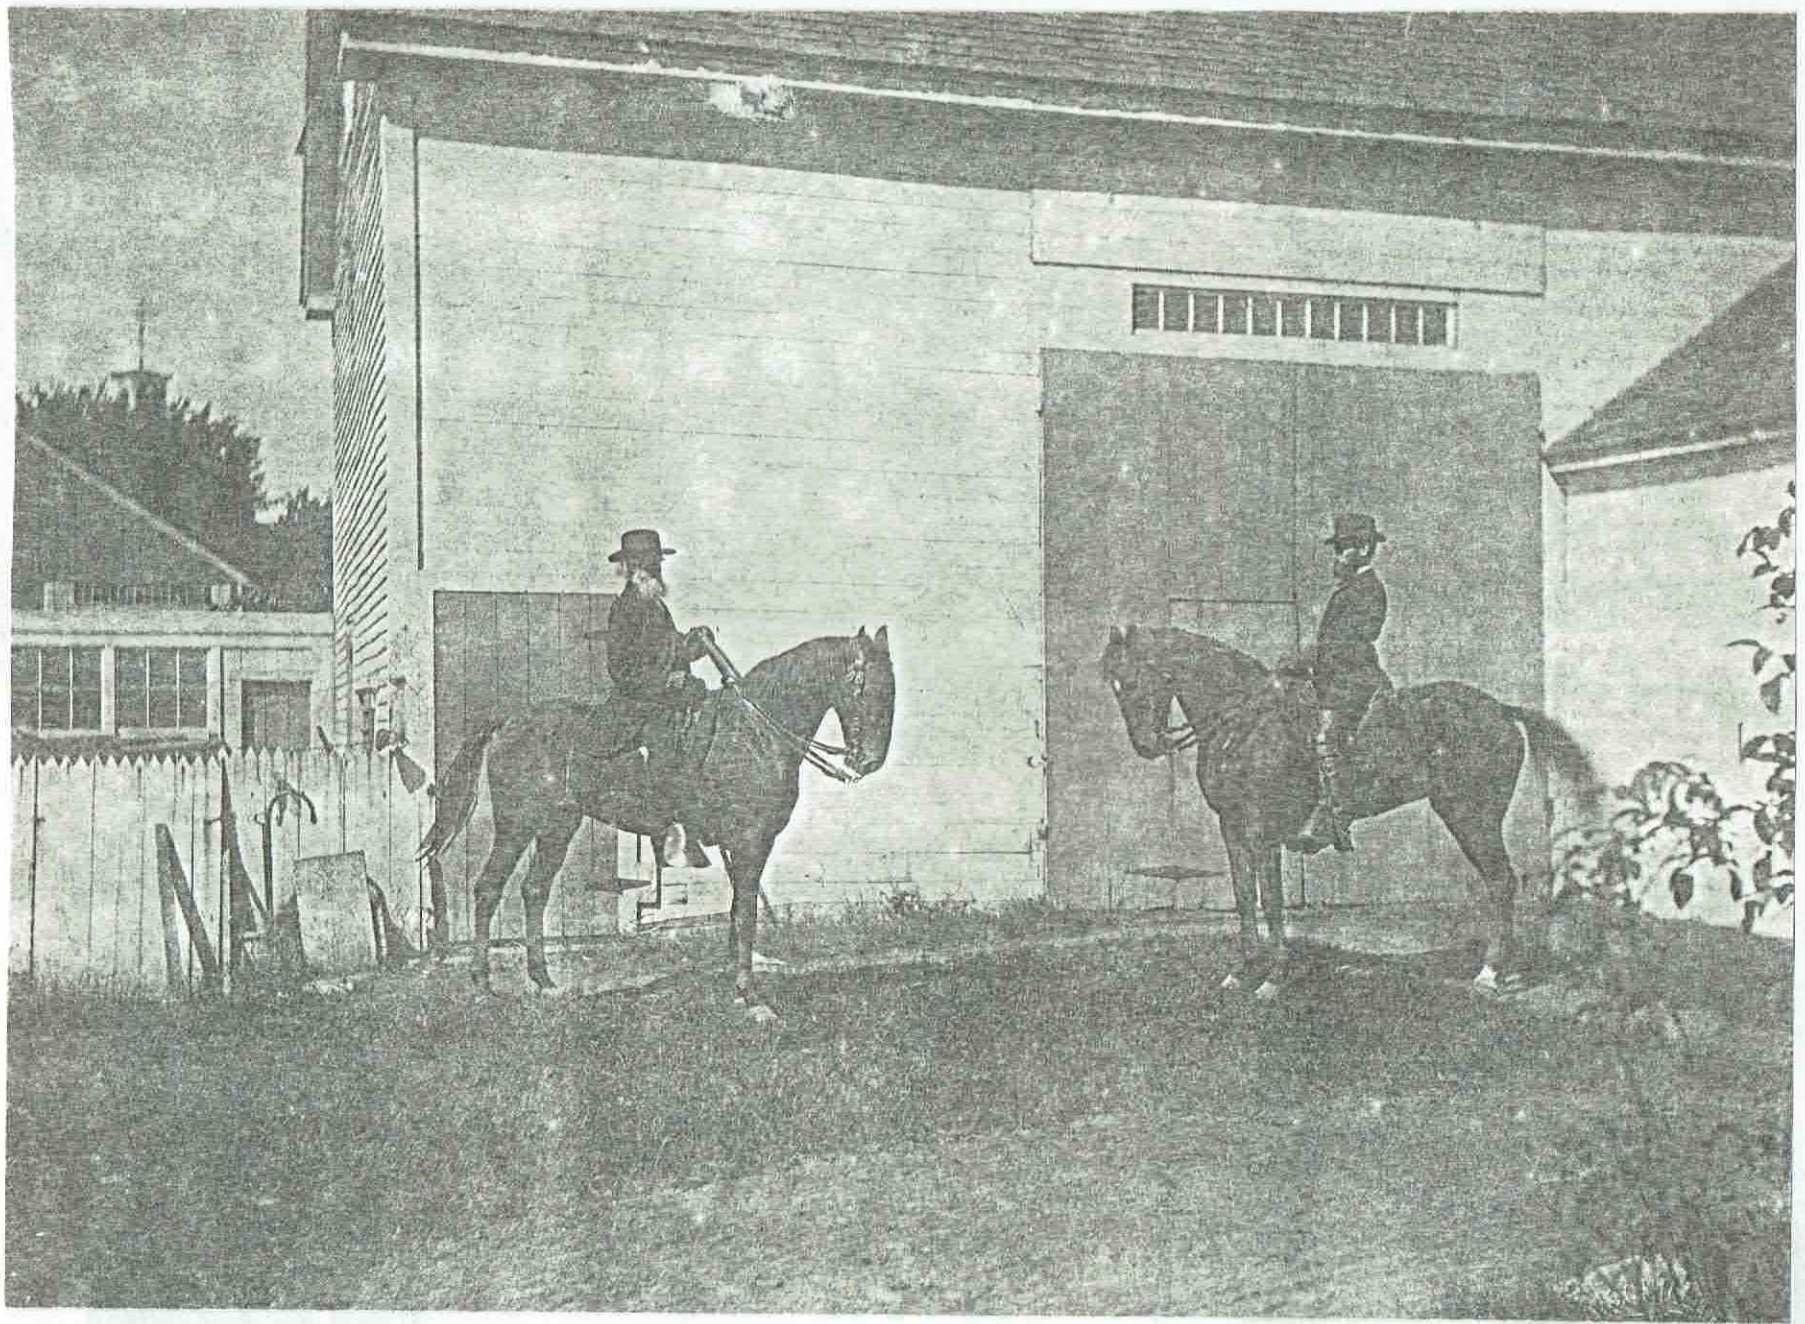
1898 photograph of Henry and Thomas Shepherd on Brer' Rabbit and Mr. Fox. Note whitewashed picket fence at horse yard adjacent to the stables, building at the end of the barn, and the larger structure beyond. In the distance, the County Jail Cupola can be seen.

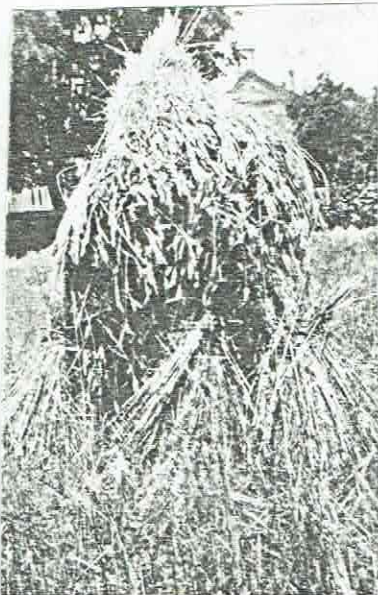
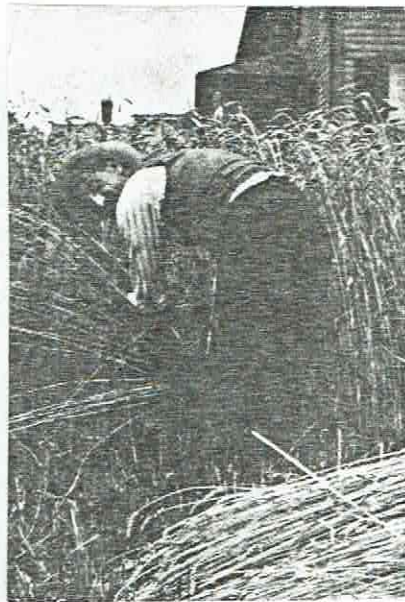
Upper left: "Wheat in Shepherd garden."

Upper middle: "Frank Switkowski cutting wheat planted by Thomas Shepherd, c. 1922."

Upper right: "Asparagus bed in 1916."

Building at rear is 46 Graves Avenue. Note palisade fencing.

Lower left: The two long planted strips at the turn of the century from the edge of the carriage drive. Note the trellis structure at the right of the riders.

Lower right: 1916 view of the garden at the turnaround, with the Shepherd Barn and Carriage ell (open at right). Note crisp edging to path and drives. The garden was a favorite place in which to be photographed.
