**Appendix 1A - Christine Thomson, Decorative Arts Conservation, Salem, MA**  
**Notes and stratigraphic charts by room from investigations at the Parsons**  
**House, 2024-2026.**

**Nathaniel Parsons House, Northampton MA**  
**Room 101 Notes**  
**December 6, 2024**  
**Revised January 16, 2026**

Nathaniel Parsons House Historic Structures Report  
Myron O. Stachiw et al.  
April 2026

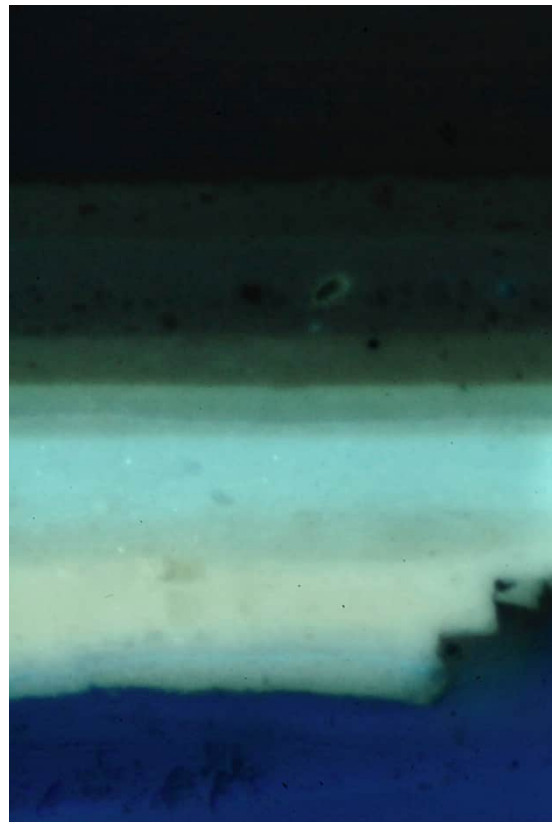
Most of the paint in this room had been removed as part of a previous renovation; however, we identified some areas that did not get completely stripped. A build-up of several paint layers was found on the south side architrave around the door leading to Rm 102. In this location (sample 039) there appear to be at least 12 coats of paint, mostly off-whites and light grays. It is difficult to see the separate paint treatments in visible light, but in UV light the demarcations between layers are more pronounced.

039 East wall architrave, south side vis. 125X

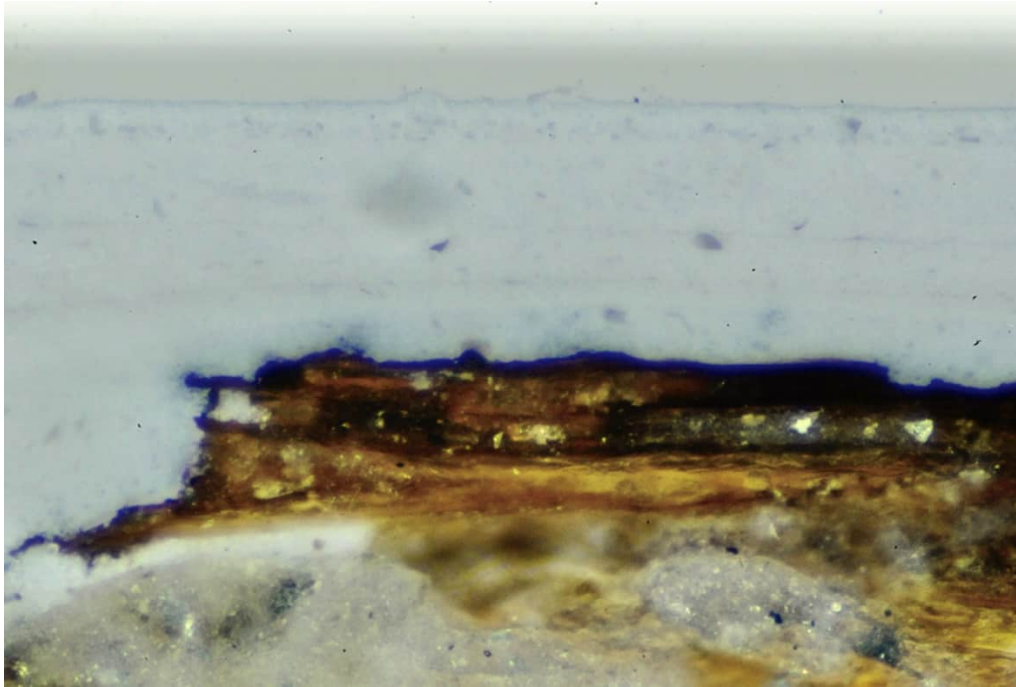
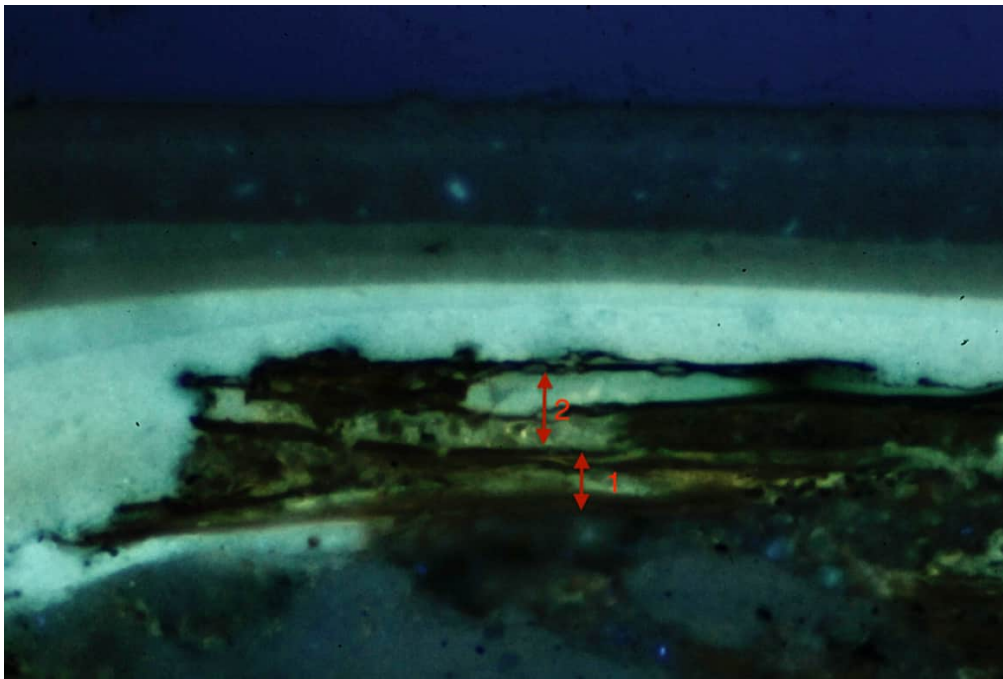
The door to Rm 112 has also been stripped, but there is evidence of two generations of early faux-wood graining. This would be consistent with the surviving grain-painted door on the second-floor entry to Rm 210. In sample 042, taken from a protected corner of the lower middle

stile there are the fragments of two faux-wood grain paint treatments, one on top of the other, forming generations 1 and 2.

042 East wall, door to room 102, lower right panel vis. 125X

042 East wall, door to room 102, lower right panel UV 125X

The ultraviolet light (UV) image above shows more clearly the two separate graining layers, each with its own layering of paints and varnishes.

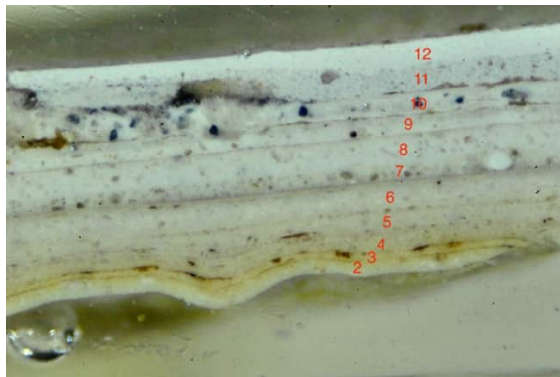
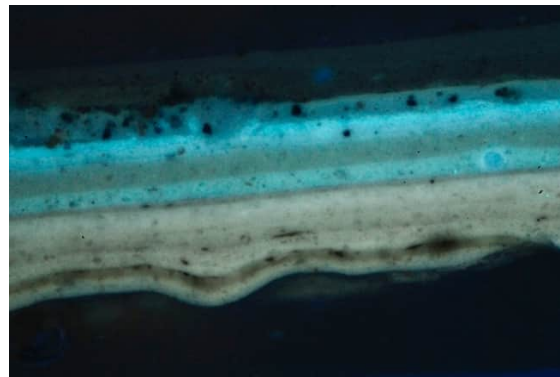
The south wall baseboard around the boxed post at the left side (east) of the exterior door appears to have been two-toned, with the flat part painted a darker brown in generation 1 and the molding on top of it painted a lighter gray brown on a primer. The images below are of a sample taken from the molding, but is not a complete stratigraphy as the generation 1 light gray brown is not visible. However, there are a total of twelve paint layers on this element, the maximum number of surviving layers identified in this space.

037 South wall, Baseboard top molding vis. 50X

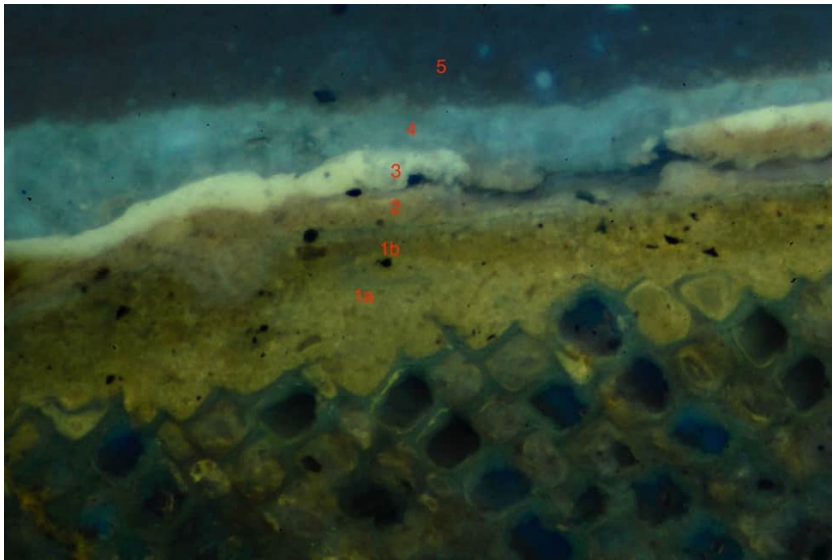
NPH 002 UV, 125X

The generation 1 paint color on the post is a thick yellowish brown. In the images it appears to be made up of multiple layers, possible as many as four, and has the visual qualities of a distemper rather than an oil paint. It has a thin bluish gray coating on top that may be an oil coating, applied before the generation 2 lavender brown. Generations 4 and 5 are modern (20<sup>th</sup> century) paints.

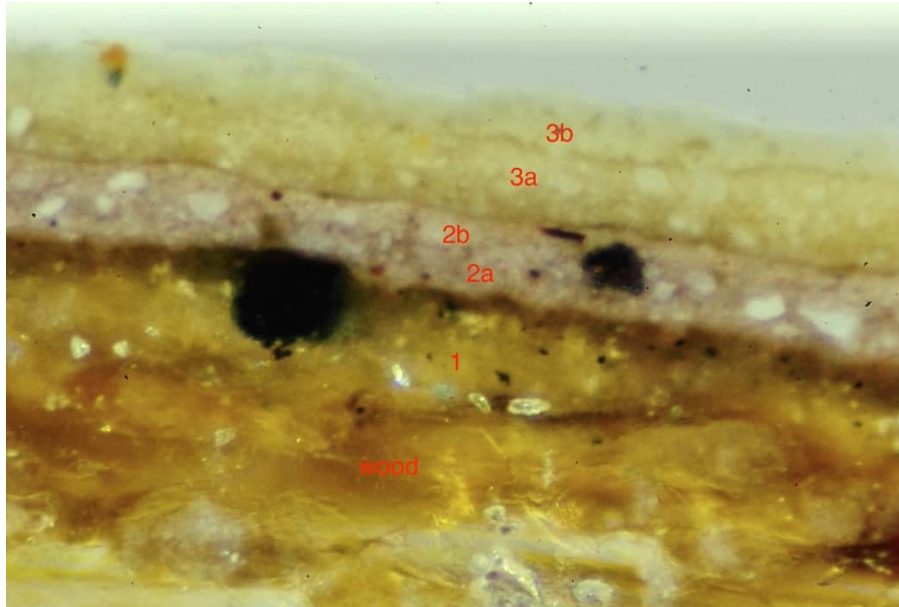
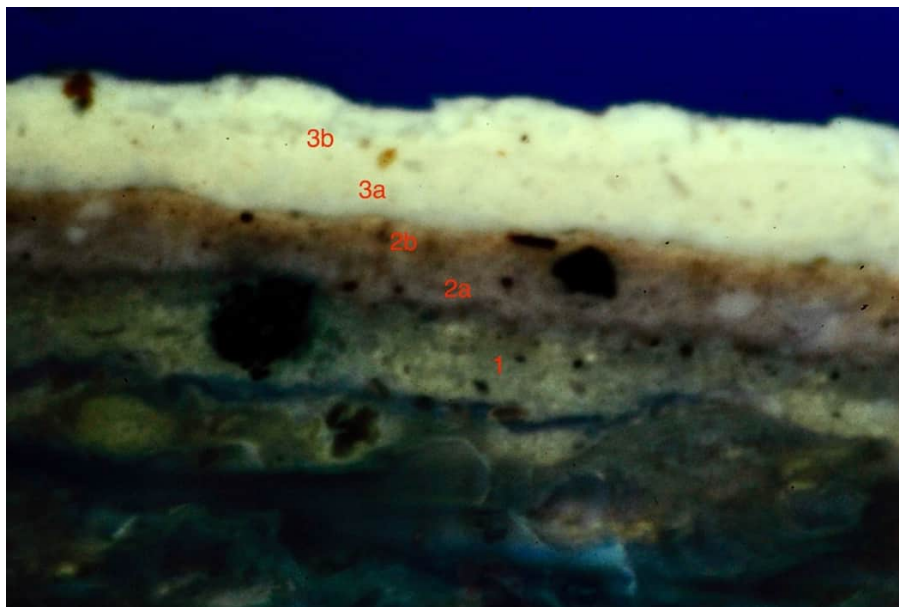
### Sample 005 North wall, exposed wainscot

NPH 005 vis. 125X

NPH 005 UV 125X

In this sample it is clear that the generation 2 lavender brown paint layer (Phase 2) is made up of two layers, the upper one being a slightly different color. The lack of a dirt line between the two layers suggests that they are all part of the same generation paint treatment. The brown line between generations 1 and 2 is heavy dirt and oxidation, often an indication that the generation 1 layer was exposed for a period of time and accumulated dirt and grime before it was painted over.

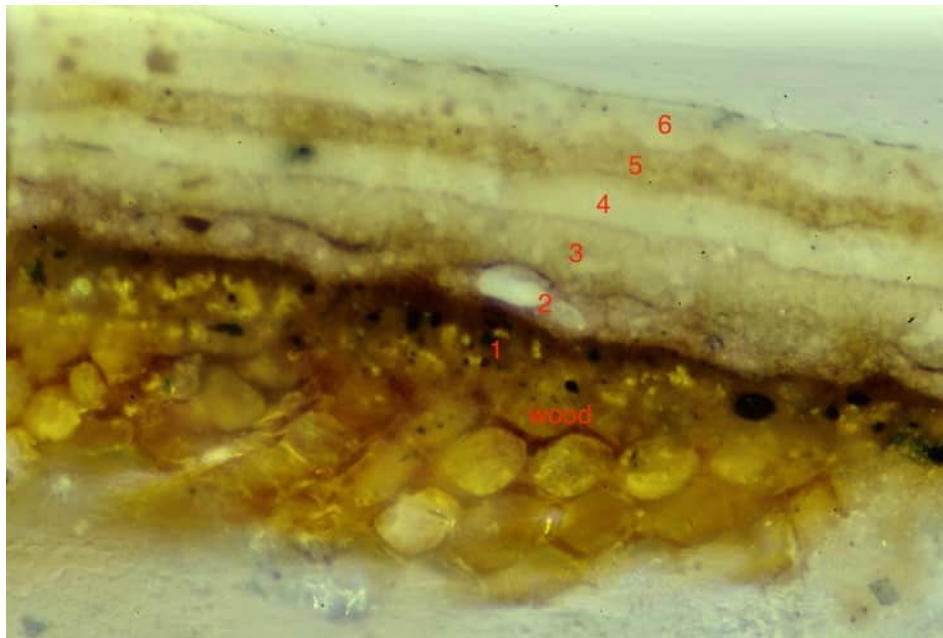
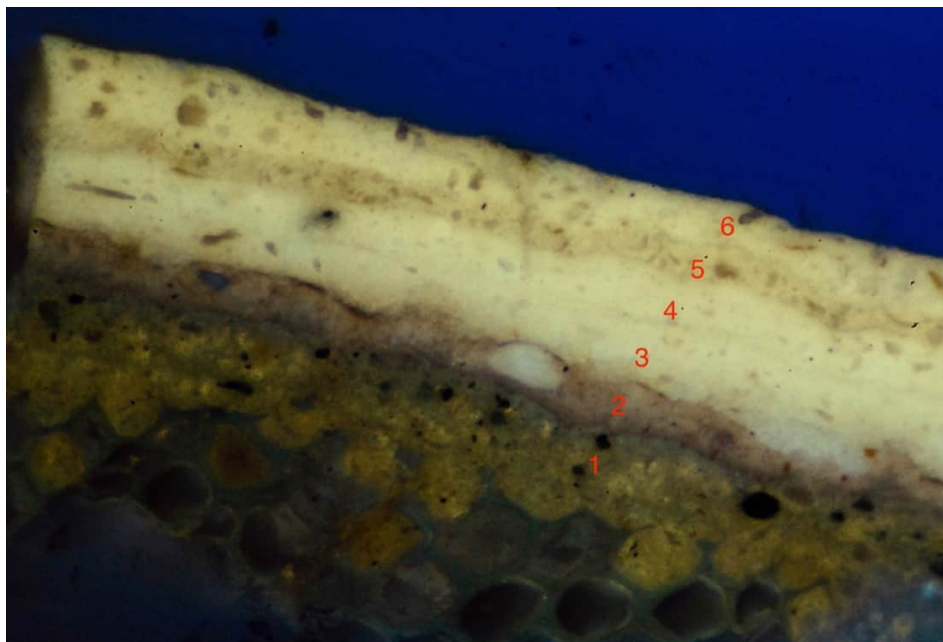
**Sample 006 North wall, exposed wainscot, different location**

NPH 006 vis. 50X

NPH 006 UV 50X

Sample 006 exhibits a more complete paint history as compared with sample 005. The first three generations are the same, but this sample has three additional layers on top, and may represent the full paint stratigraphy that had existed before the woodwork was stripped.

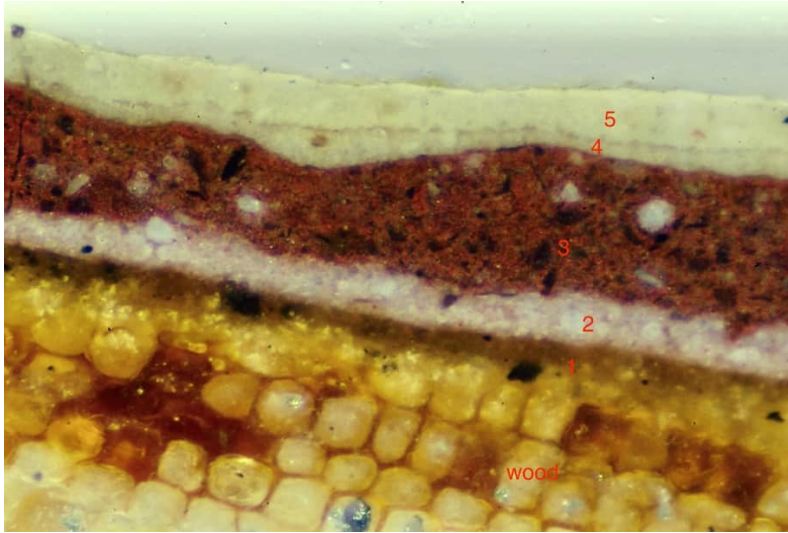
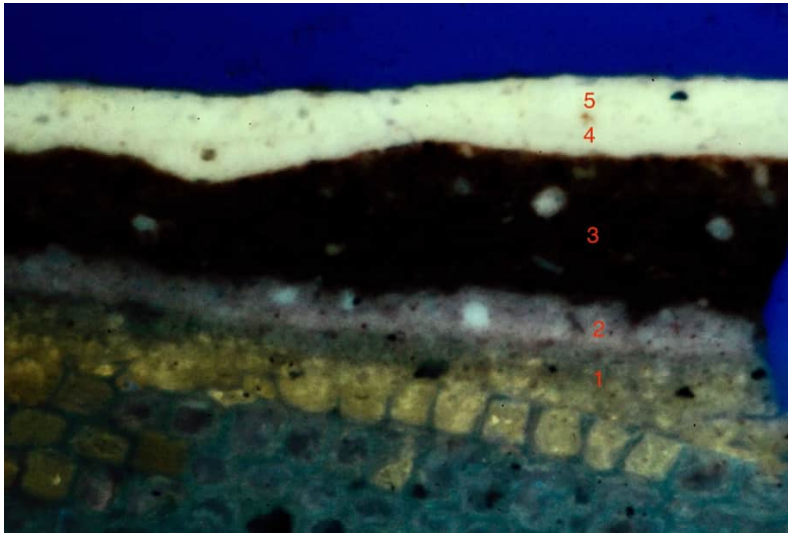
**Sample 021 North wall wainscot behind current baseboard at east door opening, at baseboard level**

NPH 021 vis. 50X

NPH 021 UV 50X

Generations 1 and 2 are consistent with other samples but generation 3 is not. It indicates that the wainscot behind the current baseboard was at one time painted dark red at the baseboard level, suggesting a dark red painted mop-board as part of generation 2 (Phase 2).

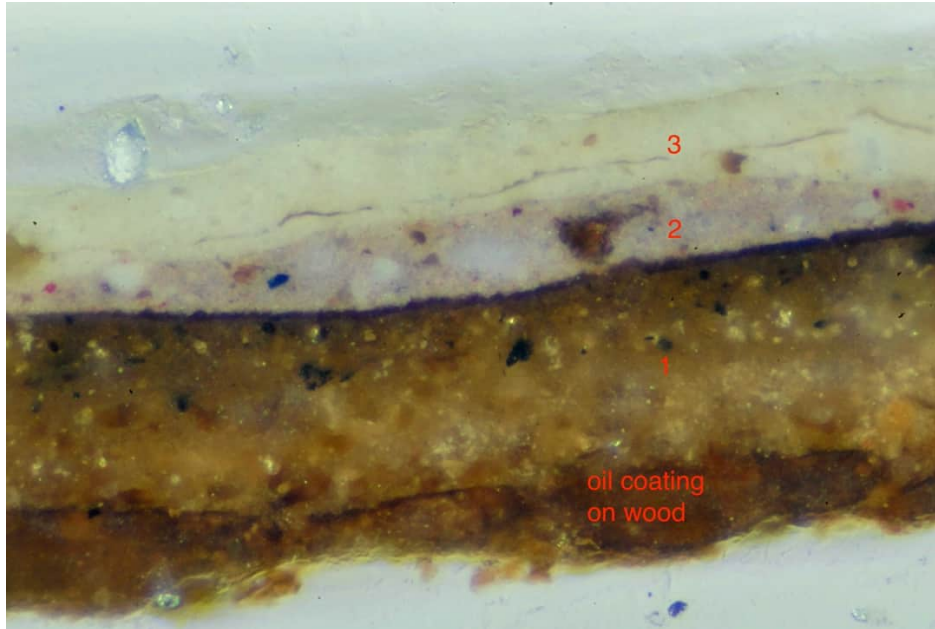
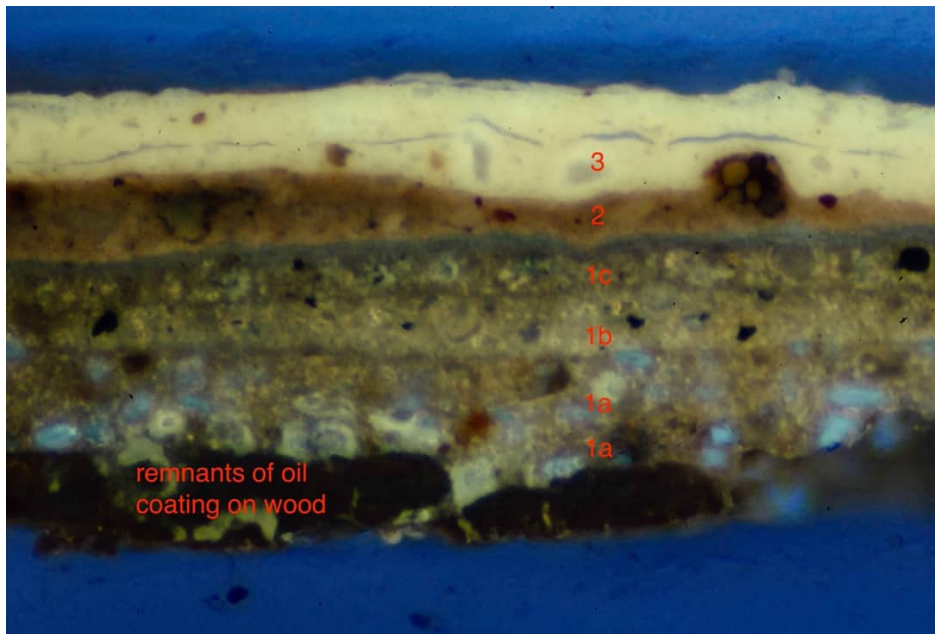
**Sample 022b North wall, above west door opening to Rm 109.**

NPH 022b vis. 125X

NPH 022b UV 125X

This sample in ultraviolet light reveals more than what can be seen in visible light. The thick, yellowish brown homogenous layer that indicates generation 1 is actually made up of three or four layers of paint, all visible in the ultraviolet light photomicrograph. Little evidence of dirt between layers exists, suggesting that all four layers were applied as part of a single paint treatment. The slightly translucent quality of the paint in ultraviolet light suggests a distemper, which utilizes animal glue instead of oil as the paint binder.

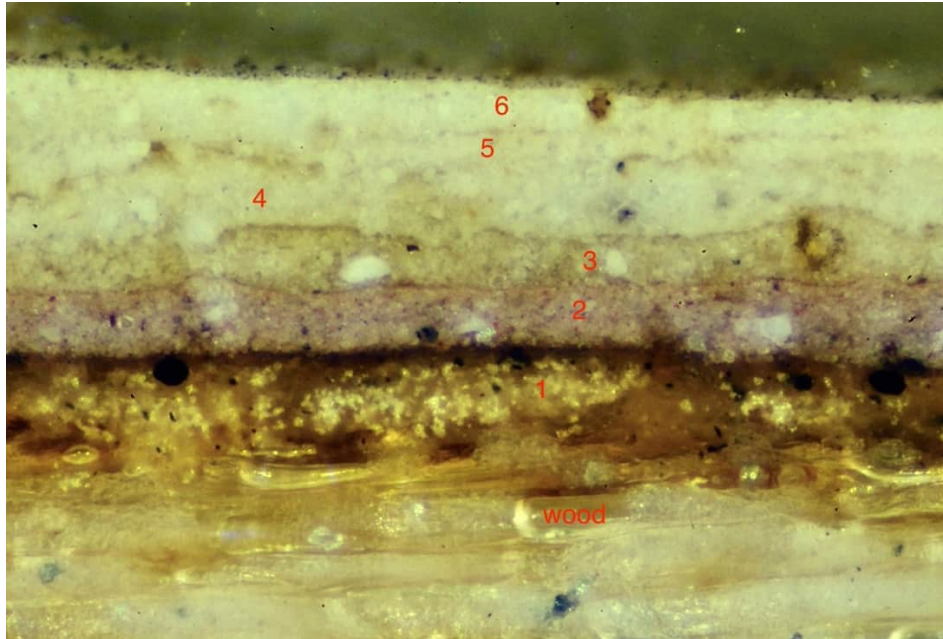
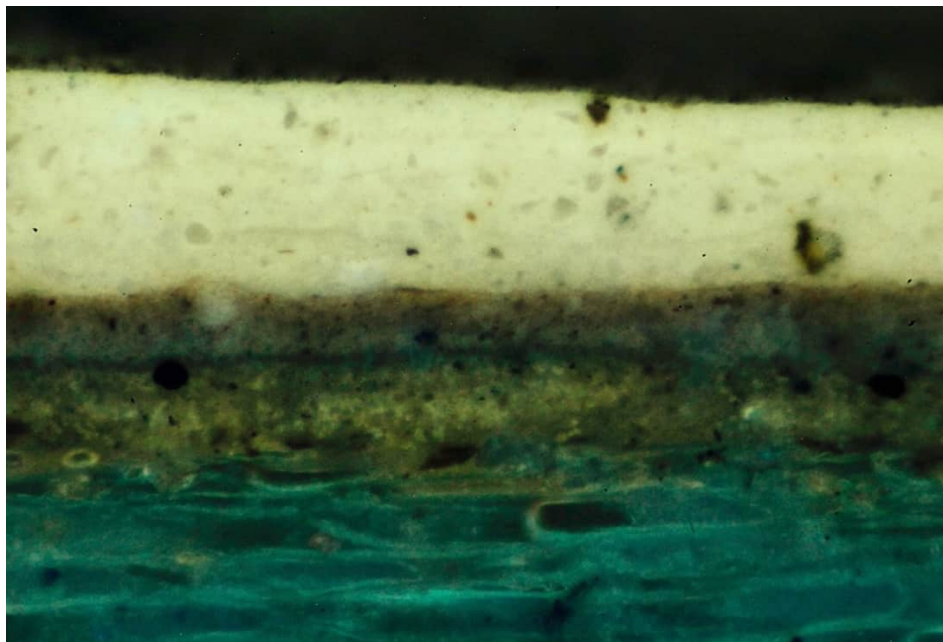
**Sample 023 – Wainscot behind current baseboard (above original baseboard level)**

NPH 023 vis. 125X

NPH 023 UV 125X

On the very top of the visible light image of NPH 023 there appears to be another thin paint layer, but it is more likely a mixture of dirt and soot. Large black pigment particles are visible. There are a total of six generations of paint in this area.

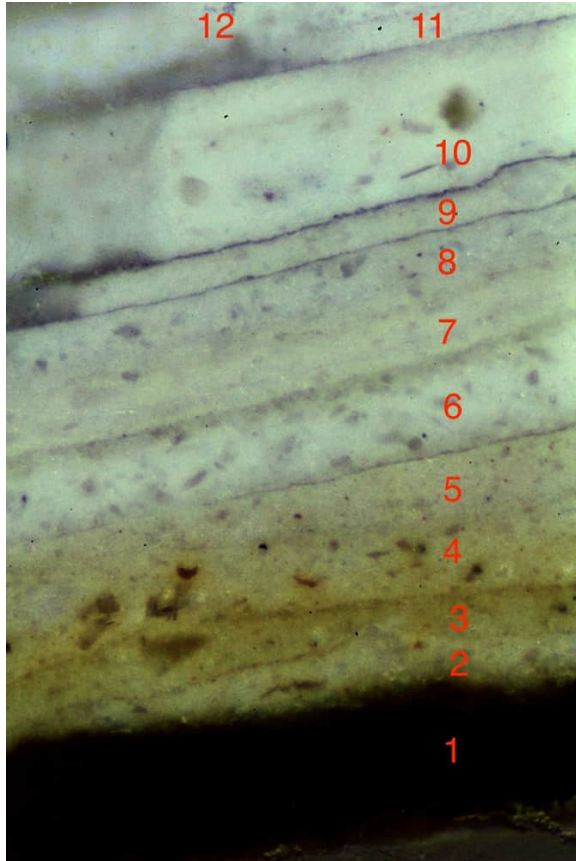
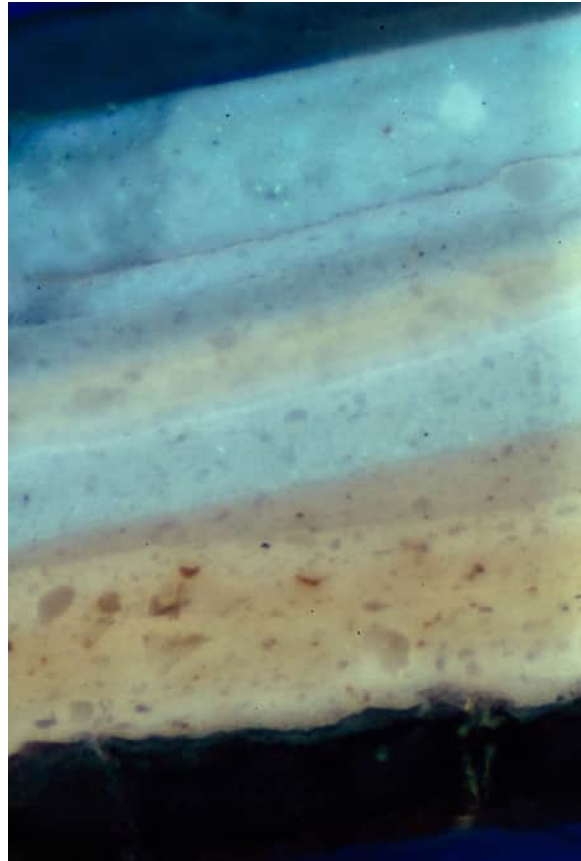
**Sample 024 South wall, right side of west window, bottom of cased girt**

Sample 024 vis. 50X

Sample 024, UV 50X

The bottom of the cased girt that runs along the south wall appears to have evaded being stripped with the rest of the woodwork. A total of 12 distinct paint treatments were identified. Generation 1 is a thick dark brown layer, quite different from the other paint layers. Without additional analysis it is unclear what its make-up is, but it could be an original (Phase 1) oily layer with accumulated soot and grease, a likely result of the earliest use of the space as a kitchen.

The top two white layers do not fluoresce in ultraviolet light as they contain titanium dioxide as the white pigment, which has no fluorescent quality. Titanium dioxide was not used as a white pigment until the early 20<sup>th</sup> century. It eventually supplanted lead white and zinc white as the primary white pigment in commercial paints.

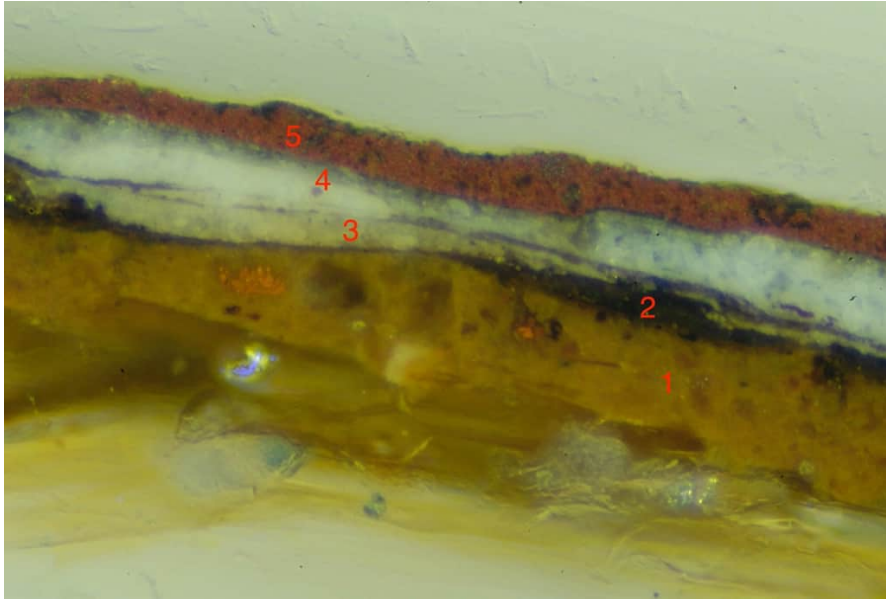
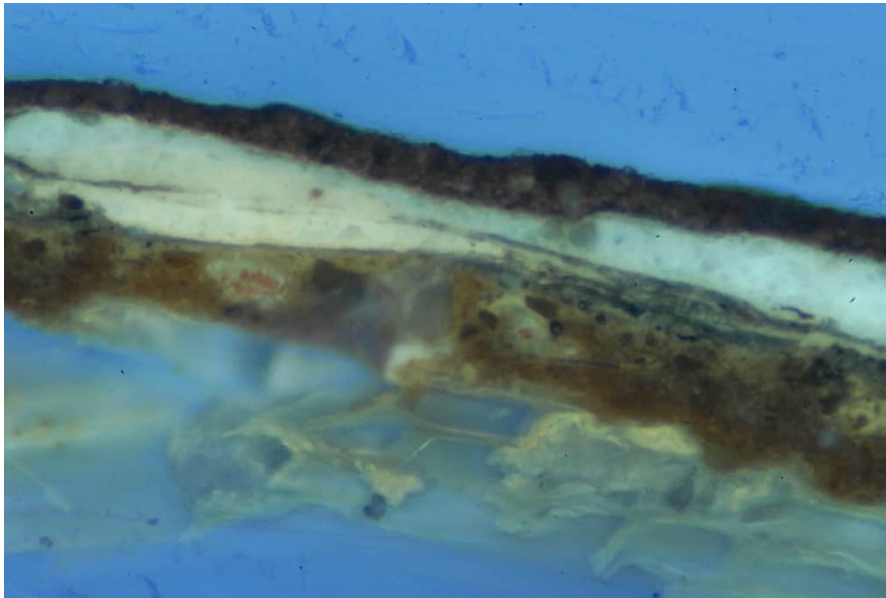
**Sample 026 East wall, floor underneath baseboard, at the former doorway opening.**

NPH 026 vis. 125X

NPH 026 UV 125X

Five or six generations of paint were identified on an area of the floor that was protected by a baseboard from the paint stripping that occurred to the rest of the floor. The thin dark layer underneath the gray with white primer layer may not be a paint treatment but more likely it is accumulated dirt and grim. No fluorescence was detected in ultraviolet light, suggesting that it is not varnish. Therefore only five layers of paint are visible, not including the thin dark layer. It is possible that this red paint layer is from the red-painted mopboard on the wainscot applied prior to the application of baseboards during phases 3 or 4.

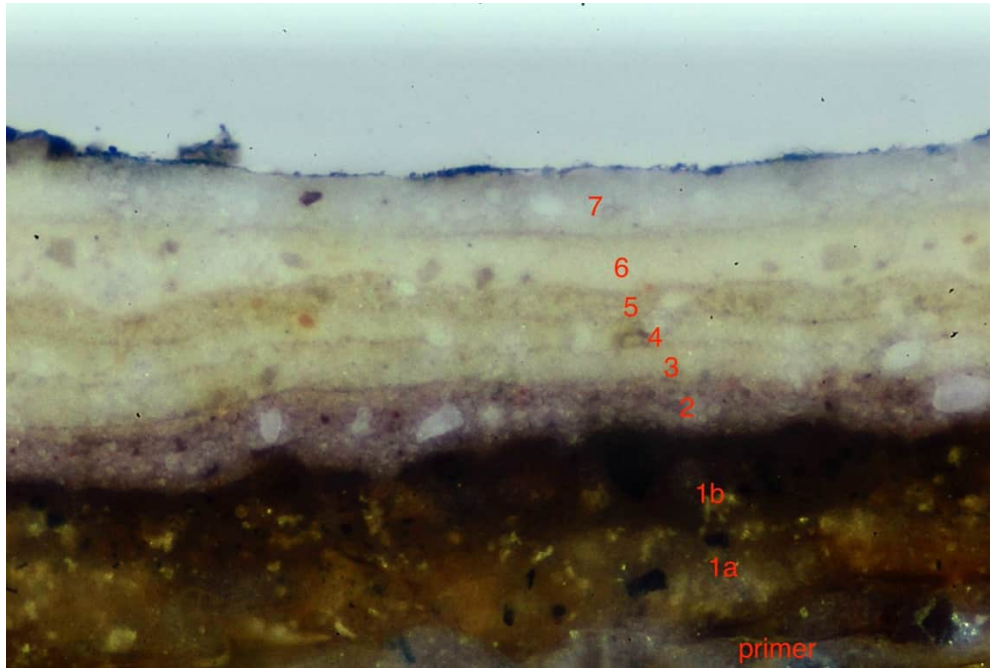
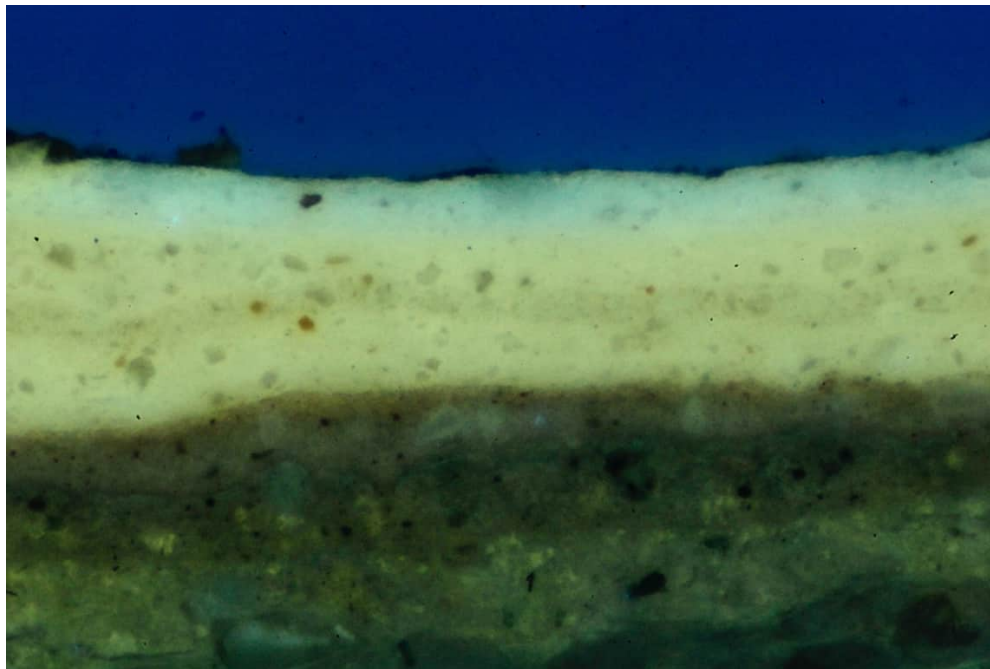
**Sample 030 East wall door architrave, from behind left-side (north) architrave (next to John Leeke sample)**

NPH 030 vis. 125X

NPH 030 UV 125X

This sample represents what is believed to be a complete paint stratigraphy from Phase 2.

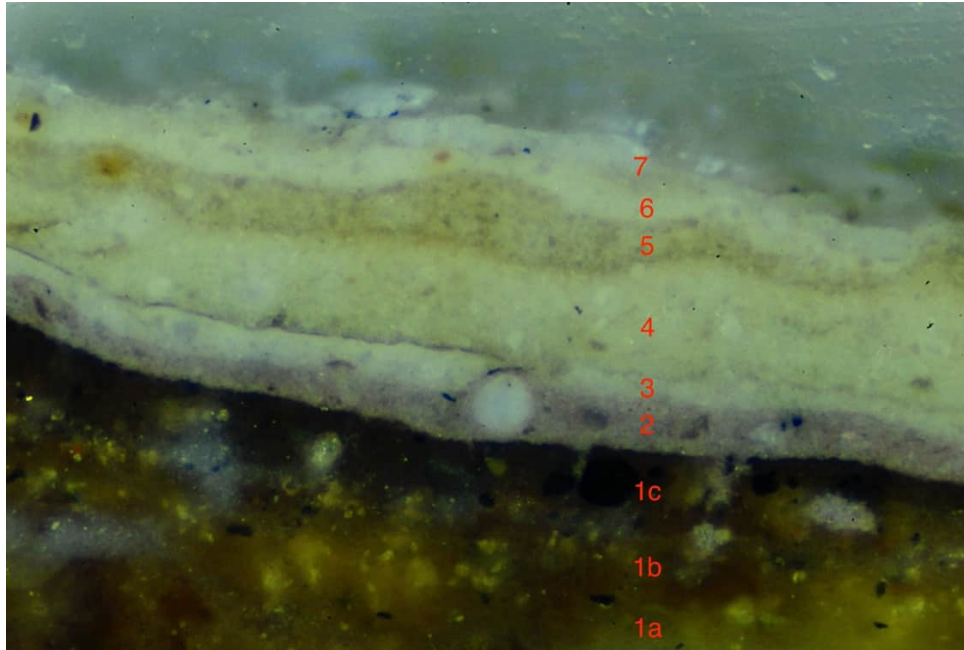
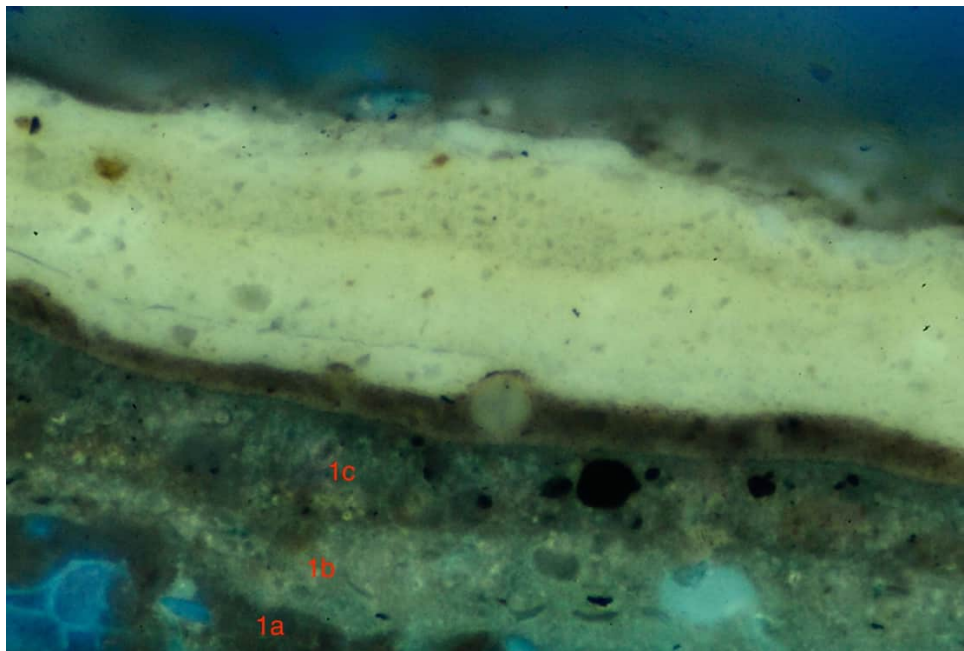
**Sample 031 East wall, beam casing above the removed architrave, next to location of 030**

NPH 031 vis. 125X

NPH 031 UV 125X

The three layers of paint that make up the generation 1 yellow brown treatment are not discernible in the visible light image but are clear in the UV light image. Variations in paint/binder proportions may account for the difference, as paints from this period were hand-mixed, perhaps with haphazard measuring of ingredients.

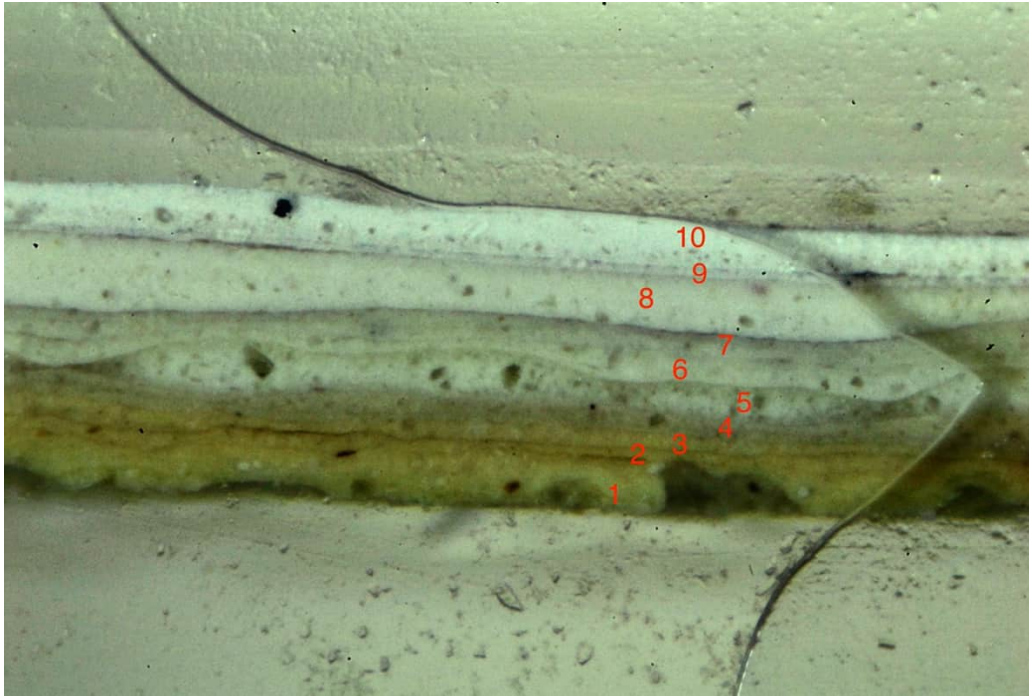
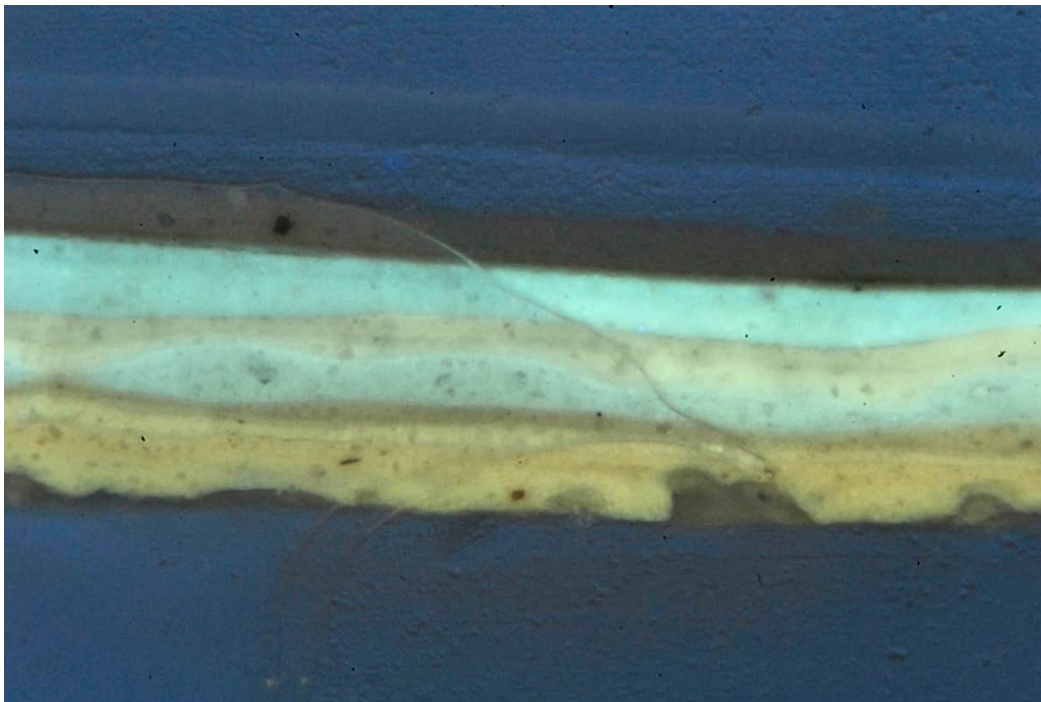
**Sample 033 North wall, door to room 104, outer edge near top rail**

NPH 033 vis. 50X

NPH 033 UV 50X

Ten separate paint treatments are visible on the edge of the door where it was not stripped.

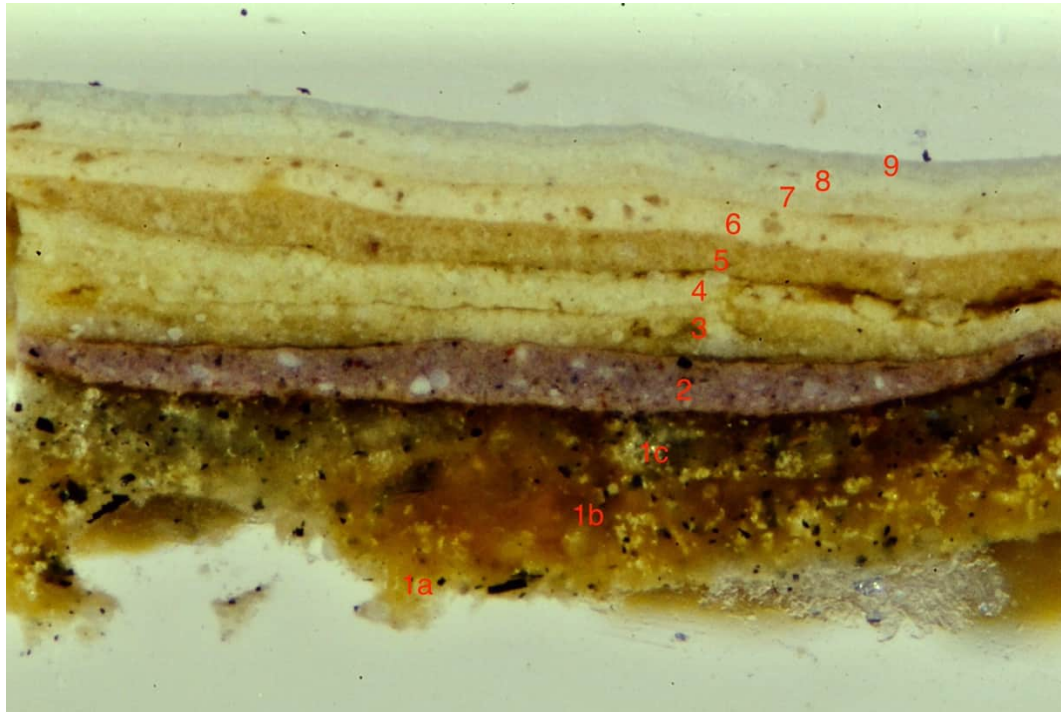
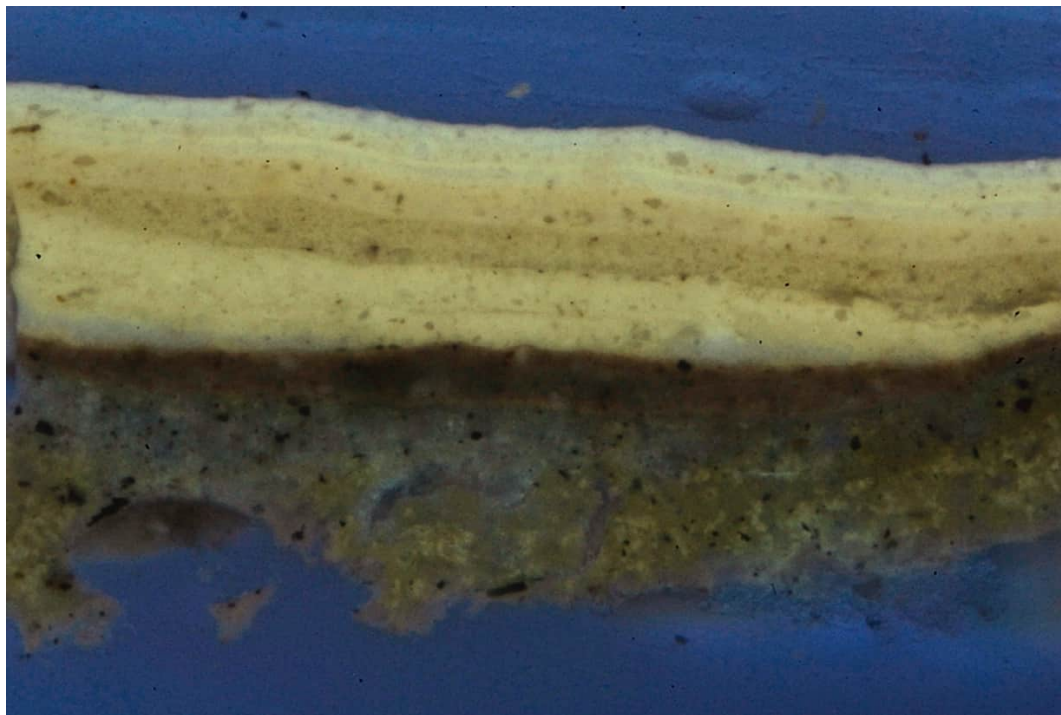
**Sample 040 South wall, wainscot behind removed baseboard. Full stratigraphy to 1950's.**

NPH 040 vis. 50X

NPH 040 UV 50X

Sample 040 was taken from an area on the wainscot paneling behind a removed baseboard.

\$\$ 040 yellow brown generation 1 looks more like a pigmented stain. This stratigraphy matches that of the west wall far south uppermost stile of the paneled chimney breast wall

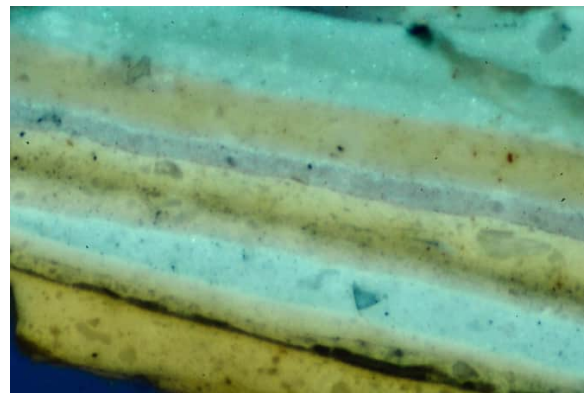
Sample 147

Generation 1 dark yellow ochres are not visible in these samples, so a different image of another sample taken from the same location is included below. Only the lower layers are visible but they show the earliest paints – the multiple yellow ochre layers at the bottom of the sample and fragments of wood.

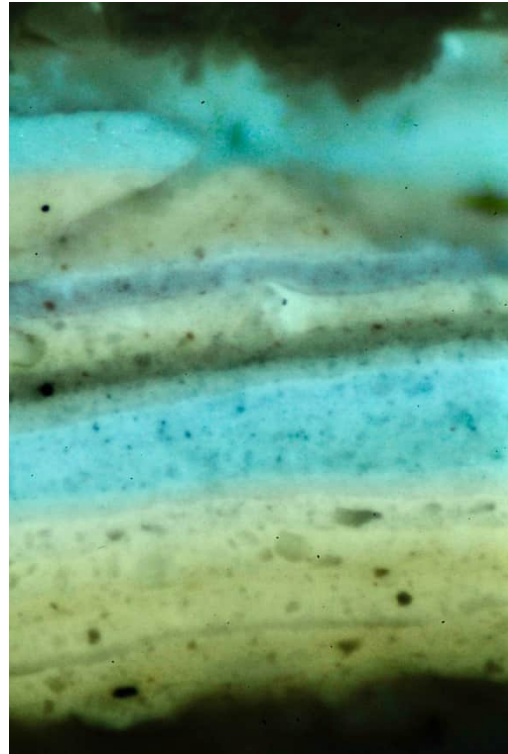
Sample 151

Sample 151, from the south-facing side of the door to the closet in the north wall, shows a nearly identical stratigraphy as compared with the stratigraphy from the mantelpiece, except for the lower first three layers. On the mantelpiece the first three layers were a dark yellow ochre/brown but the door does not have those same colors. The first three generations of paint on the door are a much lighter color, more like yellowish tan.

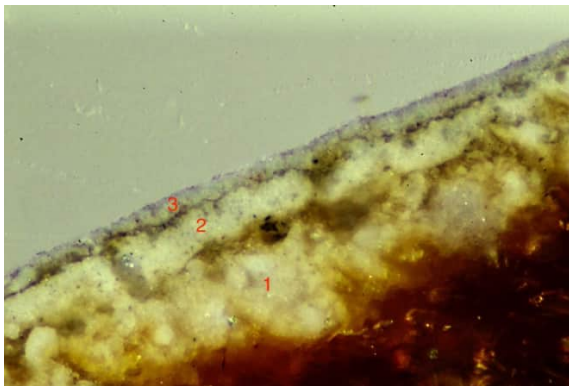
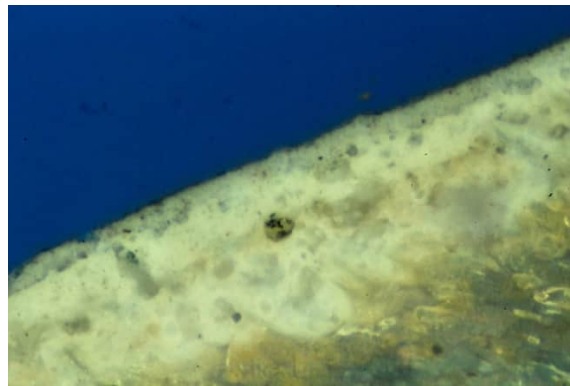
Sample 152 closet paneling east end

Samples 152 and 154 are from the closet interior. There is very little paint on the interior surfaces, suggesting that it has not been painted nearly as regularly as other woodwork in this room. Also, the paints are not modern, so the interior has gone for decades without being recoated. A total of three layers on both was identified, and there is an orange-fluorescing material in the pores of the wood which suggests a shellac sealer.

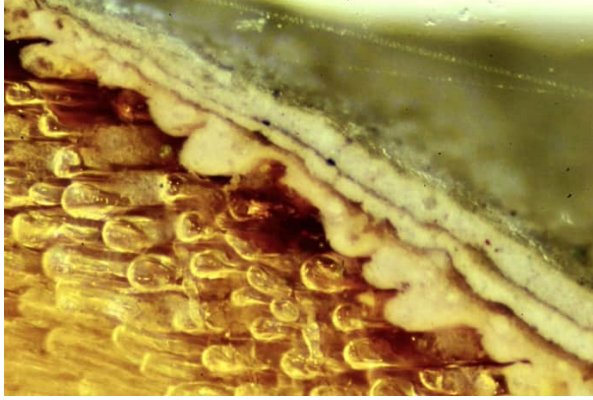
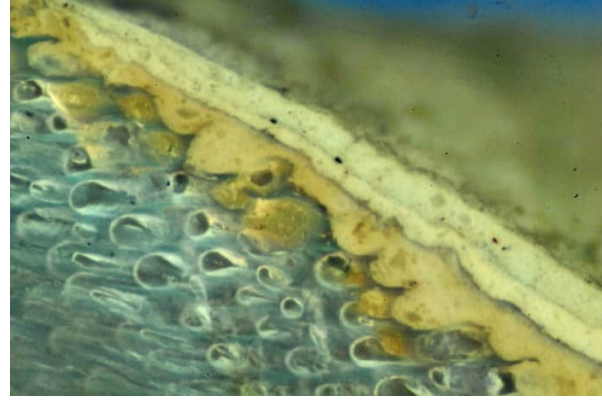
Sample 154 closet shelf support  
125X

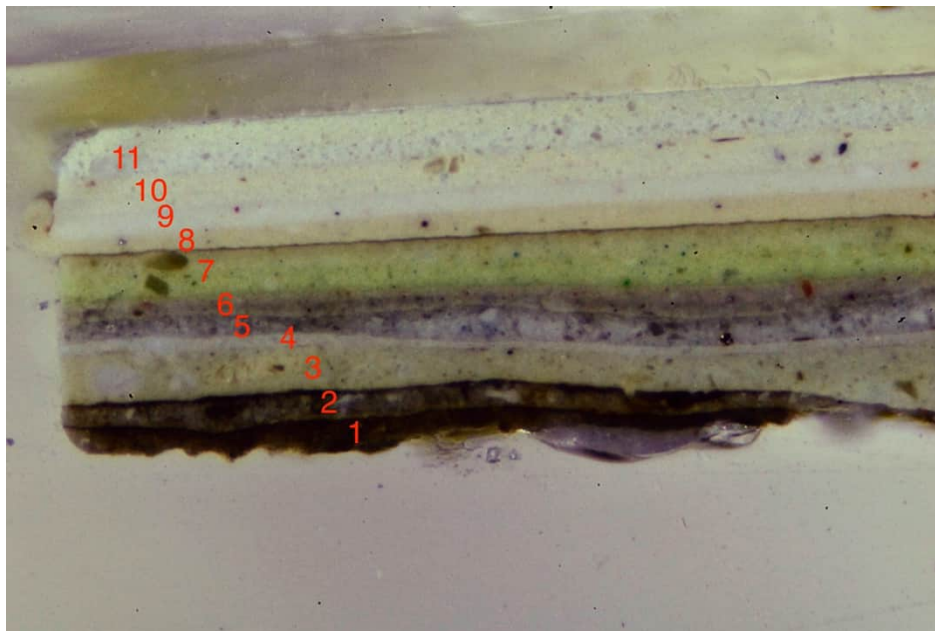
Sample 108 North wall cased post, side facing east

Some elements in room 109 were not stripped, thereby retaining their paint histories. The north wall cased post (108) side facing east, does not appear to have been stripped or altered in any other way. It has a paint sequence of approximately 11 treatments. A bit of gray paint was noted at the bottom of the bottom layer. It is possibly a floating fragment and unlikely that it is part of the stratigraphy.

A comparison of paint sequences from the cased post on the north wall of room 109 shows that the two sides have completely different paint sequences. The only explanation for this is that the east side (108) received a different treatment from the south side (109) of the casing because it was essentially in a different space, enclosed in a previous stairway relocated to that position in the early 20<sup>th</sup> century.

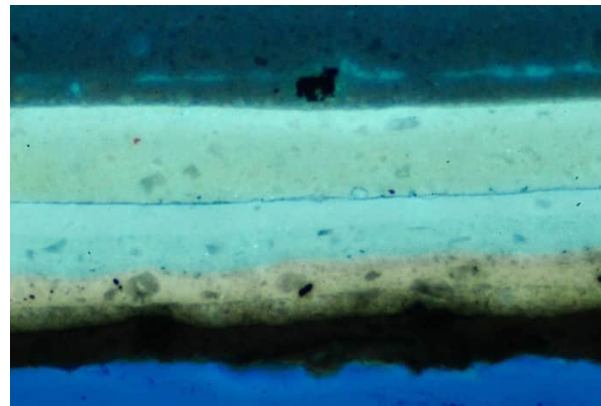
Sample 109 North wall, cased post, side facing south vis. 125X

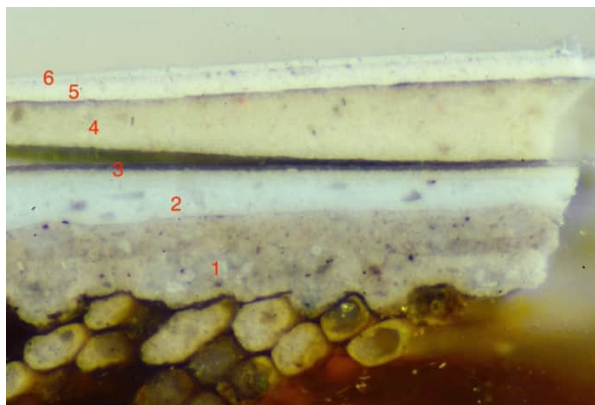
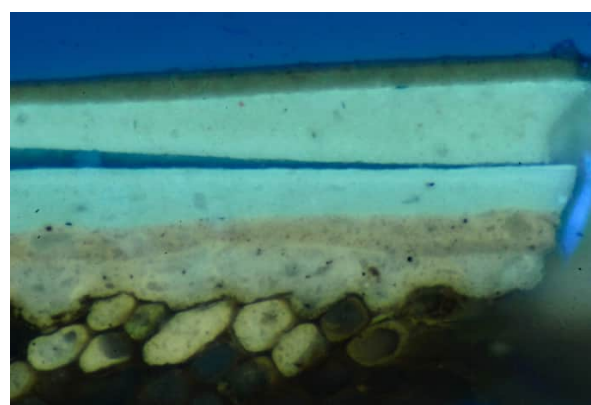
Sample 115 West wall paneling, board #1, at top vis. 125X

An engaged cabinet has been installed against the west wall in room 109. It covers the north wall, thereby trapping earlier paints and protecting them from removal. Sample 127, taken from Nathaniel Parsons House Historic Structures Report  
Myron O. Stachiw et al.  
April 2026

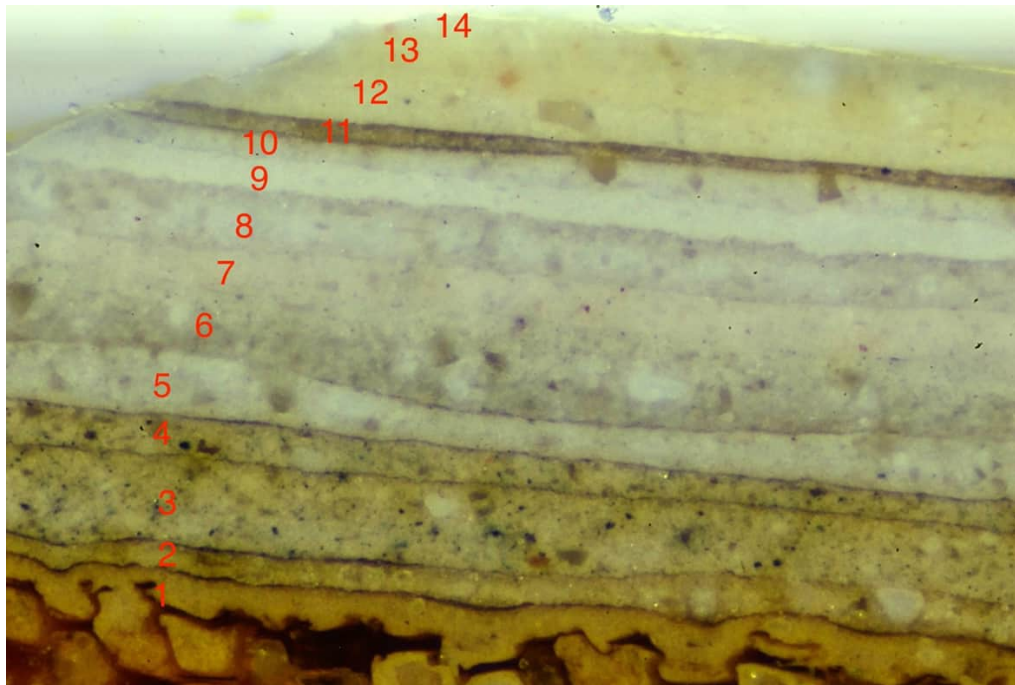
Sample 125 was taken from the stile over the doorway to room 110, in the west wall. Surprisingly it has a significantly long paint stratigraphy as compared with other painted surfaces in the room. There are a total of 14 layers, which may represent a complete history of paints in this room. However, since we know that the wall between rooms 109 and 110 was not part of the original construction but installed at a later date, it is important to determine if the stile is reused wood from another location.

Sample 125 west wall panel over door to 110, from a yellow area
