**Appendix 1A - Christine Thomson, Decorative Arts Conservation, Salem, MA**  
**Notes and stratigraphic charts by room from investigations at the Parsons**  
**House, 2024-2026.**

**Nathaniel Parsons House, Northampton MA**  
**Room 101 Notes**  
**December 6, 2024**  
**Revised January 16, 2026**

Nathaniel Parsons House Historic Structures Report  
Myron O. Stachiw et al.  
April 2026

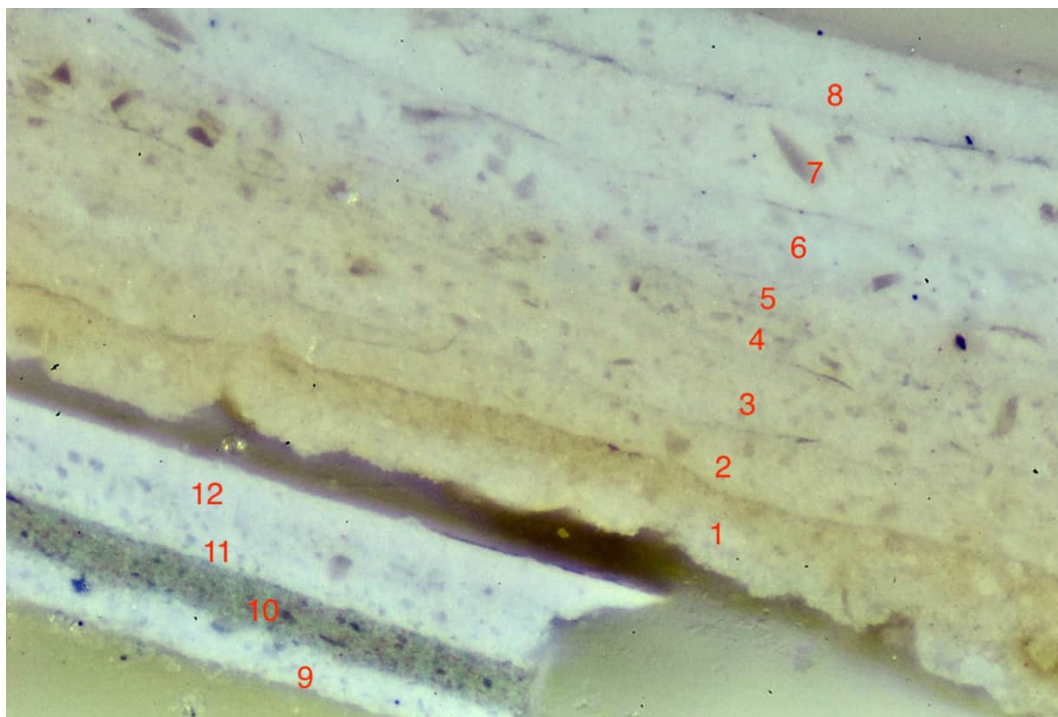
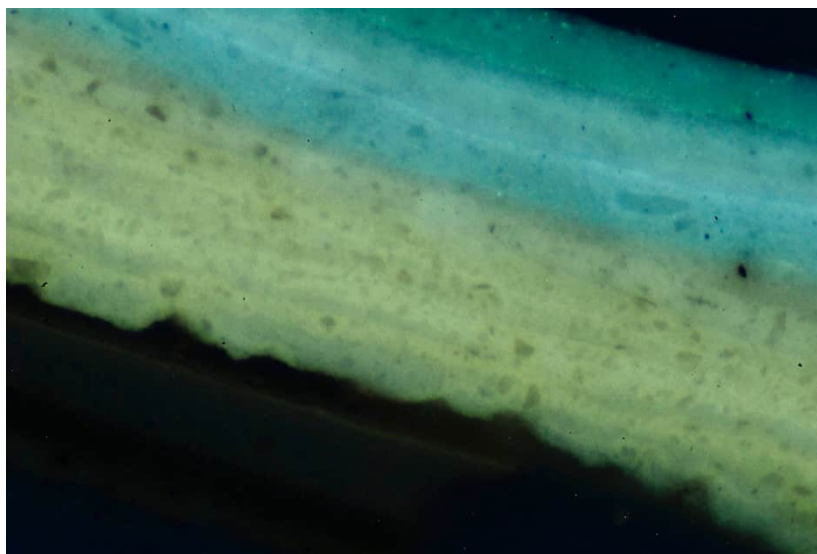
069 West wall window architrave, bottom rail,

The paint stratigraphy identified on the architrave of the west window below the sill is typical of the paint history in this room. There are approximately 12 paint treatments applied the wood, a number that appears to be consistent on other trim elements in the room.

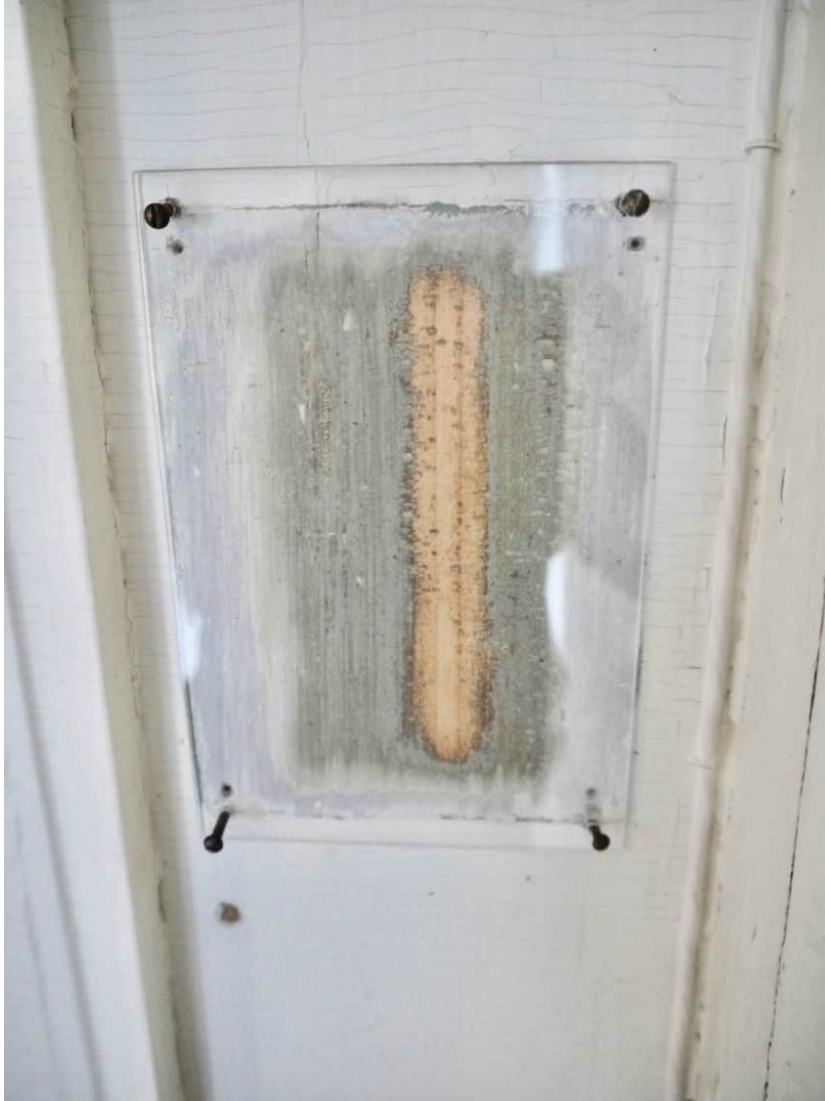
This is the “window” reveal made on the east wall of room 112 during the SPNEA investigation. It is located near the southeast corner and clearly exposes the generation 1 paint color which whose appearance is now more gray than blue.

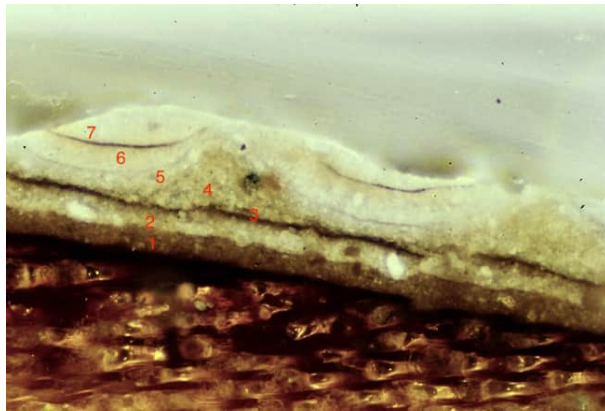
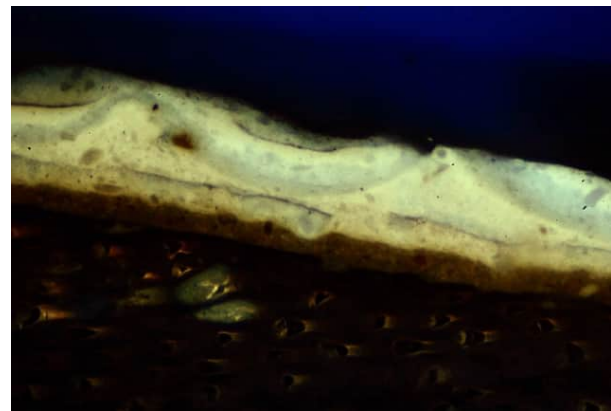
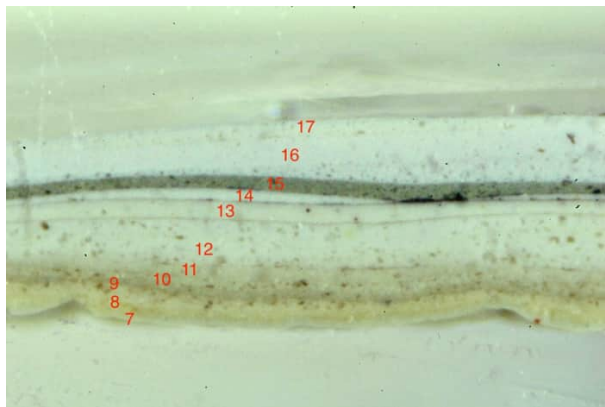
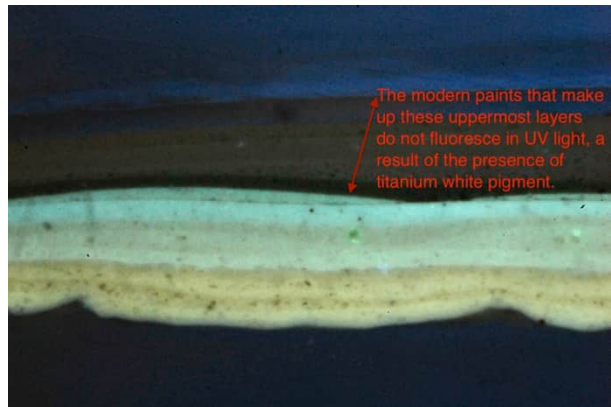
043a East wall panel, lower layers vis. 125X

The four images above show in sample 043 what is believed to be a full stratigraphy of paint treatments dating from the time that the east wall paneling was installed. There are approximately seventeen paint layers, with the first layer a gray/tan color. This Generation 1 layer is described in the Historic Structures Report as "blue green", but it does not appear to be that color now, either in the revealed window or in the cross-section images.

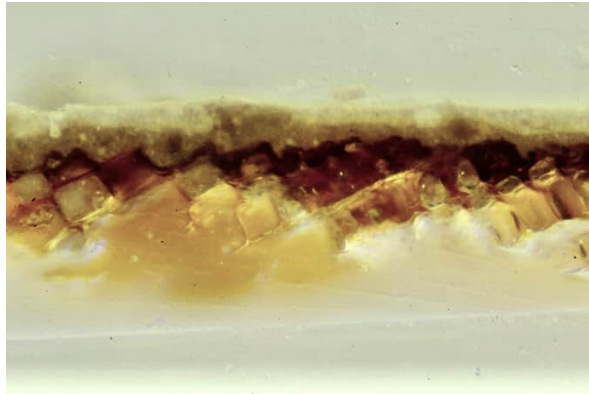
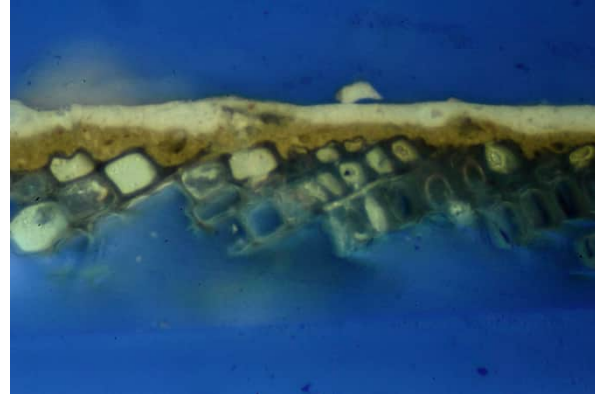
048 East wall paneling behind baseboard vis 125X

A baseboard was removed from the east wall (south of the fireplace) in order to access the paneling behind it. Interestingly, two paint layers (048) were identified on the protected woodwork, which suggests two things: the woodwork was painted before the baseboards were added, and the two paint layers are actually part of a single treatment even though they are different colors, in other words a primer and finish coat. Another indicator of these paints being part of a single generation treatment is that close examination of the border between the two layers does not show any indication of dirt or weathering, suggesting that the second layer was applied soon after the first layer, which had not been exposed to the environment long enough to accumulate any dirt or grime. That being the case, the layers numbered 1 and 2 are part of a single paint treatment. The paint found on the paneling behind the baseboard (048) provides valuable information that helps to analyze the other paints in this room. It has a distinctive appearance – a yellow tan color on a darker gray/green/tan primer, unusual in that primers are more commonly light in color. The somewhat unusual appearance of the generation 1 paint

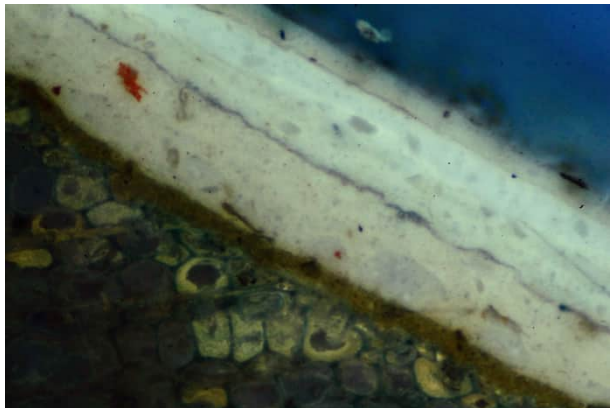
047 same loc. UV 50X

A comparison of samples 046 and 047 indicate that the molded tops were not painted the generation 1 brown but rather the generation 1 color of the rest of the woodwork. Below the sample 047 from the baseboard molding has no brown layer on the wood but there is a sealer or stain, followed by the generation 1 paint colors – yellow tan on a gray/tan/green primer.

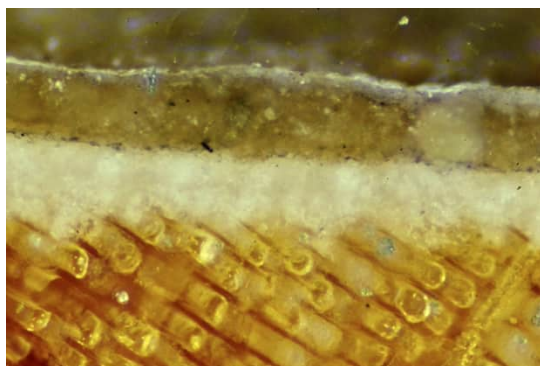
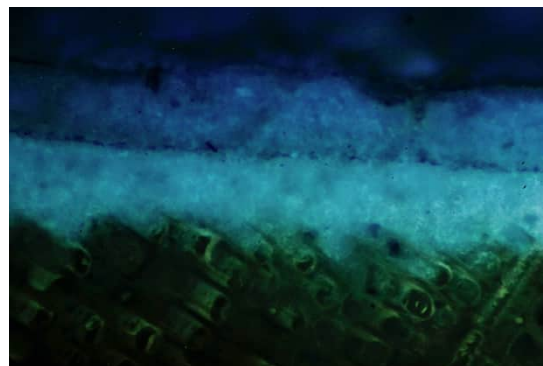
065 Southeast corner post, west-facing side vis. 125X 065 same location, UV 125X

The images of sample 065 show the first two generations of paint only. The paints have a translucent visual quality typical of lime washes or distempers, although further study and testing would be required to confirm this. In the stratigraphy chart, there is a gap of several layers suggesting that the posts were left painted brown during several subsequent campaigns of repainting.

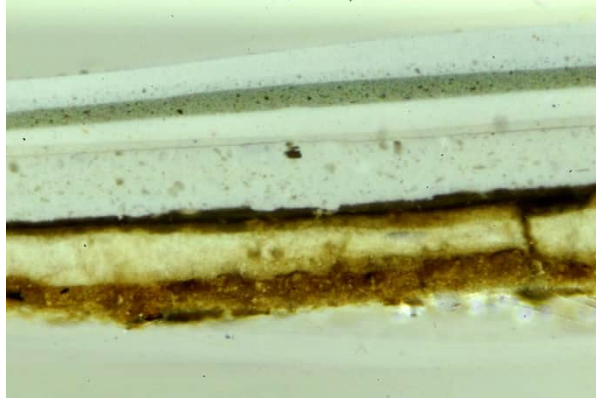
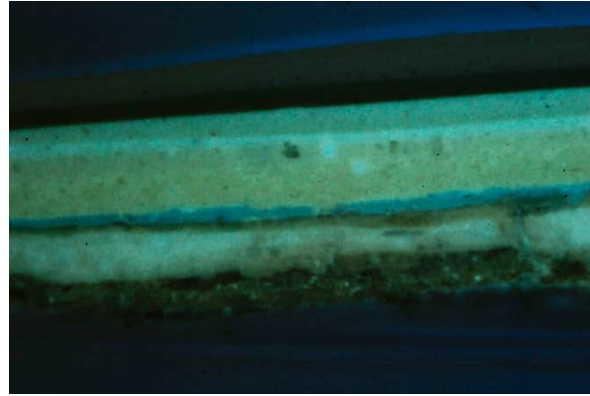
092 North wall bottom of cased beam vis. 50X

Sample 092 was taken from the bottom of the cased beam that runs along the north wall, in an area that was once covered by an engaged cabinet. There are no more than 9 or 10 paint treatments as compared with the 15-17 layers found on the rest of the woodwork. It does indicate, however that the paint stratigraphy matches that of the cornice moldings, with the earliest layers dark brown, possibly a decorative paint treatment replicating mahogany or other more exotic wood.

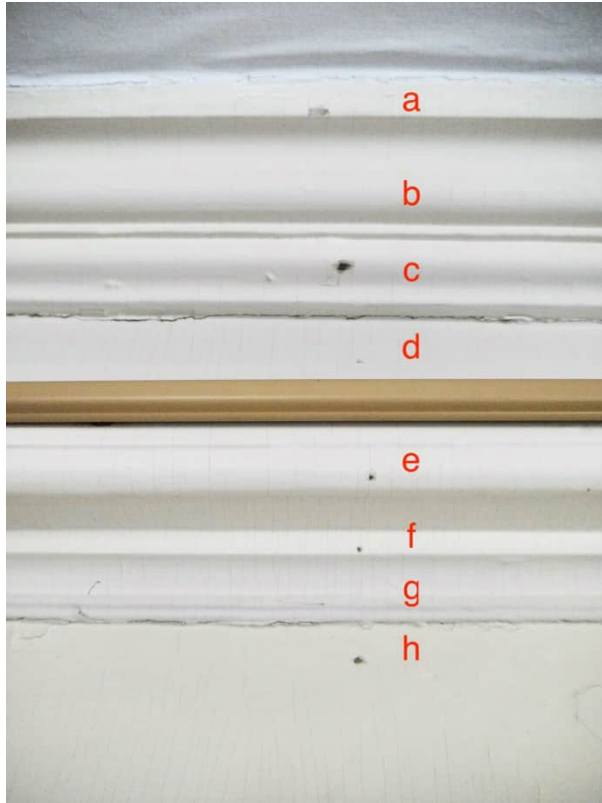
East wall cornice with labelled sections

There is evidence that the earliest (uppermost section) of the east wall cornice crown molding was originally painted dark brown with a varnish which may represent a faux wood graining paint treatment intended to make the pine of the cornice look more like mahogany or another more exotic wood. It was a common practice in the 18<sup>th</sup> and 19<sup>th</sup> centuries to apply paint in imitation of wood grain, often referred to as “faux wood graining”. However, in some of the cross-section images the possible graining treatment looks more like a single thick varnish layer, suggesting rather that the varnish layer may be simply a sealer. It is not clear if the brown color is the result of added pigment. Cross section microscopy can only suggest the presence of a faux wood grain treatment. To best determine the original appearance of the upper cornice (the part left from the previous woodwork installation) it would be necessary to create a “window” to the layers in question by removing all upper layers of paint, similar to what has been done on the paneling to the right of the doorway to the entry hall (101).

The paint sequences on the east wall cornice are consistent to a point. The lowest portions (f, g, ) of the molding have a different paint history than the uppermost sections.

The paints on elements f, g and h are consistent with one another, suggesting that the Federal molding was installed at the same time as the paneling rail, later than the uppermost portions of the crown molding (a, b, c, d, e). Sample 060 is taken from the added Federal-period molding.

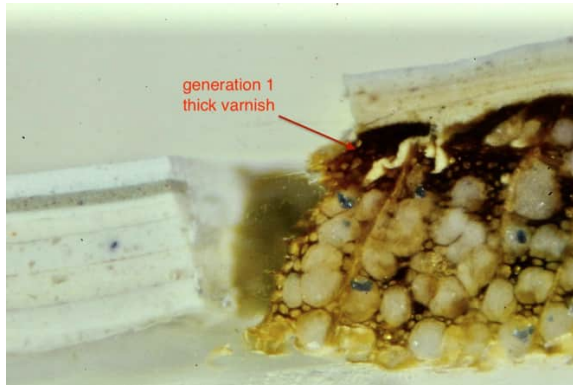
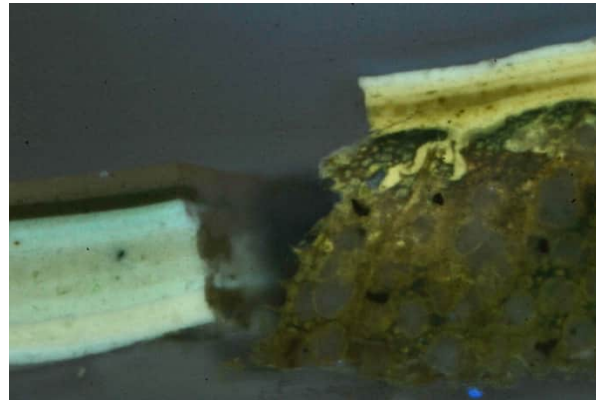
061 East wall cornice molding, uppermost ogee vis. 125X 061

Sample 061, from the upper portion of the east wall cornice molding shows a distinct thick dark layer of varnish, possibly pigmented, directly on the wood. This varnish can be seen fluorescing in the pores of the wood in the UV image on the right, suggesting that its binder is a plant resin material as opposed to oil which would be more typical of a faux-graining treatment.

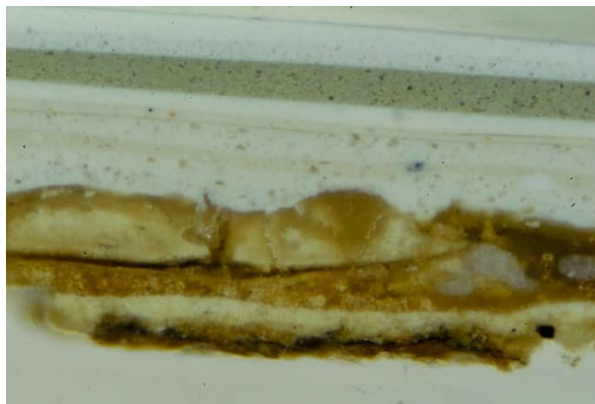
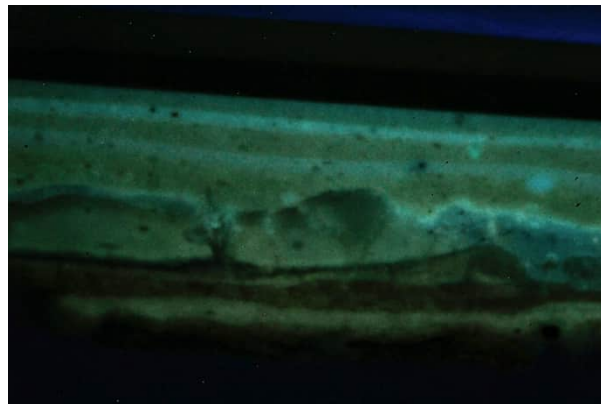
066 East wall cornice, flaking paint vis. 125X

Sample 066, removed from the east wall cornice at an area of actively flaking paint, is an anomaly. It is missing the lower layers found on the rest of the cornice. Instead, there are several layers of cream color, dark brown and what appears to be a possible layer of wallpaper between them. Wallpaper fragments repeatedly are found on woodwork, either the result of sloppy application or deliberate intentions to apply paper to cornices and cased posts.

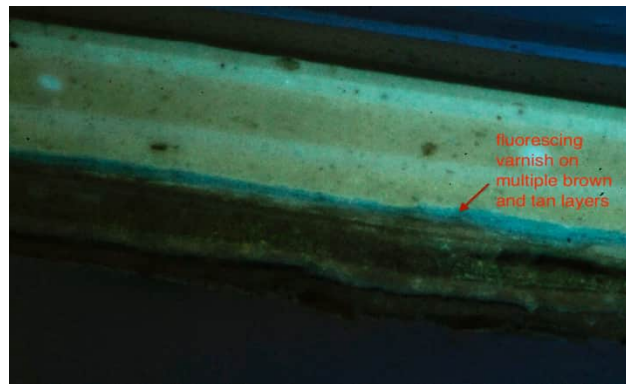
079 vis. 50X

Sample 079 has clear evidence of a decorative treatment, including the top varnish, visible in ultraviolet light. The lack of evidence of the generation 1 colors (tan yellow on a gray green primer) suggests that the graining was not covered up with new paint when the Phase 2 paneling was installed, but was eventually repainted with the rest of the woodwork in later campaigns of restoration.

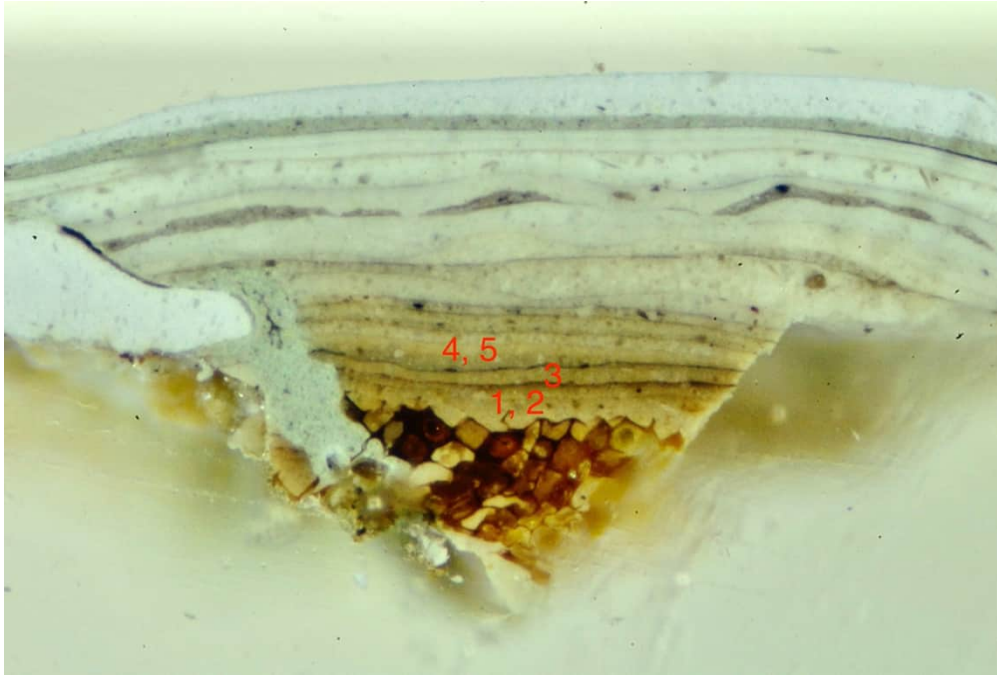
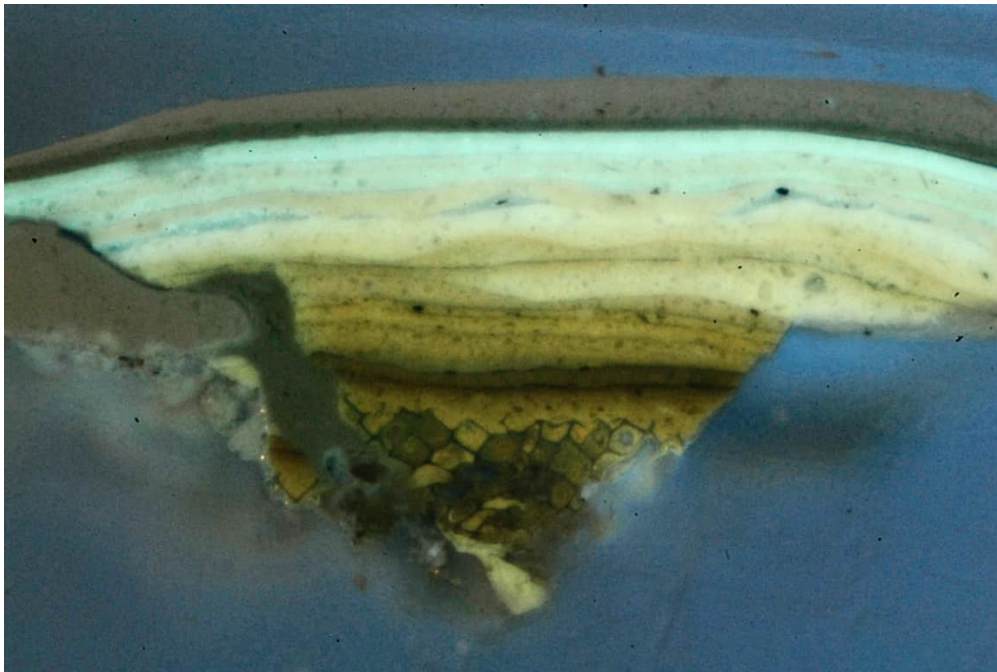
051 North wall door architrave, top rail

The sample taken from the top rail of the door architrave (051) has more paint layers than other locations and the earliest colors are light reddish browns. The marker layers that match the first paint treatment applied after the 1810-20 renovations and installation of new paneling are layers 4 and 5 in this photomicrograph. This sequence of paint layers suggests two possibilities: that the

wood and its early paint was recycled from another location, or more likely that it is surviving trim from the 18<sup>th</sup> century finishes in this space. The earlier yellow tan colors have shown up on other elements and are visible in the following samples: 054 post casing, 060 east wall cornice and 071 east wall cornice, suggesting that these elements have surviving 18<sup>th</sup> century decorative finishes, paint dating from before the early 19<sup>th</sup> century renovations

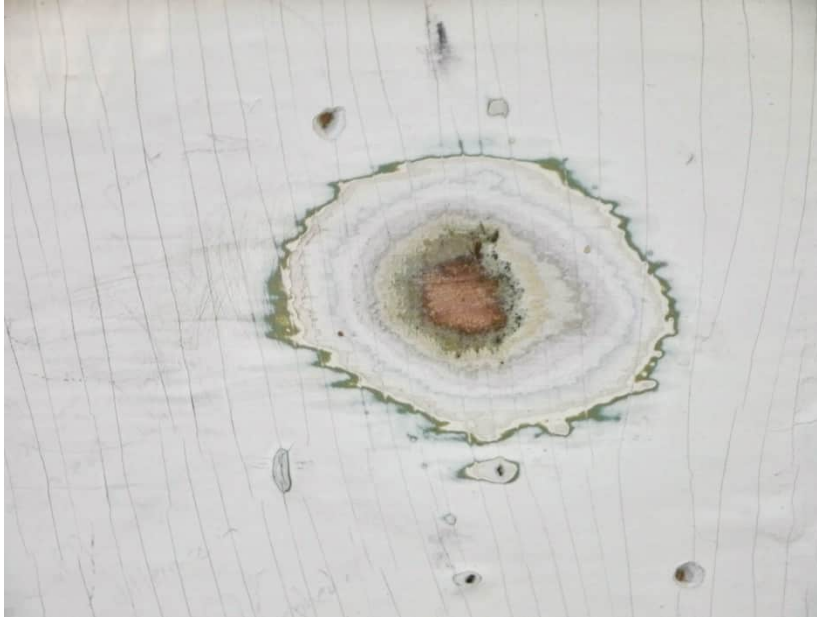
This paint excavation (“bullseye”) was made in the south wall wainscot during the compilation of the Historic Structures Report in 1993 by Greg Clancy and John Leeke. It was intended to reveal the paint layers in sequence. As seen below (067) a sample taken from close by this bullseye and prepared for cross-sectional microscopy can provide additional information on the number of paint treatments and the presence of varnishes, glaze layers or other components of a paint treatment that might not be visible in a traditional excavation.

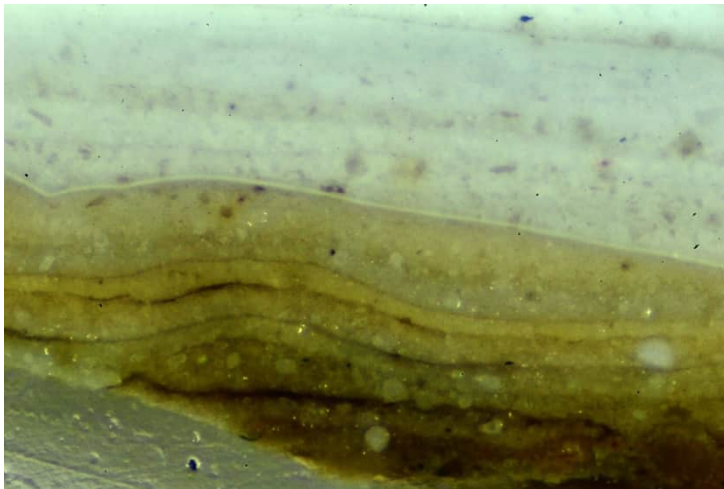
067 South wall wainscot at west end

1. \* 067 is missing four layers – a possible explanation is that a piece of furniture or other object covered this area and was too heavy to move when repainting occurred so did not accumulate the same number of paint layers as other areas.
2. \*\*071 - these brown layers are not wallpaper layers but possibly glue residues from previous wallpapers or another paint treatment applied to this particular area.
3. \*\*\* 074 - the single paint layer fluoresces slightly in UV light, suggesting that it could be pigment bound in a resin or oil-modified resin.
4. 079 shows that the earlier layers suggest a decorative treatment such as faux-wood graining and the lack of marker layers suggests that the decorative treatment was left uncovered when the 1810-20 paneling was installed. They did, however, paint the baseboards to match the paneling.

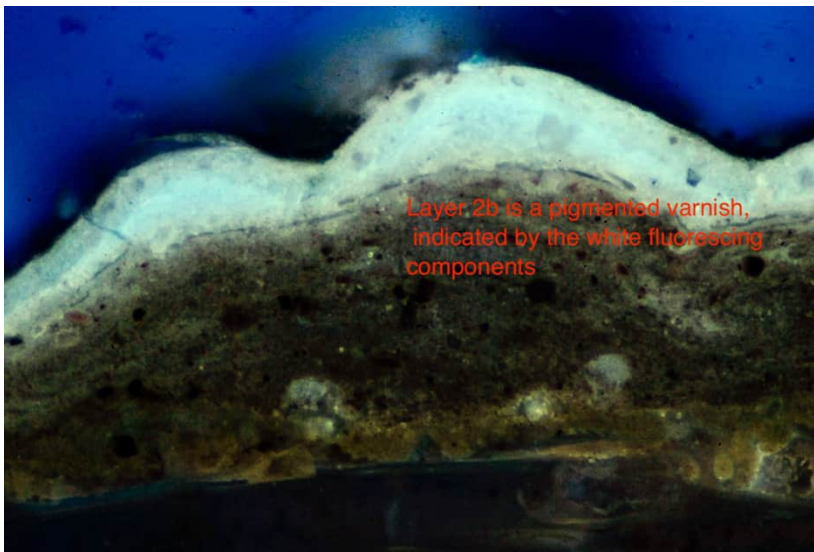
055 East wall, inside engaged cabinet UV 125X

The interior of this cabinet has been painted with strong colors, not found anywhere else in this room. The shelves were originally painted dark red with a red pigmented varnish on top, while the walls were bright blue green. The uppermost layer on the shelf was painted bright green but only fragmentary bits survive. The colorful interior is more suggestive of an 18<sup>th</sup> century color scheme. This cabinet was constructed as part of the c.1810-1820 Federal Period paneled chimney breast wall.

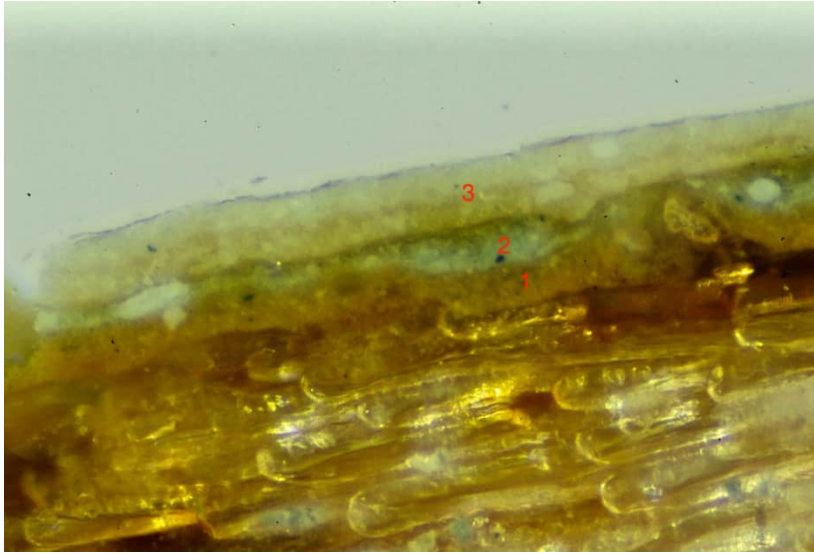
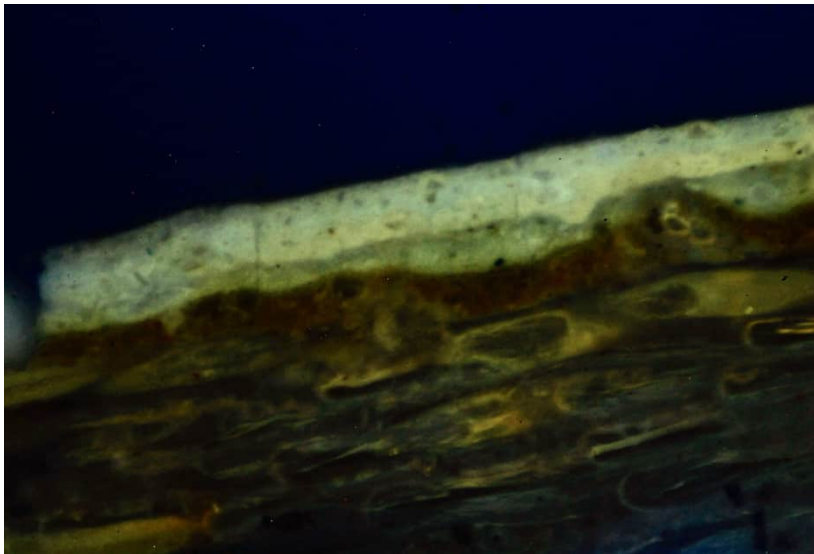
063 From inside south wall of East wall engaged cabinet, vis. 125X

Generation 3 on sample 063 is made up of two distinct layers but in UV light they appear as a single layer. Most likely a two-coat paint treatment as they are very similar in color.

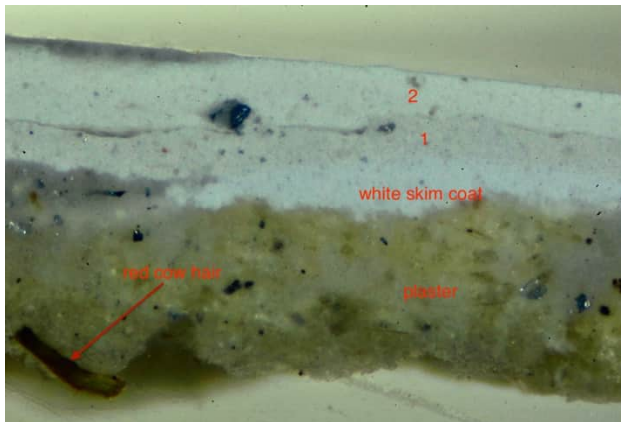
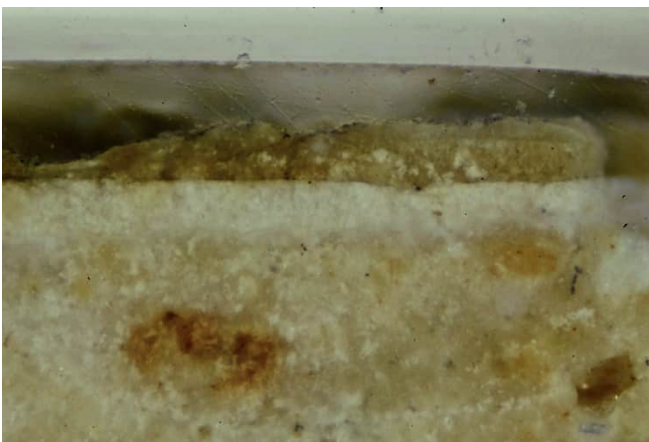
059 South wall plaster under wallpaper vis. 125X

Plaster samples 059 and 068 from different locations show that they are made up of different materials. Plaster 059 from the south wall shows that there are dark pigments and even a strand

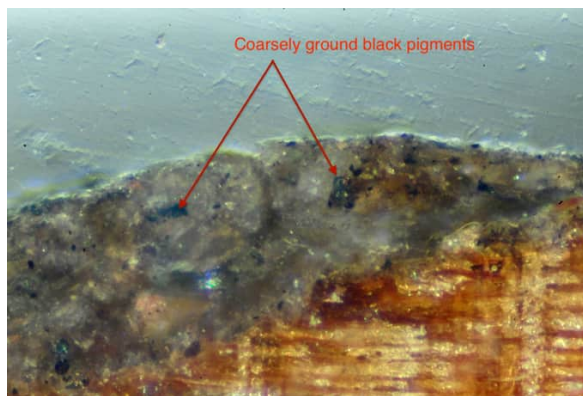
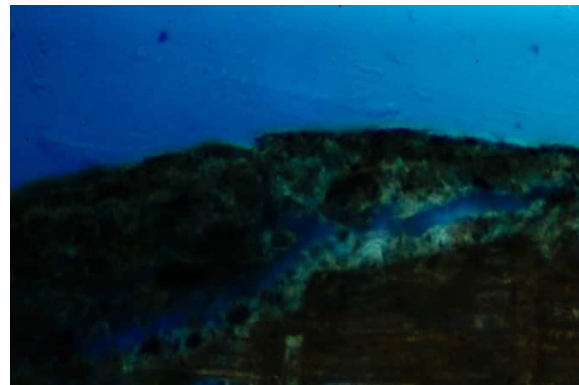
074 North wall baseboard behind wainscot vis. 125X

1. Sample 074, from a baseboard hidden behind the wainscot on the north wall. shows a single paint layer which appears to be a dark greenish brown color. It fluoresces slightly in ultraviolet light, suggesting that it may have a resinous or oil-modified resin binder. Chunky black pigments are visible in the cross-section sample.

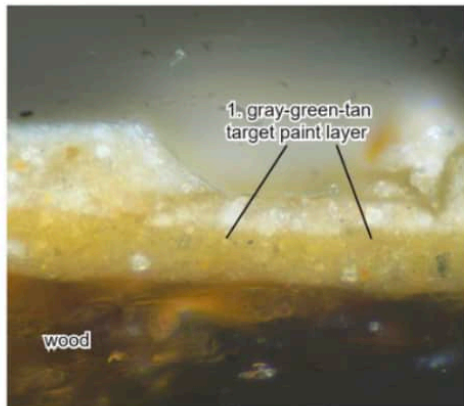
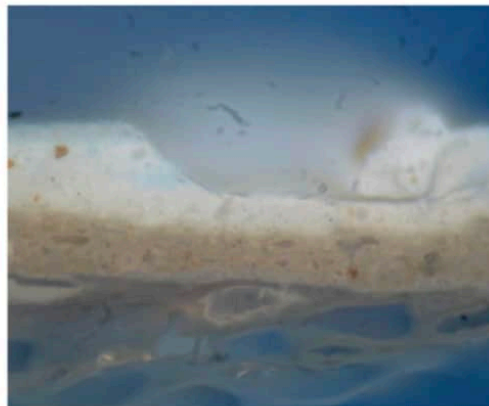
Sample 043, visible light, 200x. Prepared by C. Thompson, rephotographed by Moffitt 2025

Cross-section sample 043 contains the first generation paint described as gray/green/tan in appearance. In cross-section, the layer has a golden yellow colored-matrix overall with occasional opaque dark/black pigment particles, opaque white particles and fine orange-red particles. This layer has a dim autofluorescence in UV.
