# Placing the Parsons House: The Cultural and Ecological Context for Constructing a Connecticut River Valley House

## **Appendix 7 - Historic Northampton Nathaniel Parsons House Maintenance/Repairs Record, 1911 – 2019**

Reference: Parsons House - Structural Conditions Assessment

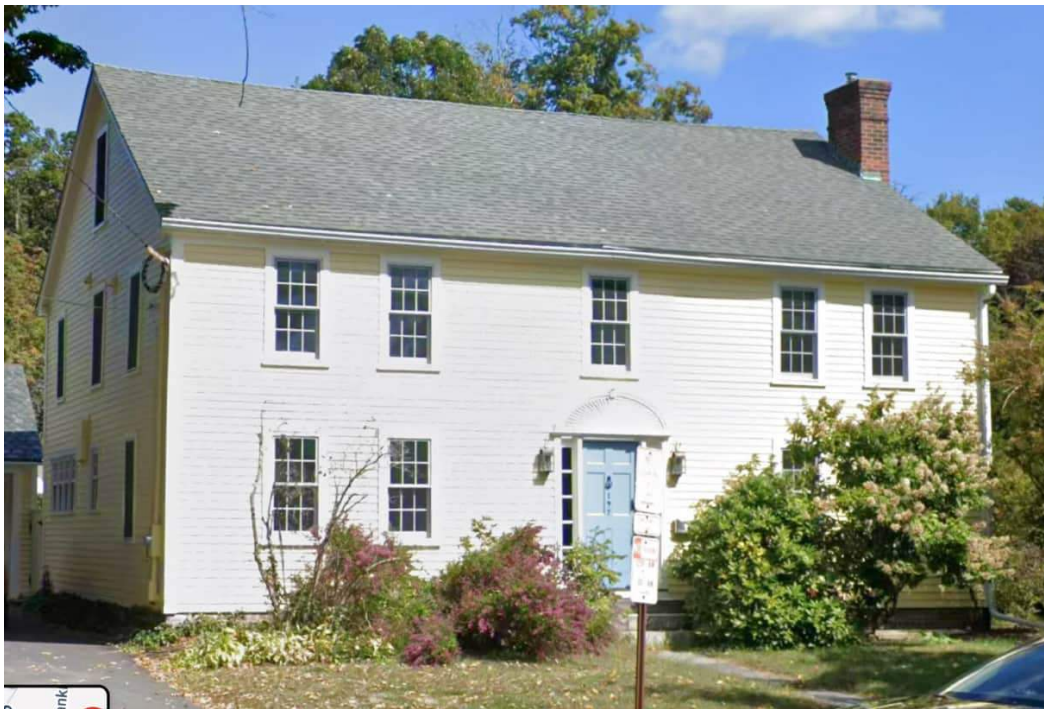
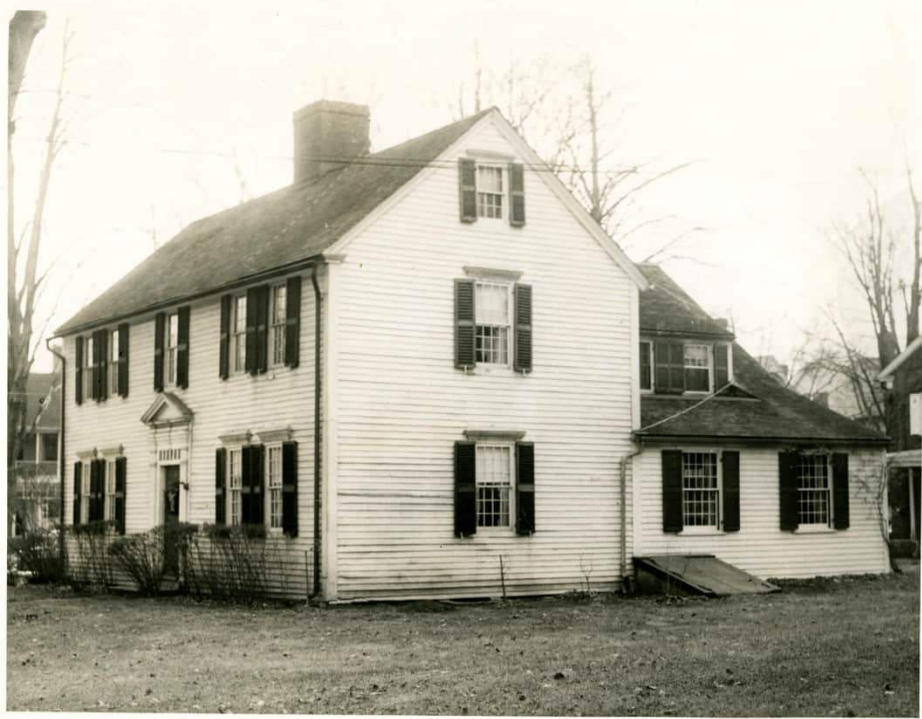
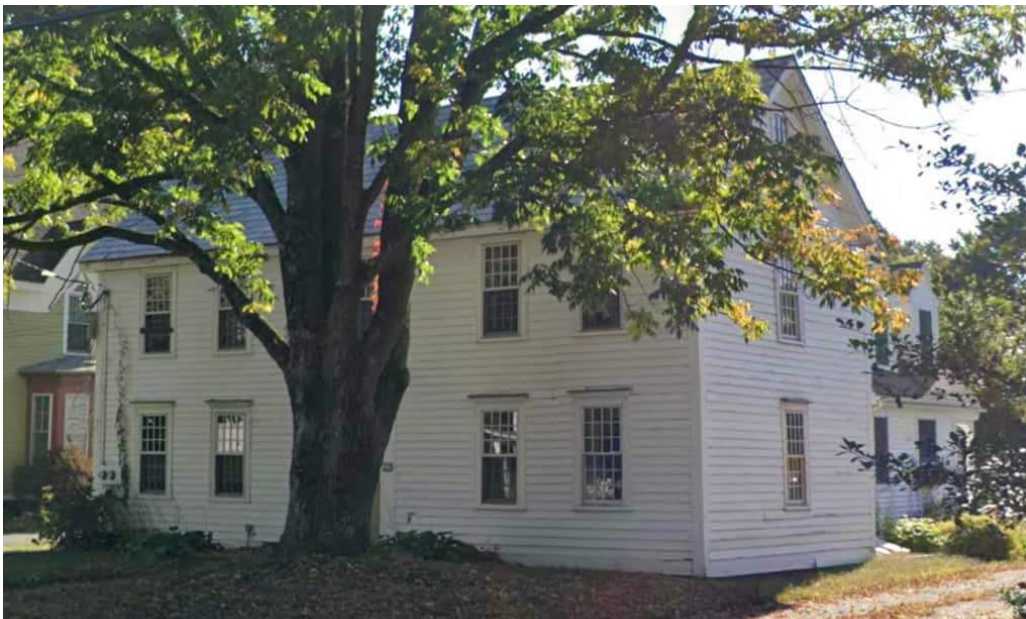
*Figure 38: Ebenezer Clark House 1730 c. 197 Elm Street, Northampton, MA. (Image courtesy of Google Maps.)*

*Figure 39: Clapp House 1713 c. 148 South Street, Northampton, MA. (Photograph courtesy of Historic Northampton.)*

*Figure 40: Unattributed house early 18th century 208 South Street, Northampton, MA. (Image courtesy of Google Maps.)*

The 3 houses in Northampton and the 1 house in Suffield shown above should be investigated for their similarities or differences in construction to the Parsons House.

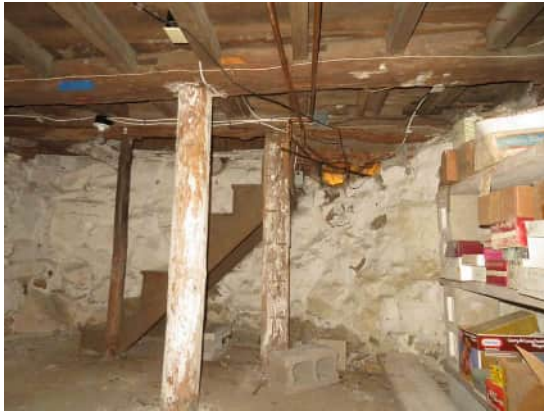
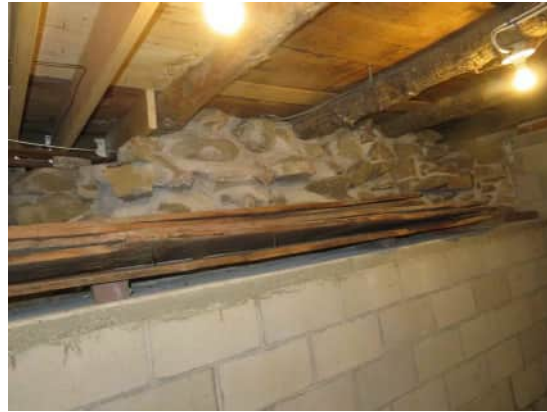
*Left: West block looking north to stair below lean-to; Right: Lean-to looking south*

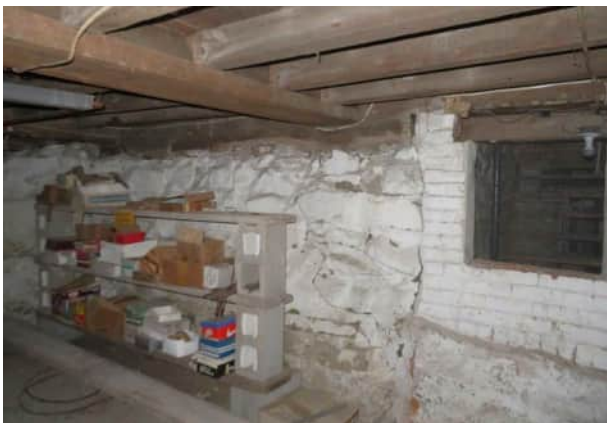
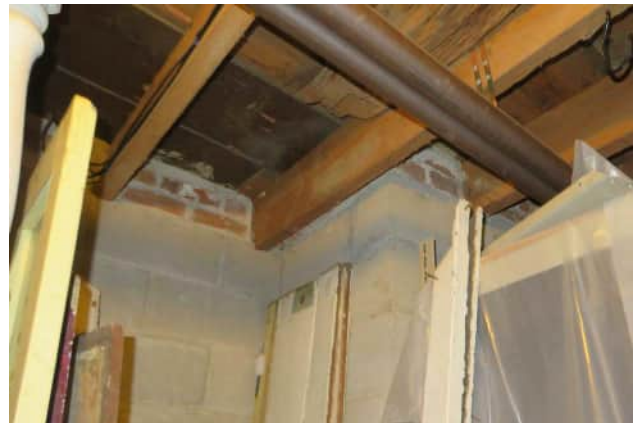
- *Original House with Expansions (c. 1719 to c. 1816).* A large chimney mass is located at the center of the building. The base is constructed of rubble fieldstone like the foundations and appears to have been extended to the north when the lean-to was expanded. During the 1981-82 work, it appears that the north, east and south sides of the chimney base were underpinned with concrete and concrete block masonry to accommodate the new (lower) basement. The chimney mass is constructed of brick masonry at the living levels and extends to a brick chimney mass above the roof.

*West (original rubble stone) and east (1981-82 CMU underpinning) side of main chimney mass base respectively*

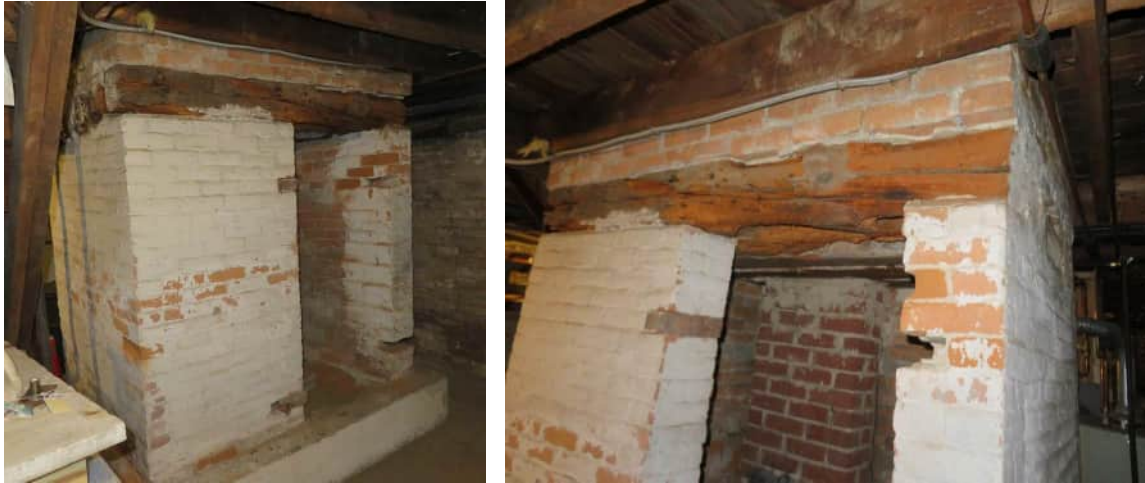
*Kitchen Ell chimney mass base from the north*

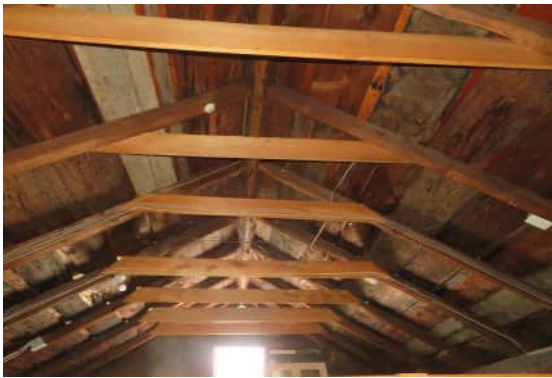
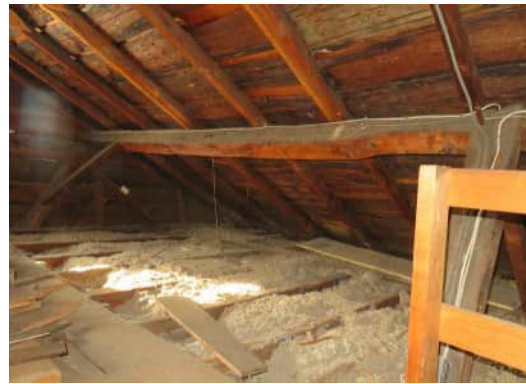
*Original House roof framing showing 5-sided ridge pole; common rafters and central purlin*

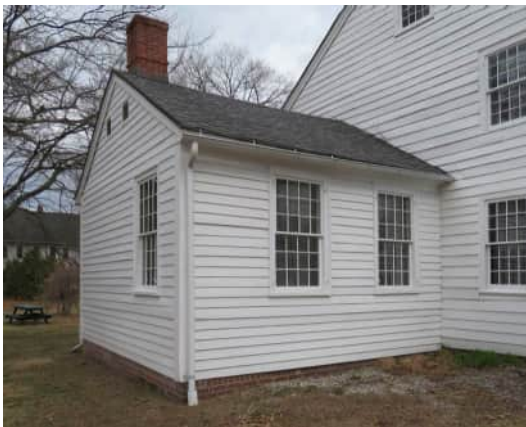
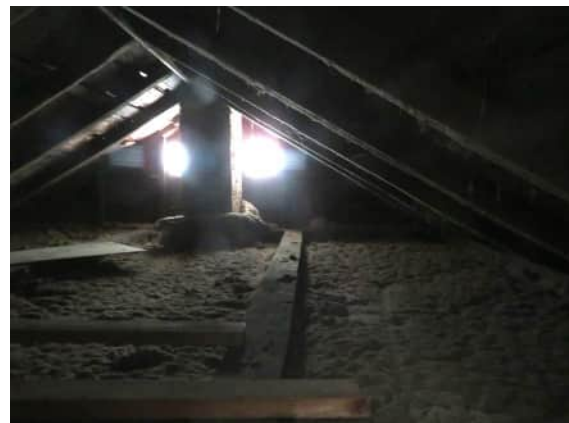
*West Wing exterior; roof framing, looking west*

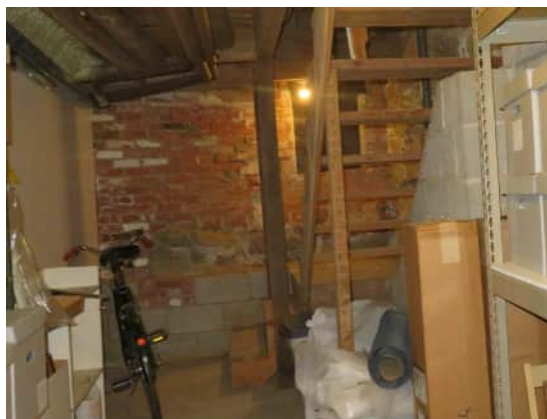
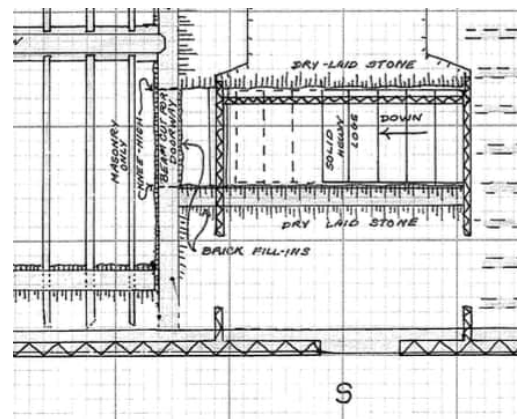
The observations noted above suggest a shifting of the west end of the masonry chimney base. The chimney base is likely constructed of dry-laid stone on the interior; therefore, any introduction of water ingress (say from an open flue above) or change of support (say during the process of excavation and underpinning the north, east and sides) might cause stones to shift and put increased pressure on the west wall. Further investigation is recommended to determine if water is getting into the flues, perhaps by using a drone to check the chimney cap. It would also be beneficial to perform supplementary structural investigation to learn more about existing concealed condition as follows:

*Left: Brick infill wall between west (higher / original) basement and east lower basement, note CMU underpinning below brick and along south wall of the chimney mass; Right: Excerpt from 1979 Rexford drawing showing narrow basement below front vestibule prior to underpinning and constructing full east basement in 1981/82.*

- Review documents from 1981/82 work to determine if CMU block along the chimney mass is underpinning the existing chimney mass or constructed alongside it to serve as a buttress. If documentation not available, consider performing exploratory openings.
- Expose and review: a) the space below the basement landing to view the geometry and condition of the underpinning on that location (below the cracks in the brick; and b) the drywall concealing the connection between the brick separator wall and CMU exterior south basement wall.

- Expose and review the geometry and condition of the concealed masonry near the southwest corner of the chimney mass at the first floor.
- Explore the possibility of removing the base of any of the first floor fire boxes (if not historic) to better understand the construction of the chimney base below.

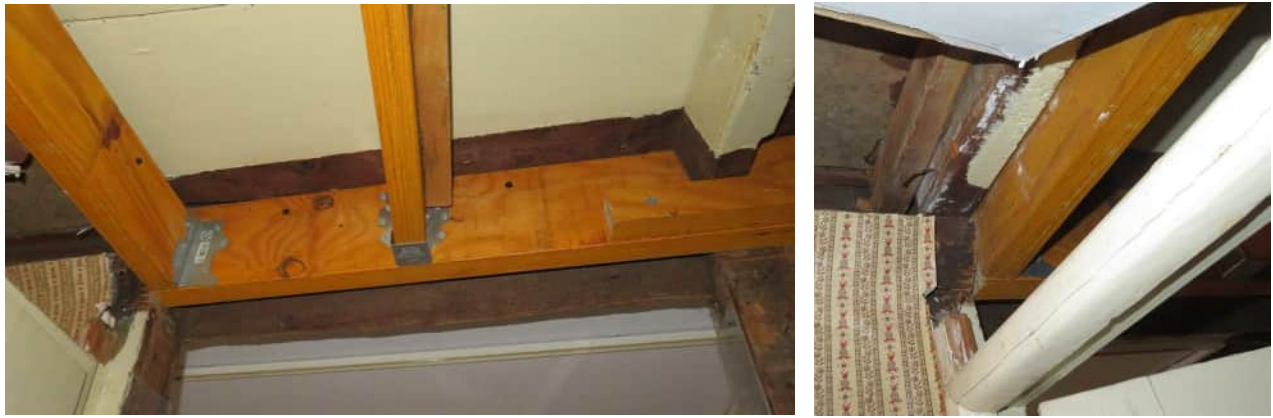
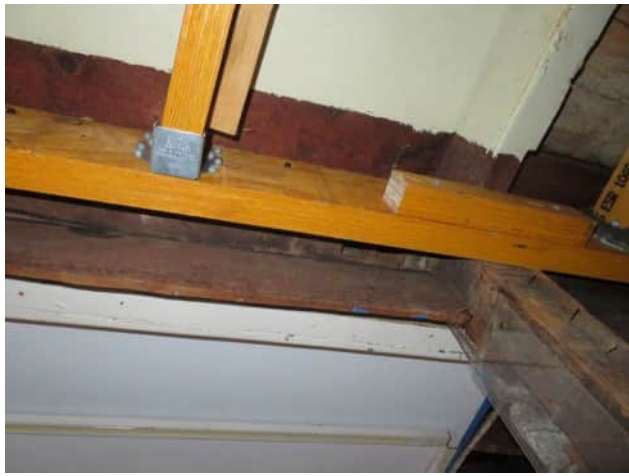
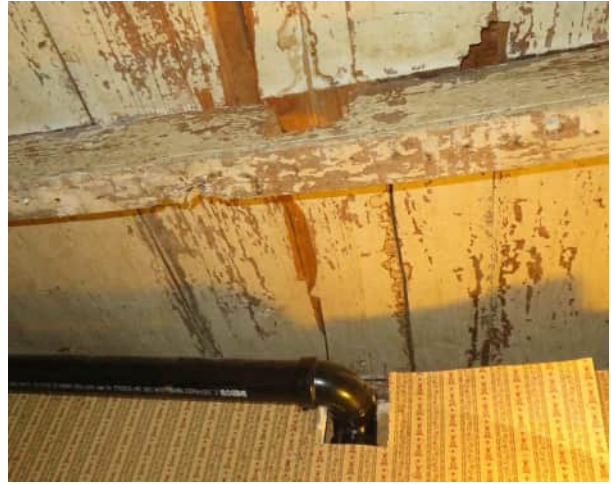
*Top: Ledger at south side of infill, overview and east end (not fastened) respectively; Bottom Left: Central portion of south ledger; Bottom Right: Notch in joist from former waste pipe*

- Item 7 – Reframe stair infill at Lean-to in more historically appropriate way, address deficiencies
- Item 10\* – Cable ties at attic, monitor
- Item 11 – Spray foam, consider removing as part of other planned work

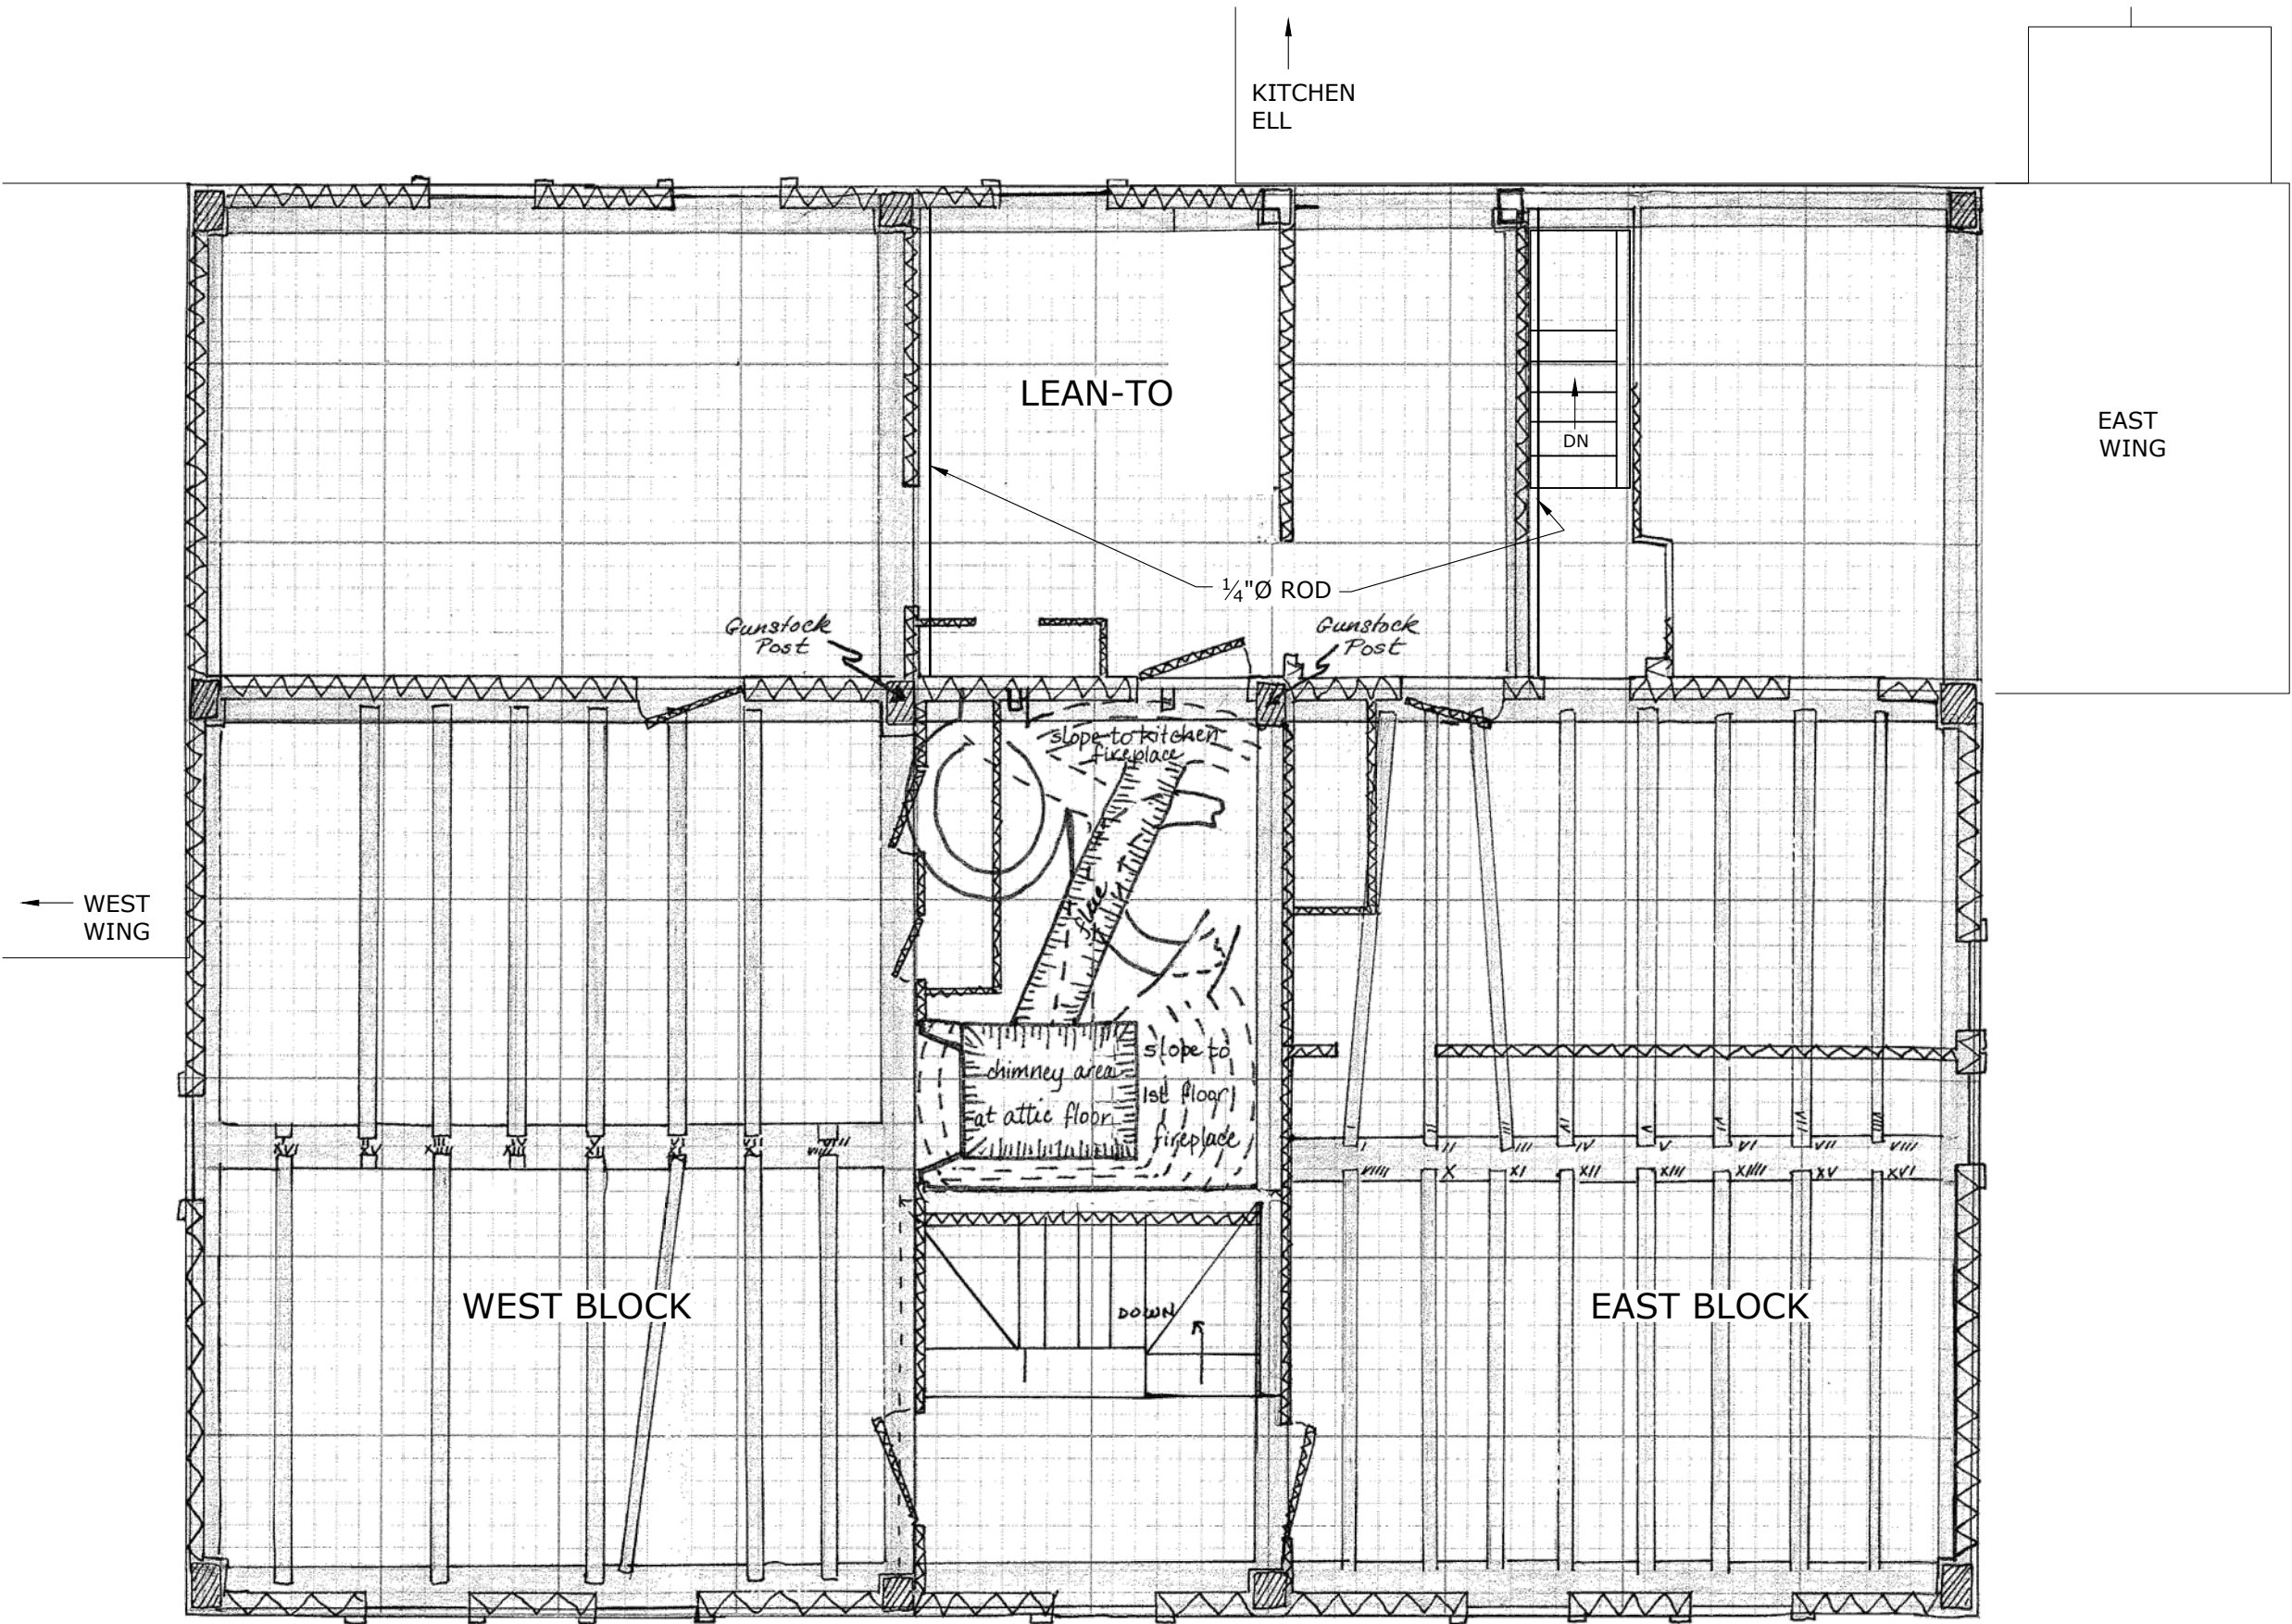
| Drawing No:<br><b>S-3</b> | |

1/4" = 1'-0" 1979 DRAWINGS OVERLAID  
WITH UPDATED NOTES

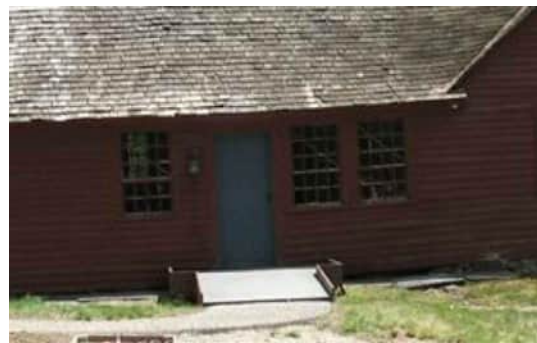
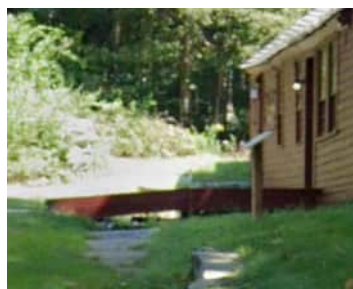
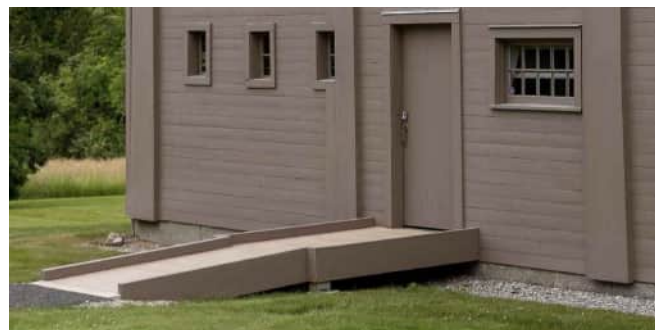
WALKWAY/RAMP SAMPLES

HANDRAILS ARE NOT REQUIRED FOR A SLOPE OF 5° OR LESS. THESE SAMPLES ARE LESS THAN 5°. THE "BRIDGE" PORTION ALLOWS THE GRADE TO REMAIN AS IS TO PROTECT SILLS.

MINIMUM DOOR WIDTH REQUIREMENT FOR ACCESSIBILITY IS 32". EXISTING DOORS ARE APPROXIMATELY 30" - 32" AND ADJUSTMENT MAY NEED TO BE CONSIDERED.
